**Subject:** Resolution No. 2013- 04, Finding that Parcel is Occupied by a Structurally Substandard Building

### **TIF ANALYSIS FOR 5146 EDEN AVENUE (PUBLIC WORKS FACILITY)**

**5146 EDEN AVENUE  
CODE/CONDITION DEFICIENCY REPORT**

**Map No. & Building Name:** Map No. 1 Former Public Works Facility  
**Address & PID:** 5146 Eden Avenue, PID 28-117-21-31-0016  
**Inspection Date(s) & Time(s):** March 12, 2013, 3:30pm  
**Inspection Type:** Interior/Exterior

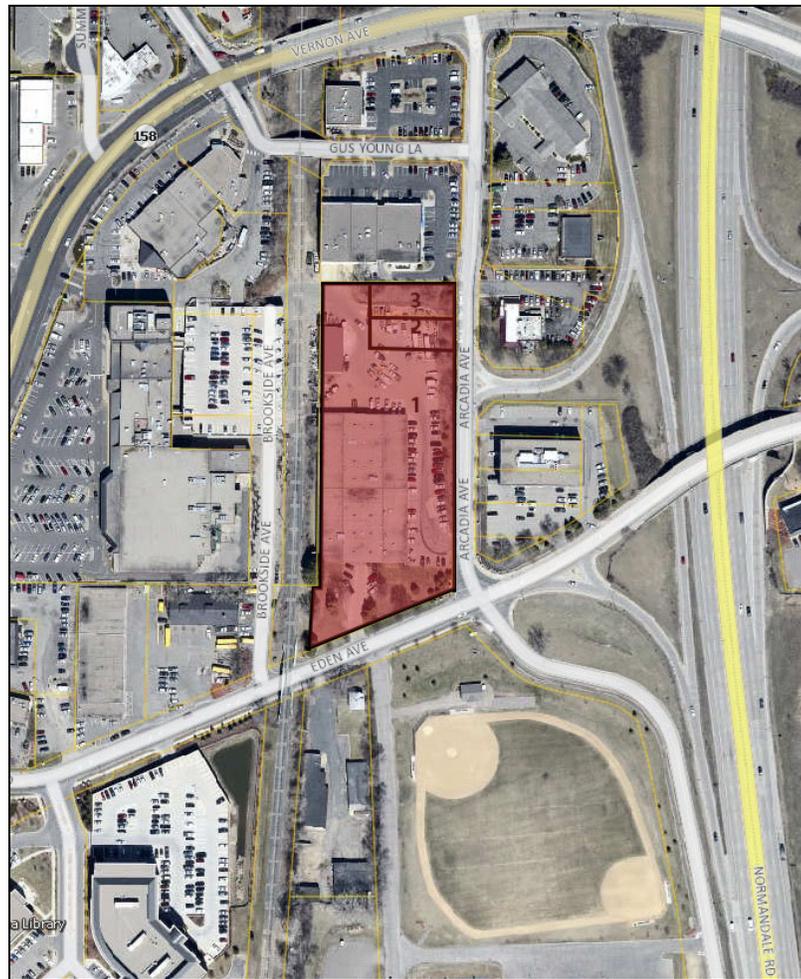
Site Diagram 1

The public works site is made up of three parcels, with more than 15 percent of each parcel occupied by buildings, streets, utilities, or paved or gravel parking lots (see attached site diagram no. 1, and summary spreadsheet).
