Architect's Observation Report

Report: 12
Date: August 19, 2014
Time: 3:00 pm
Temp: 85 Degrees+/-
Weather: Partly Cloudy

Project: 13-0639 – Edina Sports Dome and Ice Rink
Owner: City Of Edina
Architect: Cunningham Group Architecture Inc.
Copy To: File

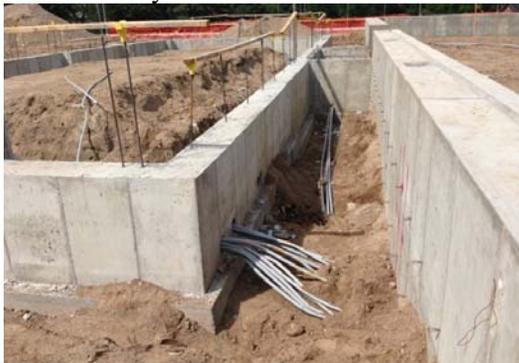
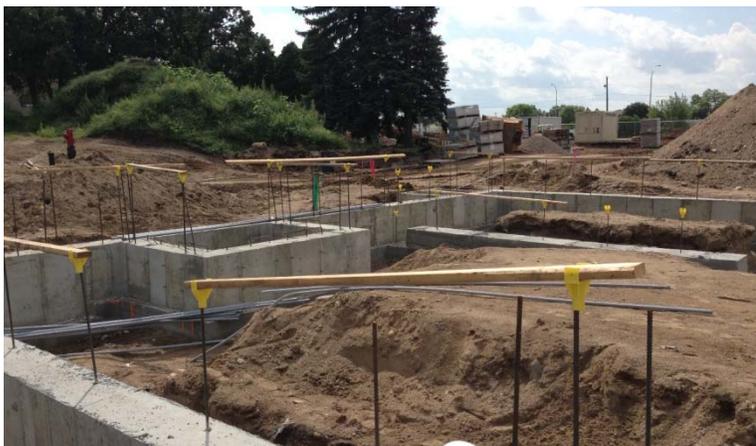
1. Accessory building footings and foundation walls are in place, and sub-grade conduits are under way.

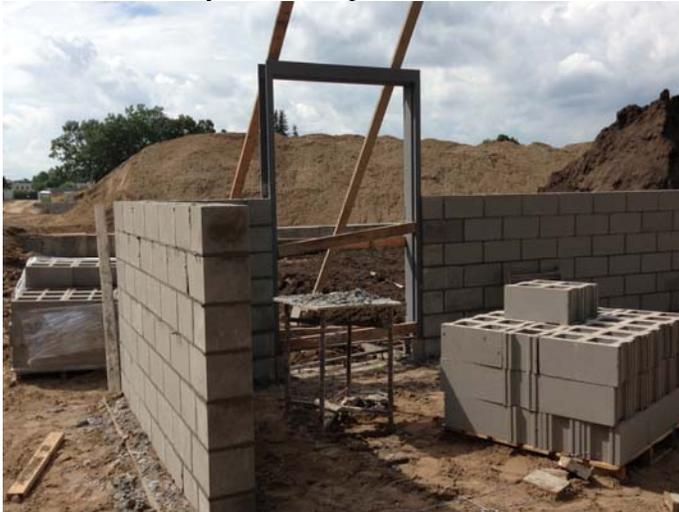
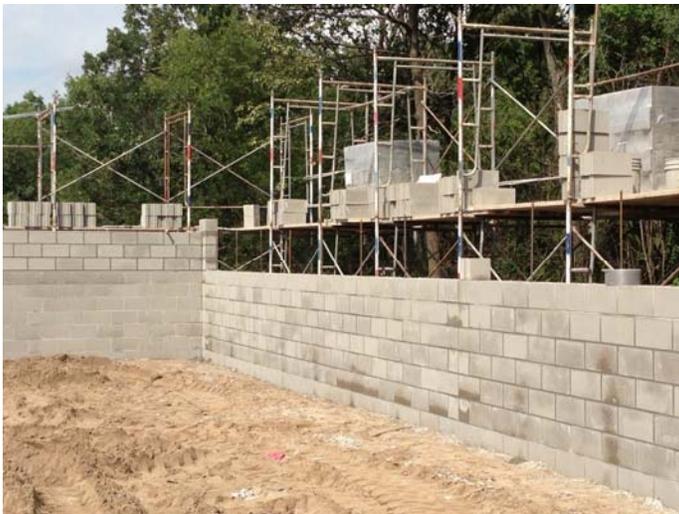
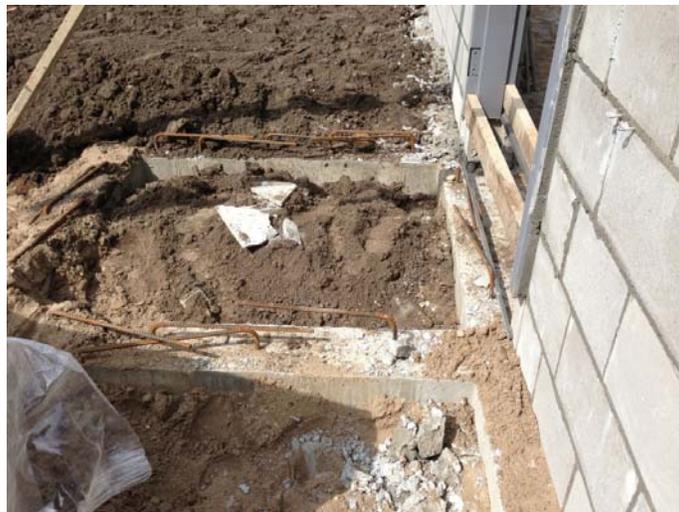
2. Storage building masonry is underway and roughly half complete. One door frame is installed. Masonry ties are in place.

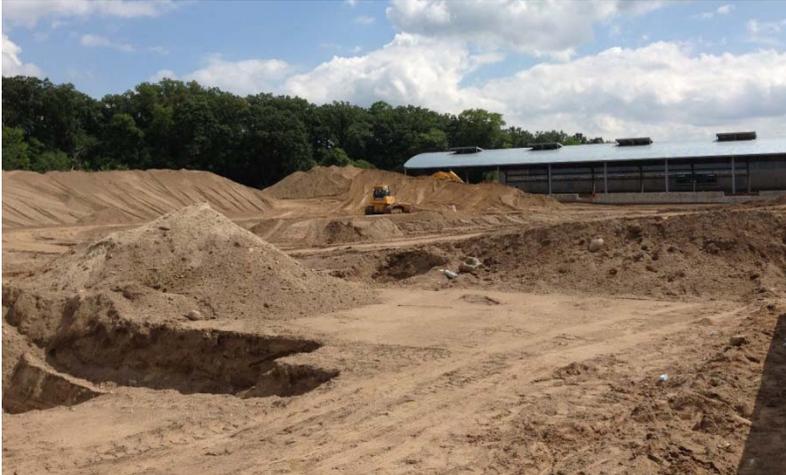
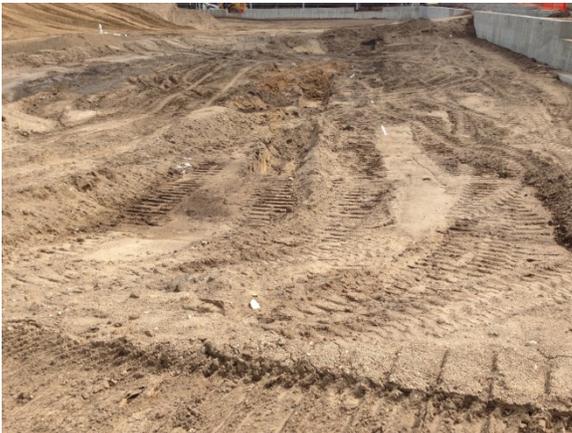
3. Sand for dome interior grading was being delivered and stockpiled at southwest corner of dome. Material is not being placed in area between the two access drives into the dome interior, pending soil corrections at sub-grade infiltration area.

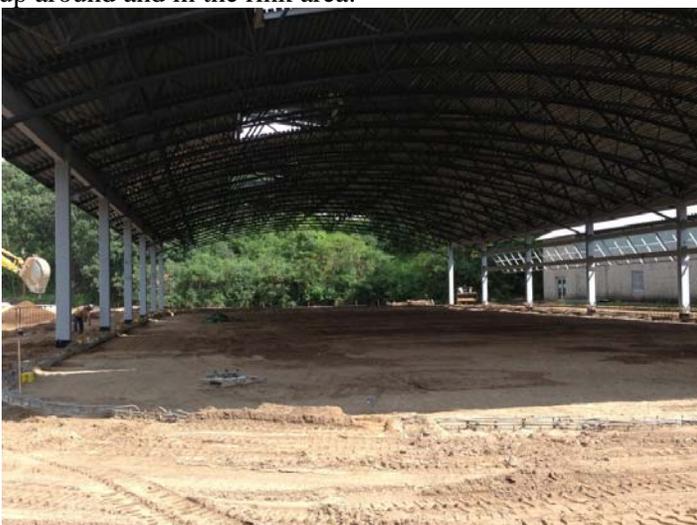
4. Steel decking for Ice Rink roof appears to be complete, and grading has been brought up around and in the rink area.

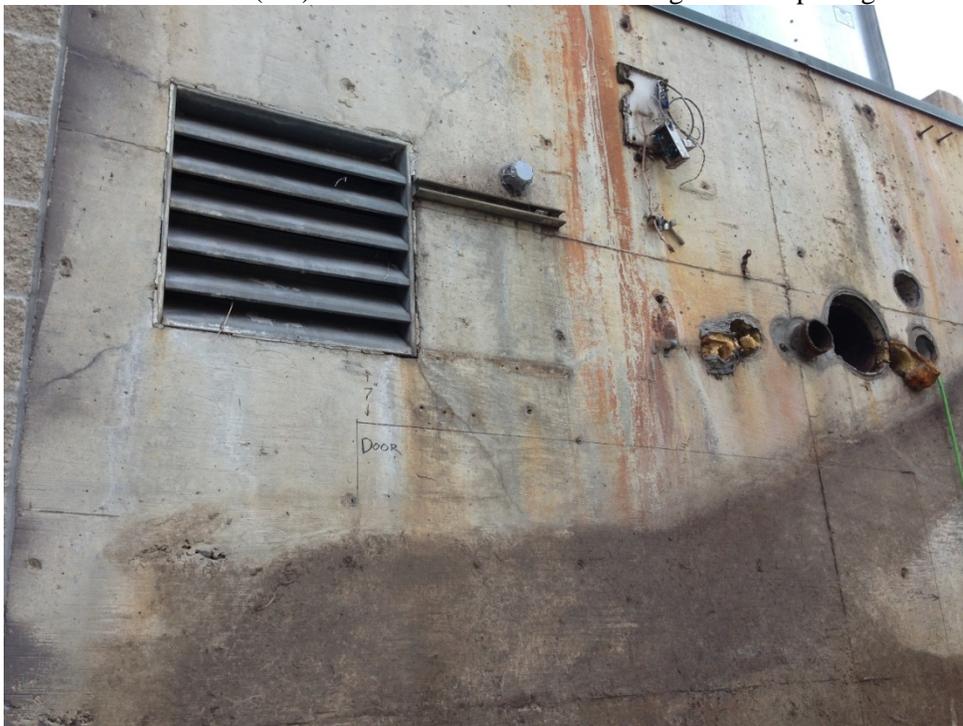
5. North wall of east arena Refrigeration Room has been abated, and preparations are being made to cut the opening. Dale noted that the markings in this photo are located 8" too far to the west (left). See info below re: reinforcing for this opening.
