# Architect's Observation Report

Report: 03  
Date: June 10, 2014  
Time: 2:36 pm  
Temp: 76 Degrees  
Weather: Sunny

Project: 13-0639 – Edina Sports Dome and Ice Rink  
Owner: City Of Edina  
Architect: Cunningham Group Architecture Inc.  
Copy To: File

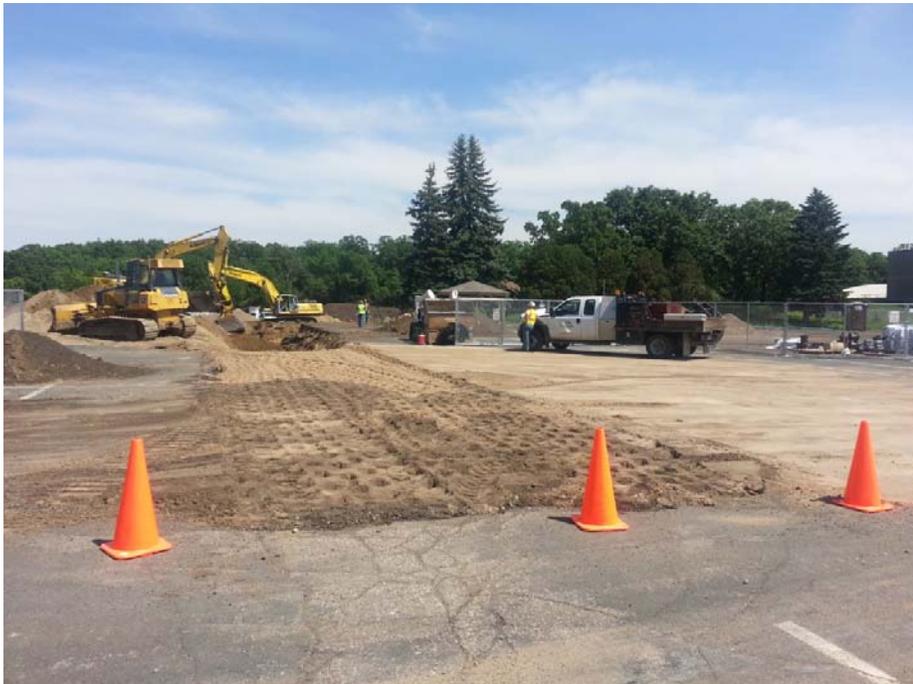
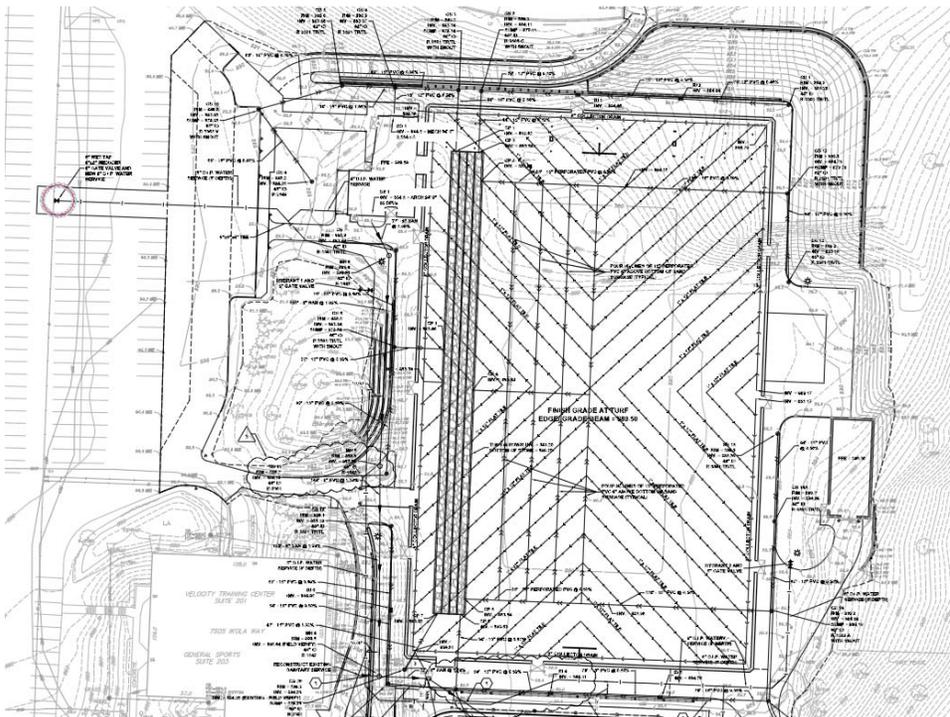
1. 6" wet-tap, reducer and gate valve connection on west side of the construction site has been completed.

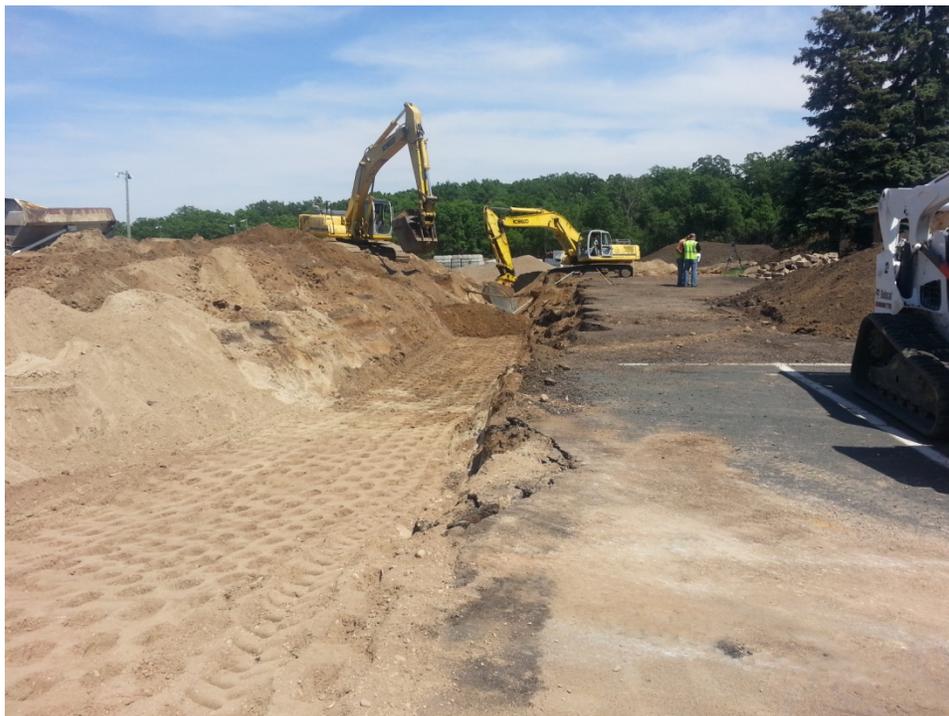
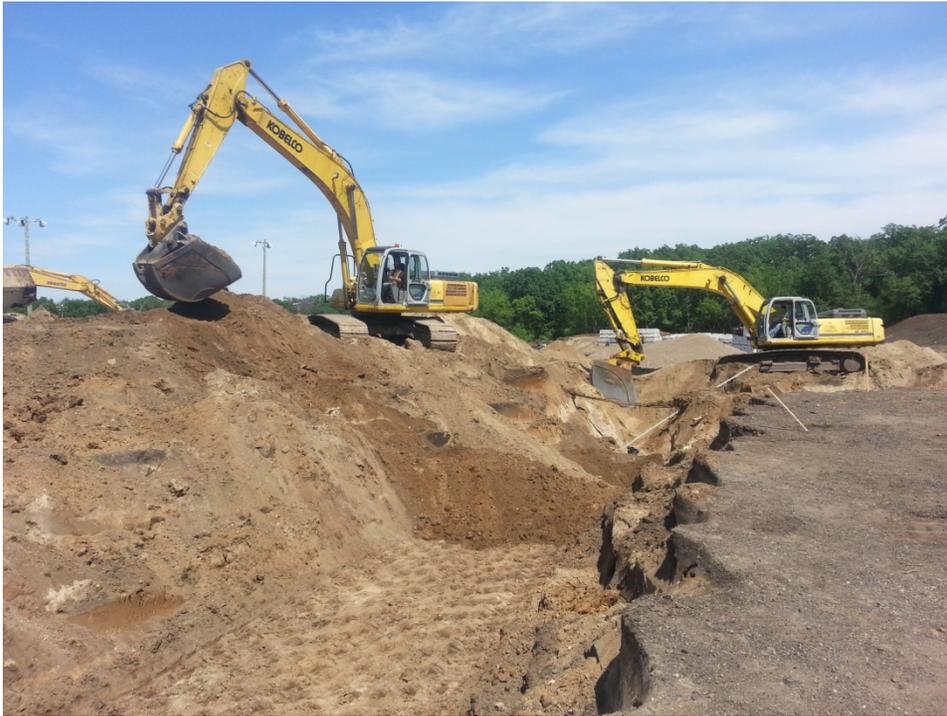
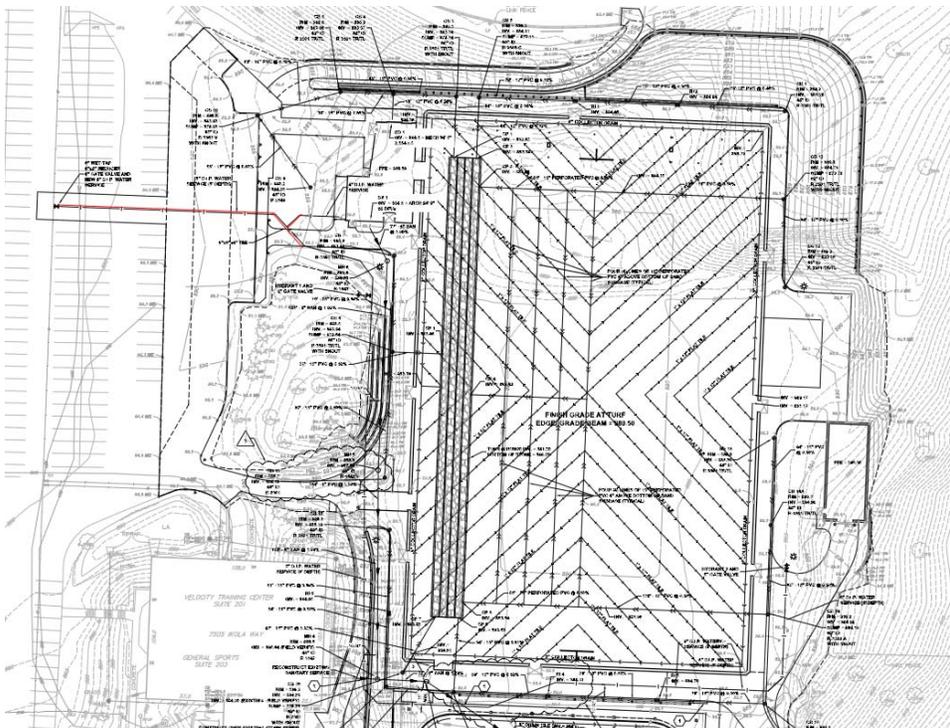
2. 8" Ductile Iron Pipe water service installation has begun at west wet tap installation. Excavation and simultaneous backfill of ductile iron pipe towards project site is ongoing.

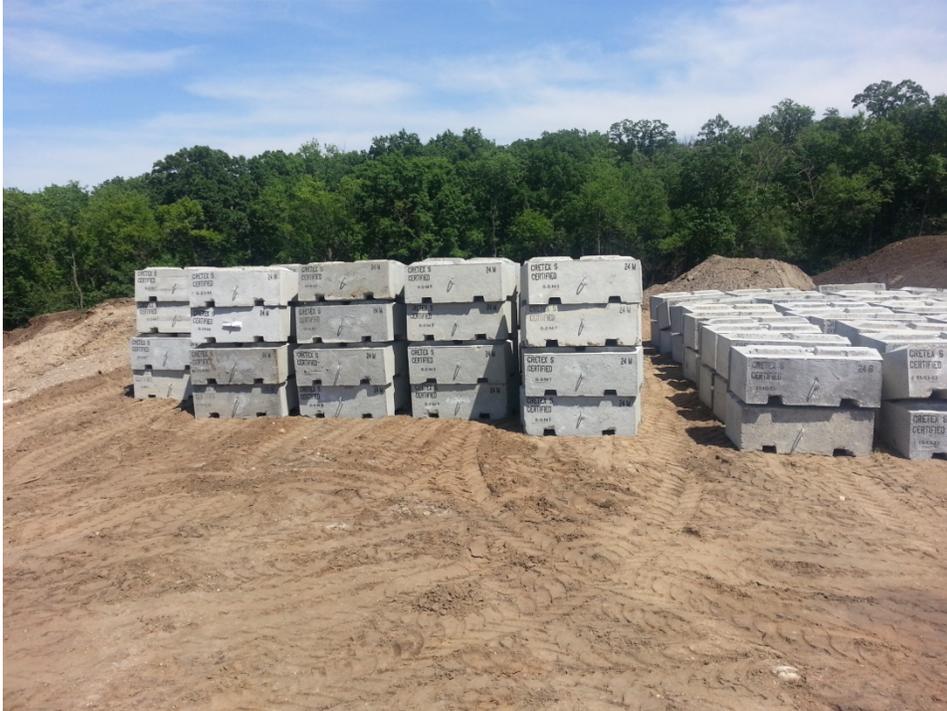
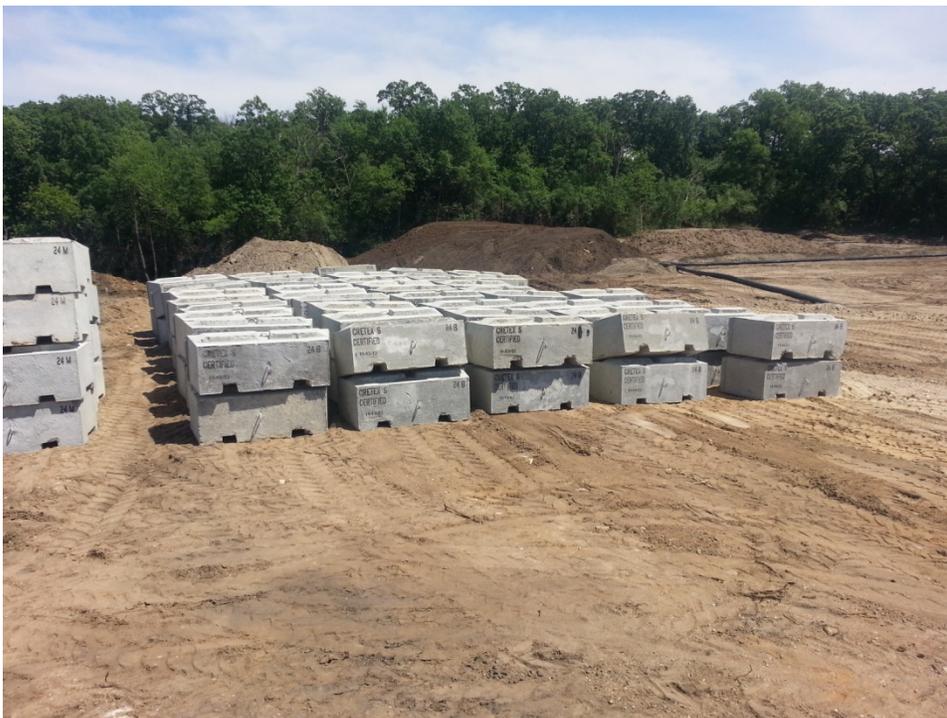
3. Big block retaining wall blocks for the large north retaining wall are currently onsite pending issuance of the retaining wall permit.

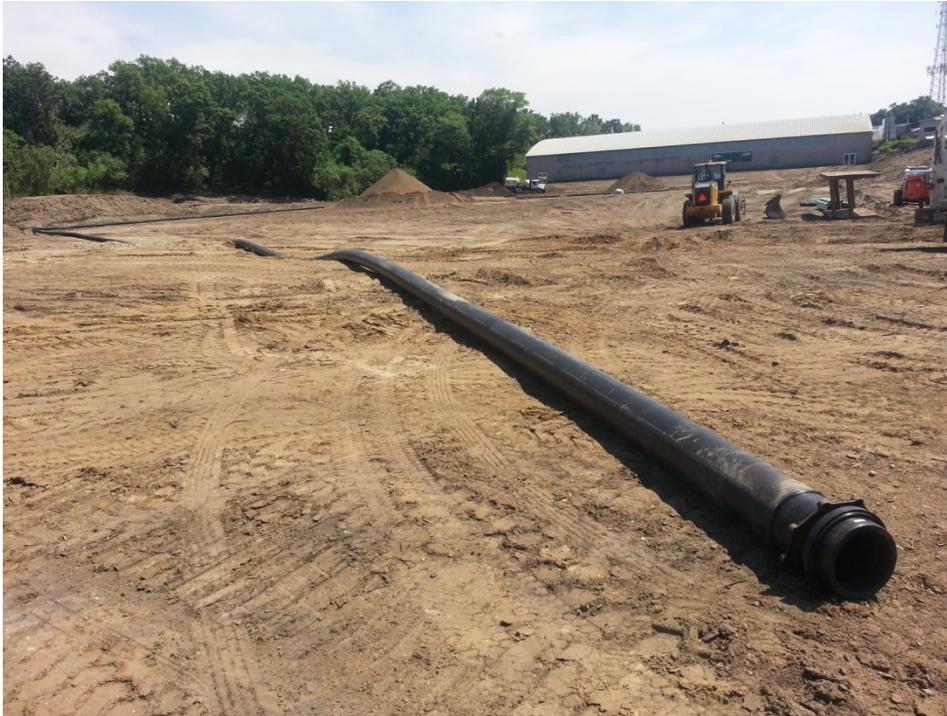
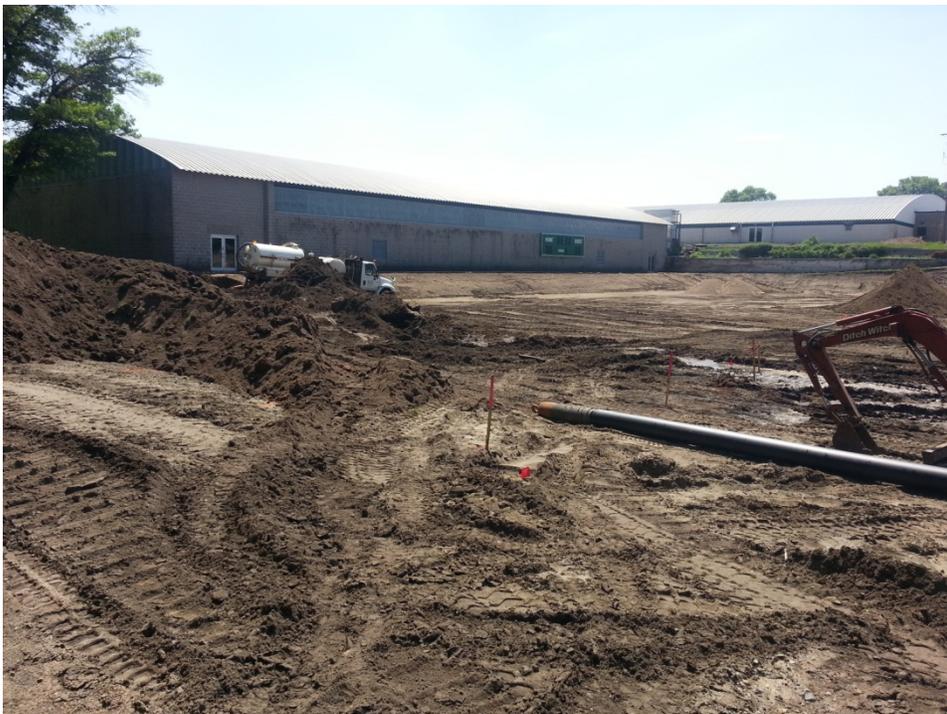
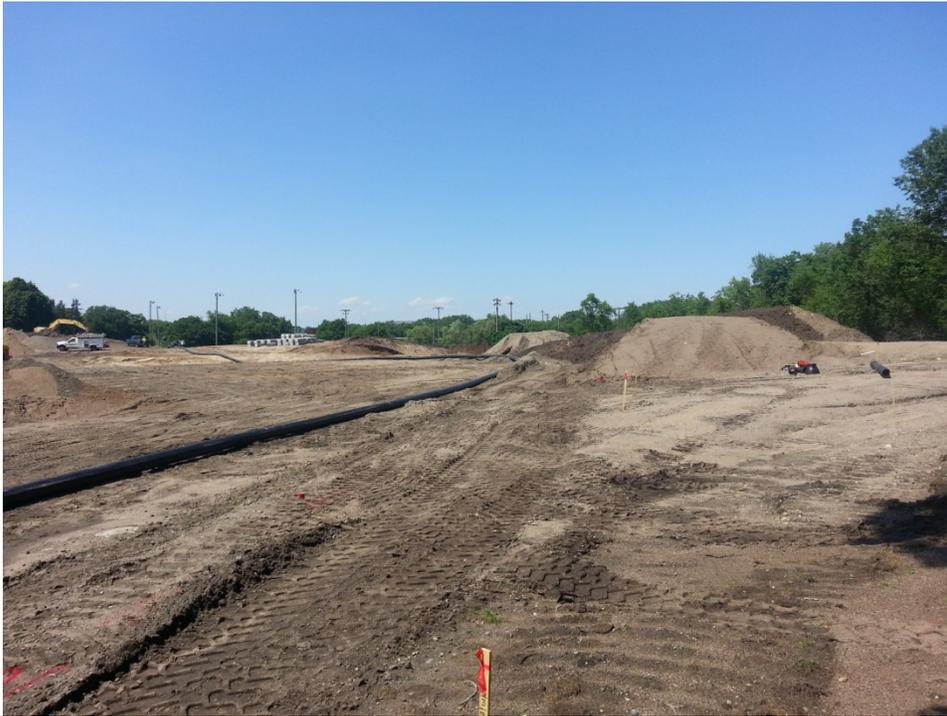
4. HDPE pipe to be pulled into the directionally drilled hole

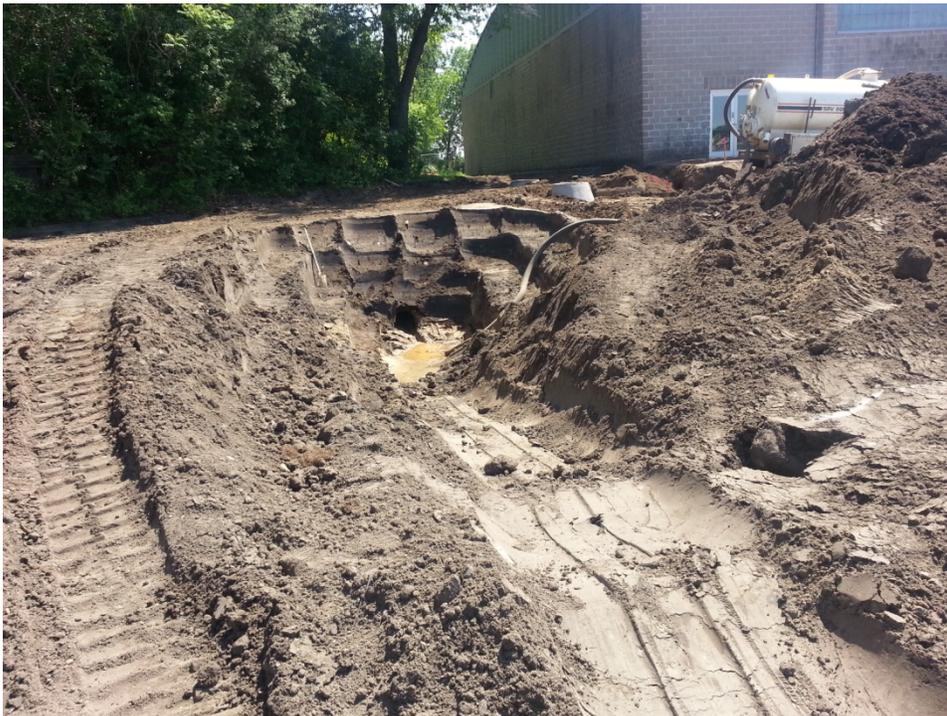
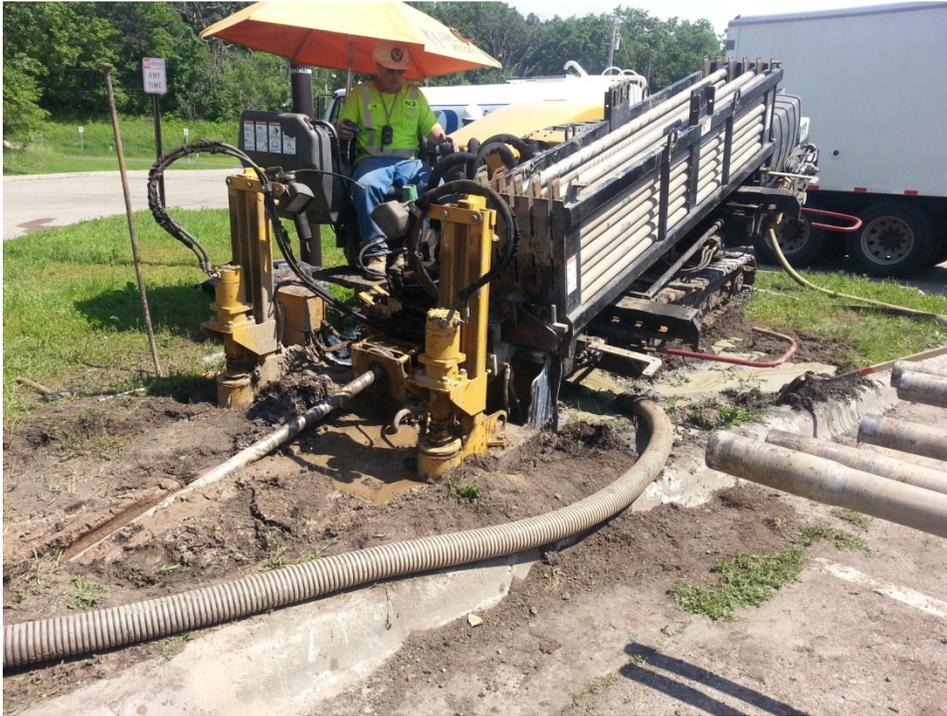
5. Directional drill outlet on north side of East Arena is currently being drained and set up to pull HDPE pipe into the directionally bored hole is currently ongoing on south parking lot.

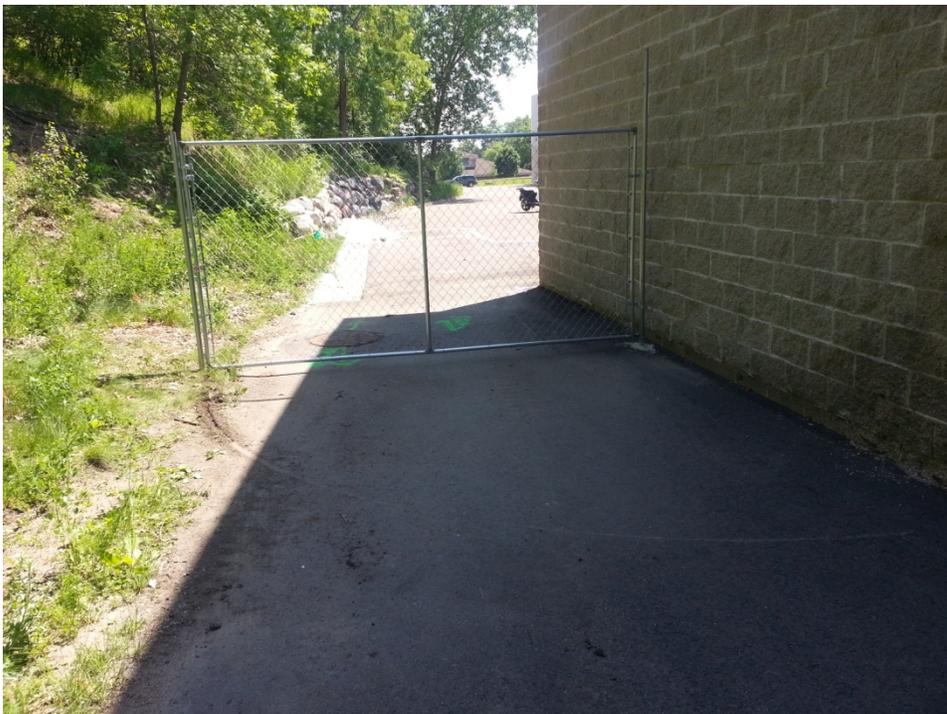
6. Gate has been installed on the east side of East Arena.

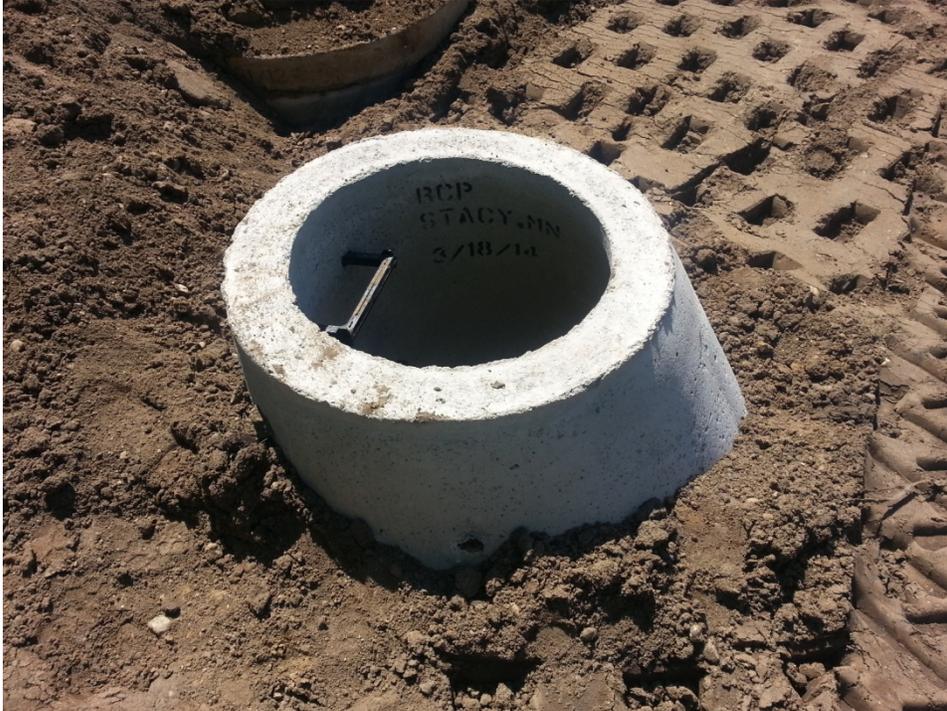
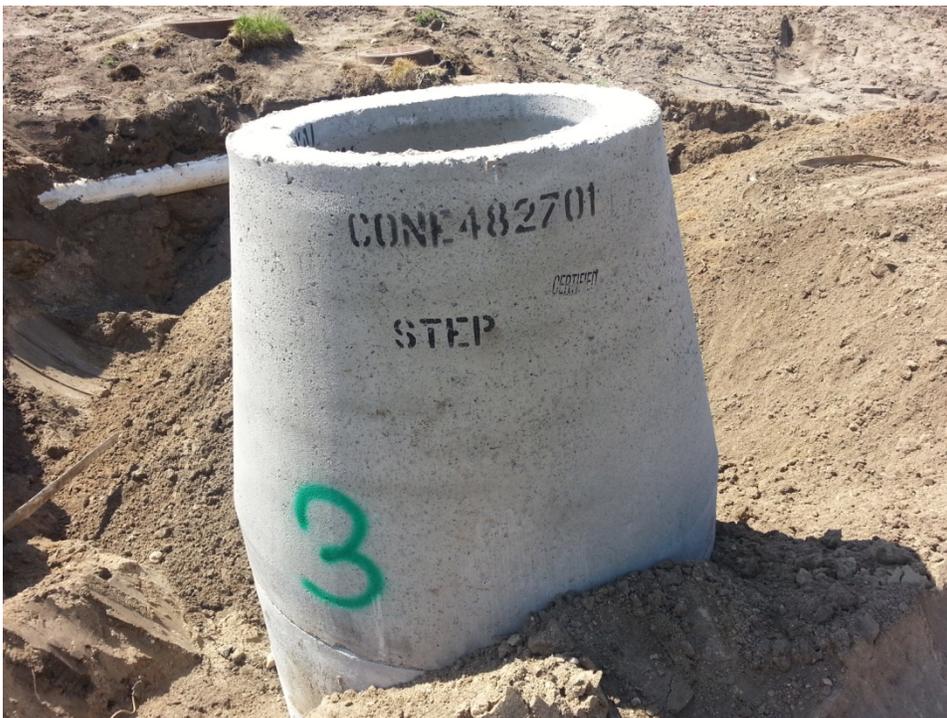
7. 3 Precast concrete manhole installation ongoing and remaining precast manholes/catch basins stored onsite.

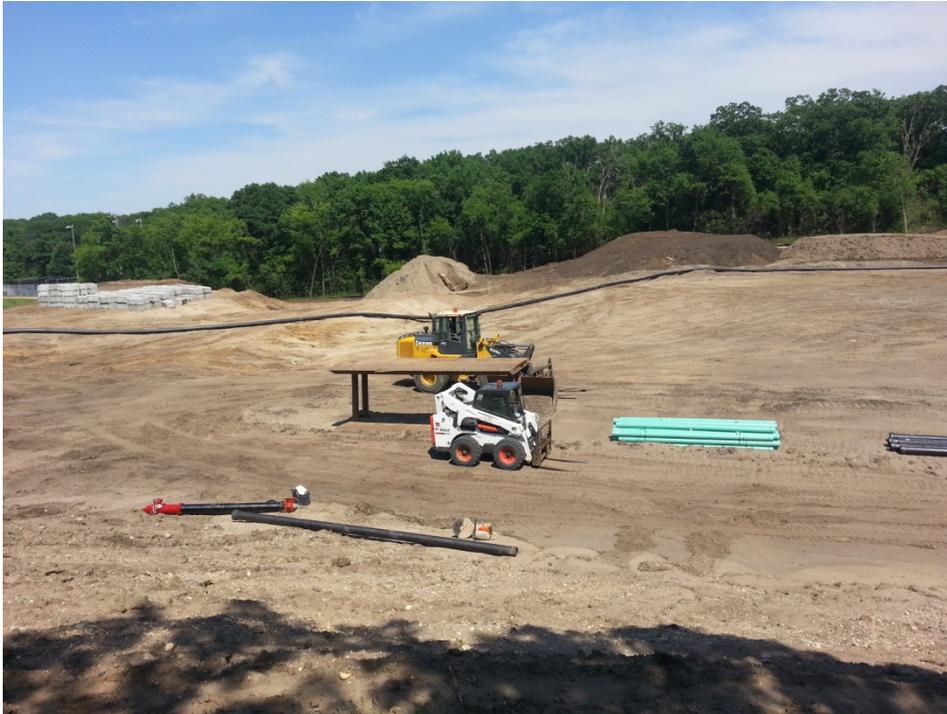
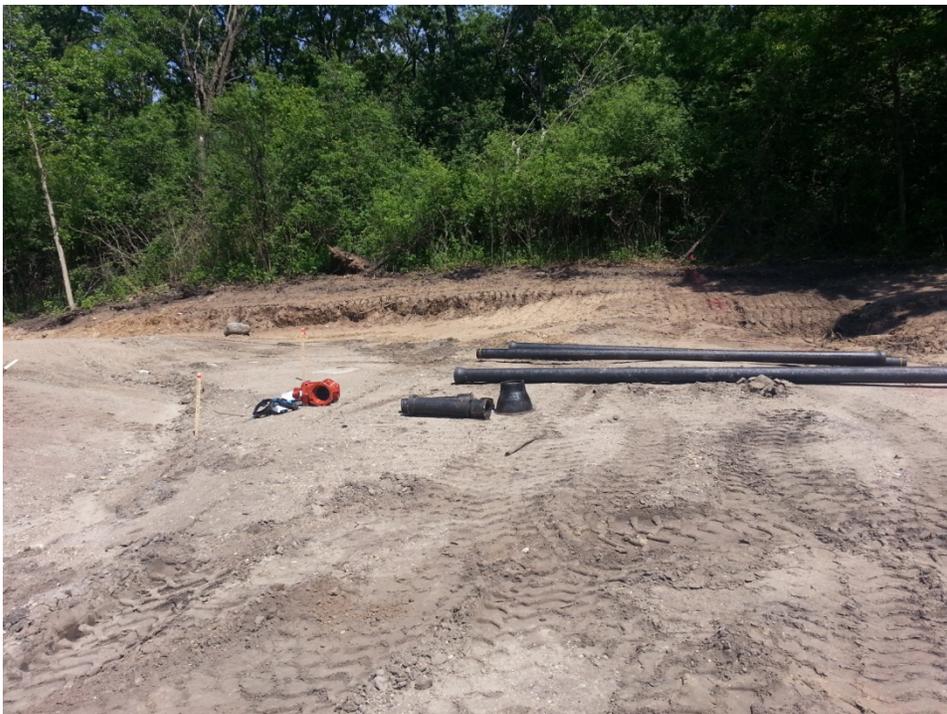
8. Hydrant and gate valve assembly currently in progress onsite.

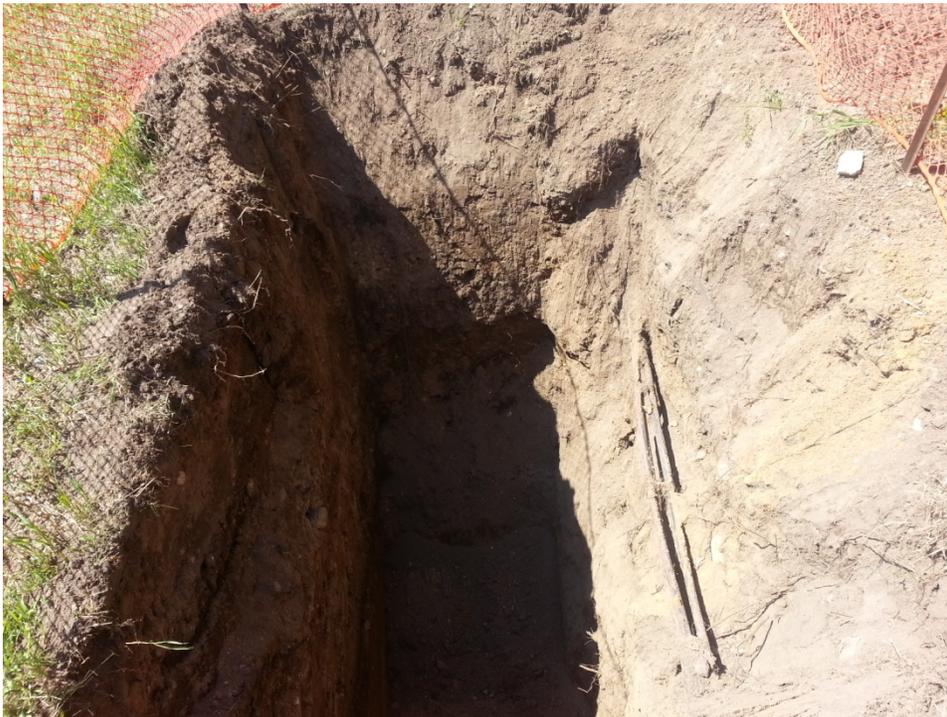
1. A Comcast cable line serving the Golf Dome Accessory Building was hit by New Look Construction last week. Dale Michalek to verify that it has been fixed. **Susan Faus to verify if Braemar Golf Dome Cable is still functioning.**
2. Retaining wall permit is also pending, ~~Tunde Olusanya to contact Steve Kiehn to determine Status of permit.~~ **Pending signed special structural testing and inspection schedule.**
3. Directional drill hit an unmarked storm line just East of South Arena; the City of Edina has been notified – repairs to follow.
