# REPORT / RECOMMENDATION

**Subject:** Traffic Safety Committee Report of August 13, 2014

## Traffic Safety Preview

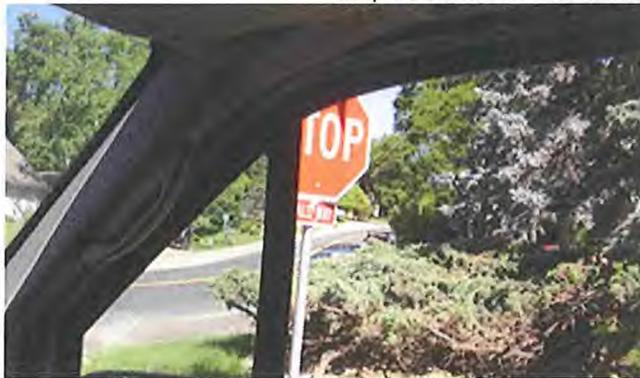
Requestor states that stop signs on Gleason Rd are being ignored. Site investigations showed that this location was at the bottom of a steep (8.75% grade) hill, and is controlled by an all-way stop. In a video study of the intersection on July 8<sup>th</sup>, from 10:19 AM to 1:48 PM (250 vehicles), traffic traveling south on Gleason ran the stop sign at a rate of 22%, while full and complete stops were performed at a rate of 15 percent. Gleason has 2,451 vehicles daily (from a state-aid count), while Scotia has 200 daily vehicles. No accidents relating to traffic control were reported in the last five years.

*Photo : Sightlines from the stop of Scotia*

**After review, staff recommends approval of this request. Police have already been stationed at this intersection and will continue to conduct operations at this location.**

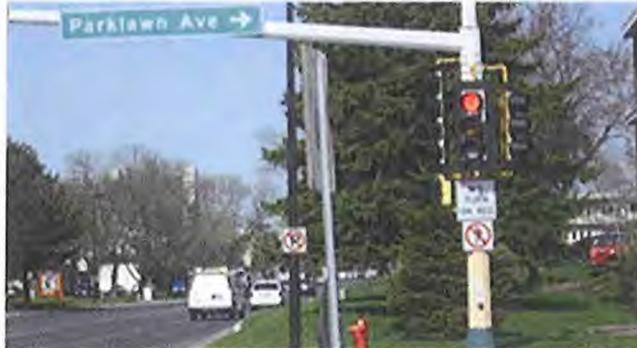
This request concerns the bus stops on 77th Street and Parklawn Avenue and the pedestrian environment of the intersection. Currently there are near side bus stops, and signs banning pedestrians from crossing the north, south and east legs. The concern is that a law-abiding user of transit would be unable to use the bus stops, due to the ban on pedestrian movements. Specifically the south and west legs were requested to have their signs removed and pedestrian signals installed. The Minnesota Manual on Uniform Traffic Control Devices, section 2B.51, addressing such signs states in the support section that the sign is intended to be used on only one leg of an intersection, in order to provide access.

*Photo: 77<sup>th</sup> Street and Parklawn Avenue, looking west*

**After review, staff recommends a request for proposals be submitted for a crosswalk on the north leg of the intersection, to provide access. Staff also recommends that the no right on red restriction remain in place.**

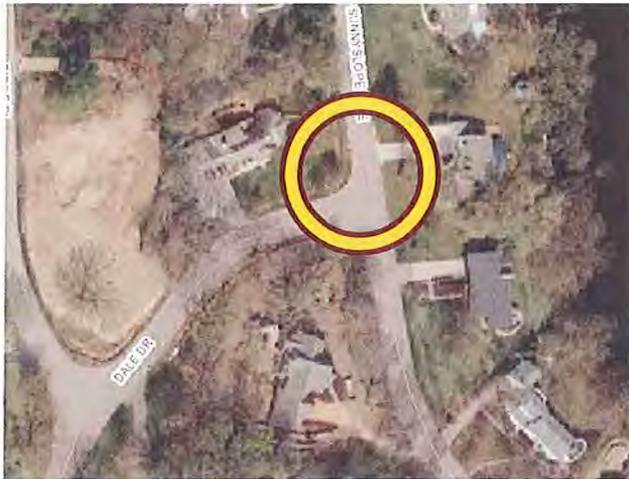
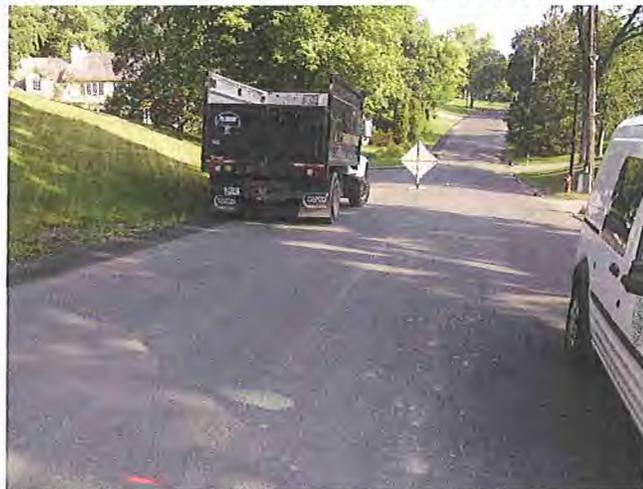
Requestor asks for stop signs at this intersection, noting that it is currently uncontrolled, and dangerous. Counts were conducted on the streets as they approach the intersection, with Dale Dr having 120 ADT with an 85<sup>th</sup> percentile speed of 19.3 mph, and Sunnyslope Rd having 208 ADT with an 85<sup>th</sup> percentile speed of 26.2 mph. Traffic eastbound on Dale and northbound on Sunnyslope cannot see each other adequately according to AASHTO's (American Association of State Highway and Transportation Officials) 2004 Geometric Design of Highways and Streets, due to a hill on the southeast corner of the intersection. No accidents have been recorded at this intersection in the past five years. Stop sign warrants are provided in Appendix A.

*Photo : Sunnyslope Rd and Dale Dr sight obstruction, 115 feet from conflict point*

**After review staff recommends placing a stop sign for Dale Drive at the intersection of Sunnyslope Road, due to sightline constraints.**

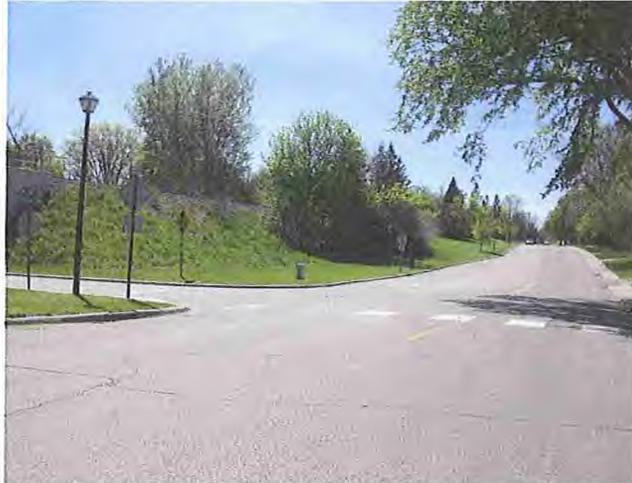
Requestor states that the intersection delay is very high at 44<sup>th</sup> St and Brookside Ave for those on 44<sup>th</sup>, where there is a one way stop. The requestor also noted that Division St has an all way stop with Brookside, while it is a more minor street than 44<sup>th</sup>. Counts were taken and are shown on the diagram in Appendix B. A delay study of 44<sup>th</sup> was done during the peak hours and maximum delay (5 minute average) was 37.5 seconds-per-vehicle, total delay over the morning peak was 0.475 hours for 325 vehicles and over the evening peak was 1.08 hours for 456 vehicles. No crashes at the intersection have been reported in the last five years. Application of an All-Way stop is detailed in Appendix A.

*Photo : Brookside at 44<sup>th</sup>, looking south (towards Division)*

**After review staff recommends denial of this request, due to lack of warrants.**

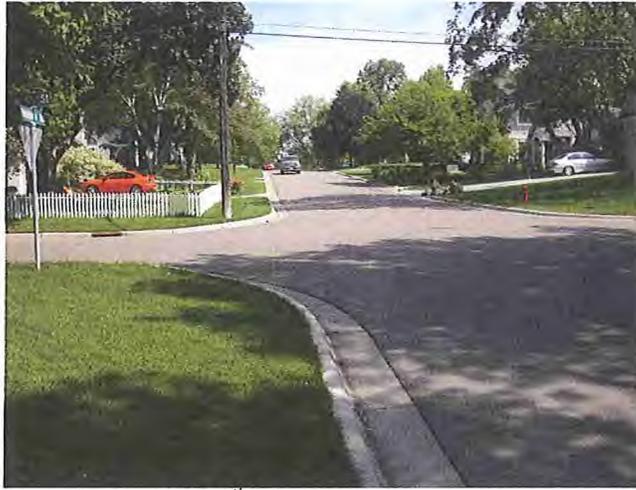
A 2010 traffic study was done on this intersection, and similar speeds and counts to previous studies show that the area is not experiencing large changes in traffic conditions. West 55<sup>th</sup> Street has an 85<sup>th</sup> percentile vehicle speed of 14.6 mph. Brookview has an 85<sup>th</sup>-percentile vehicle speed of 23.7 mph. Due to requestor concerns that previous requests had not included the children of the area on bicycles, scooters and walking, a video study of the intersection was done. The video study showed that an average of 306.5 users per day of the intersection approached on 55<sup>th</sup> (including 74.5 pedestrians and 73.5 bicycles), while 418.5 users per day approached on Brookview (including 78.5 pedestrians and 53 bicycles). There is one reported accident at this location.

*Photo : W 55<sup>th</sup> St. and Brookview Ave looking north.*

**After review staff recommends denial of this request based on lack of warrants. This decision took into account motorized traffic as well as bicycles and pedestrians.**

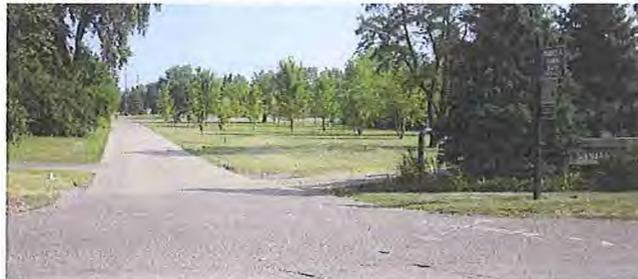
Requestor states that traffic accessing the park is going at high speeds and wishes for traffic calming, along the south access drive of the park. Counts were taken early in the year (end of April) and in midsummer to account for differences in the park's demand. The spring counts had 137 weekday ADT, with an 85<sup>th</sup> percentile speed of 24.9 mph, 88 Saturday ADT, with an 85<sup>th</sup> percentile speed of 25.6 mph, and 103 Sunday ADT, with an 85<sup>th</sup> percentile speed of 24.7 mph. Summer counts had 161 weekday ADT, with an 85<sup>th</sup> percentile speed of 24.5 mph, 138 Saturday ADT, with an 85<sup>th</sup> percentile speed of 24.5 and 154 Sunday ADT with an 85<sup>th</sup> percentile speed of 24.1 mph. The access drive is very narrow at 18.5 feet in width, no accidents have been reported on the access drive in the past five years.

*Photo : Pamela Park south access drive, looking north*

**After review, staff recommends denial of this request, based on low speeds and the planned future construction of a sidewalk/pedestrian trail on the east side of the access drive.**

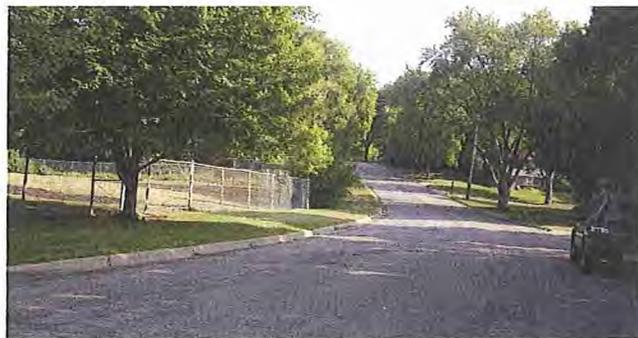
Requestor states that people often speed up and down the hills on Lynn Ave and Monterey Ave and asks for placement of speed bumps, further enforcement, and the dynamic speed signs on Monterey Ave. Requestor has already been informed that the city does not install speed bumps. Counts were taken on Monterey Ave, with a weekday ADT of 150 vehicles and an 85<sup>th</sup> percentile speed of 25.2 mph. Neither street has a reported accident in the past five years. There is a significant hill on Monterey Ave (8.75% grade), the condition of the roadway and curves in the roadway, prevented counts nearer to the hill.

*Photo : Monterey Ave, midblock, looking north*

After review, staff recommends denial of this request, based on the low speeds in the area.

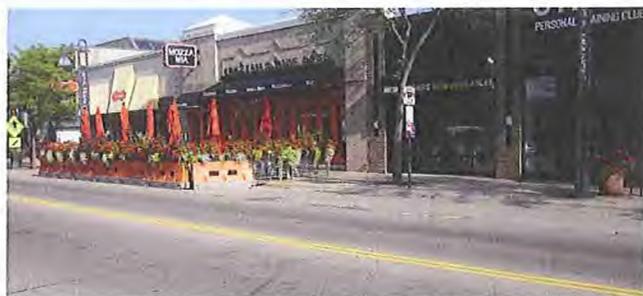
This request comes from the 50<sup>th</sup> and France business association. Noting the Mozza Mia patio in the front of a bus bay on 50<sup>th</sup> St. west of France Ave. the business association has asked for a 15-minute parking / loading zone to be added to the front of the two remaining stalls along 50<sup>th</sup> in the area. Metro Transit field operations has indicated their preference not to place the stall in the bays, as drivers often do not recognize that there is only one stall. However, if a stall is to be placed, Metro Transit does request it be in the rear of the bus bays. Metro Transit's concerns involve curbing their buses, overuse of the parking, and winter use of the bays.

Photo : Mozza Mia patio in bus bay

After review, staff recommends denial of this request, based heavily on the advice of Metro Transit, and traffic flow issues that might stem from any abuses of the request.

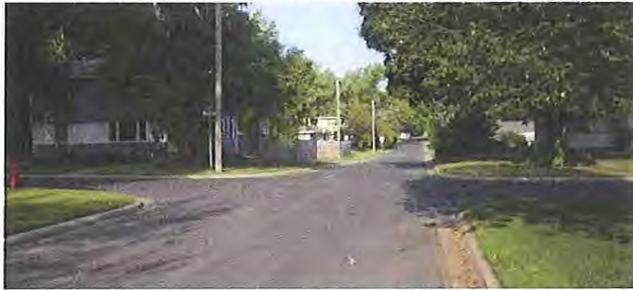
Photo : W. 51<sup>st</sup> St and William Ave

Requestors note that this intersection is uncontrolled and has become a cut through for traffic from Interlachen Blvd to Vernon Rd, avoiding congestion at the intersection of those two streets. The surrounding area is uncontrolled, one reported accident has occurred in the last five years at this location. Counts were taken at this location, with 51<sup>st</sup> St having 120 ADT and 85<sup>th</sup> percentile speeds of 15.8 mph, on Saturday 16.3 mph was the 85<sup>th</sup> percentile speed. On William, ADT was 139 and the 85<sup>th</sup> percentile speed was 24.5 mph. Due to parking near and possibly on the counting equipment, these counts have a higher margin of error than is typically associated with counts

After review staff recommends denial of this request due to lack of warrants.

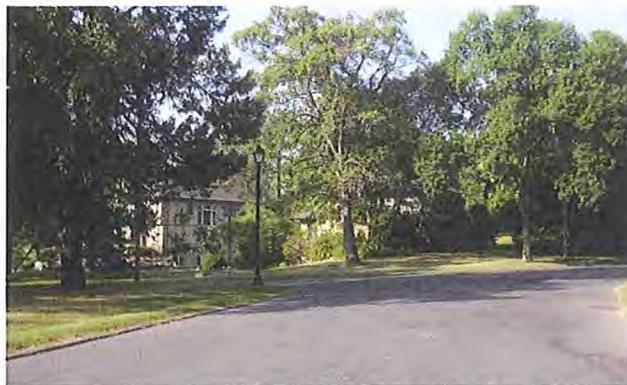
*Photo : Ridge Pl and Woodhill Way*

Requestor asks for stop signs at this intersection, noting that it is currently uncontrolled, and dangerous. The surrounding area is uncontrolled, counts were conducted on the streets as they approach the intersection, with Ridge having an ADT of 273 and an 85<sup>th</sup> percentile speed of 20.0 mph. Repeated counter failure on Woodhill Way does not allow for a full picture of the intersection, however in site visits, it became apparent that Woodhill is the minor street at this intersection, with most traffic turning to or from Ridge. During site visits multiple residents voiced their opposition to adding stop signs to this intersection. There have been no accidents at this location recorded in the last five years.

**After review, staff recommends denial of this request, based on lack of warrants.**

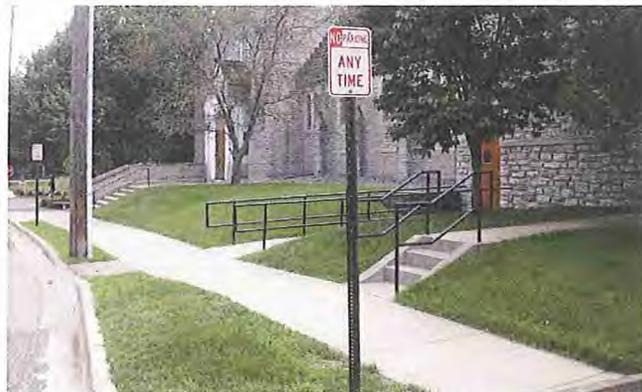
This request comes from the Edina Morningside Church, asking for parking spaces near the accessible entrance of the church to be marked as handicapped only parking. The requested area is along Morningside Road. Typically two parishioners drive themselves, or are escorted up to the church, for services, which leads the requestor to ask for two spaces be reserved for parking and another to be used as a drop off zone. Currently this area is signed as no parking, for 150 feet from the corner of Morningside and Grimes Avenue, which is all-way stop controlled.

*Photo : Morningside, looking east, towards Grimes*

**After review, staff recommends that more measurements be taken to be sure of available space for legal parking between the intersection and the curb's taper.**
