THE SECRETARY
OF THE INTERIOR'S
STANDARDS FOR
REHABILITATION &

ILLUSTRATED
GUIDELINES ON
SUSTAINABILITY
FOR
REHABILITATING
HISTORIC
BUILDINGS

U.S. Department of the Interior
National Park Service
Technical Preservation Services

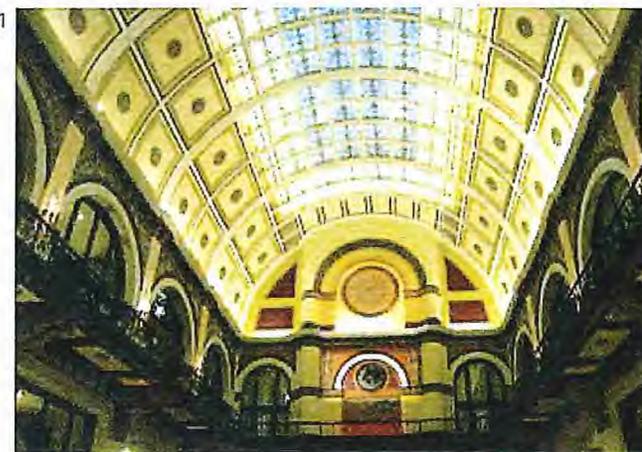
[1] Stained glass skylight provides natural light in a historic train station.

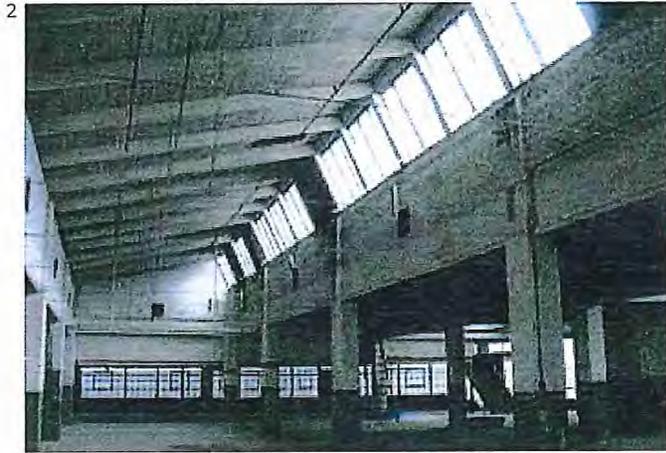
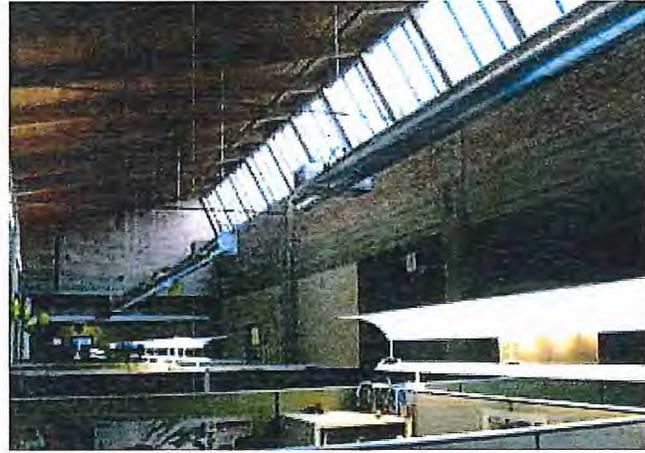
[2-3] Clerestory windows provide natural light in a historic industrial building: Before and after rehabilitation.

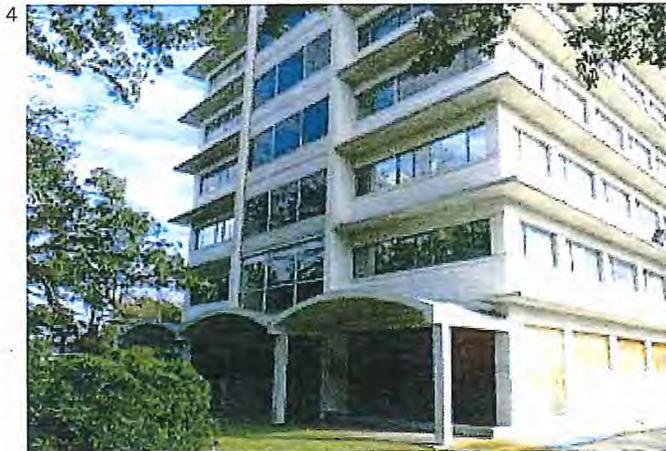
[4] Covered walkways and horizontal sun screens are distinctive and sustainable features in some mid-century modern office buildings.

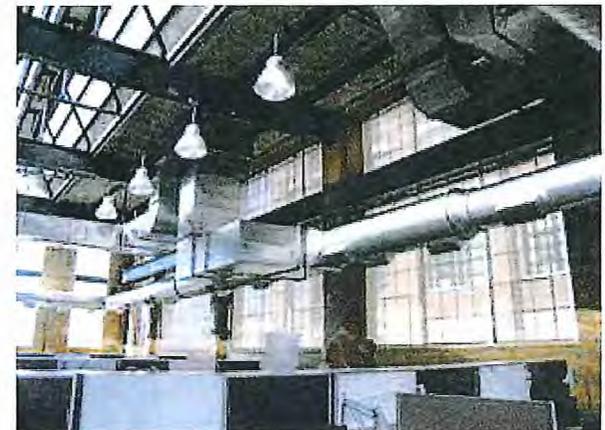
[5-6] Large windows and a roof monitor provide natural illumination in a historic industrial building.

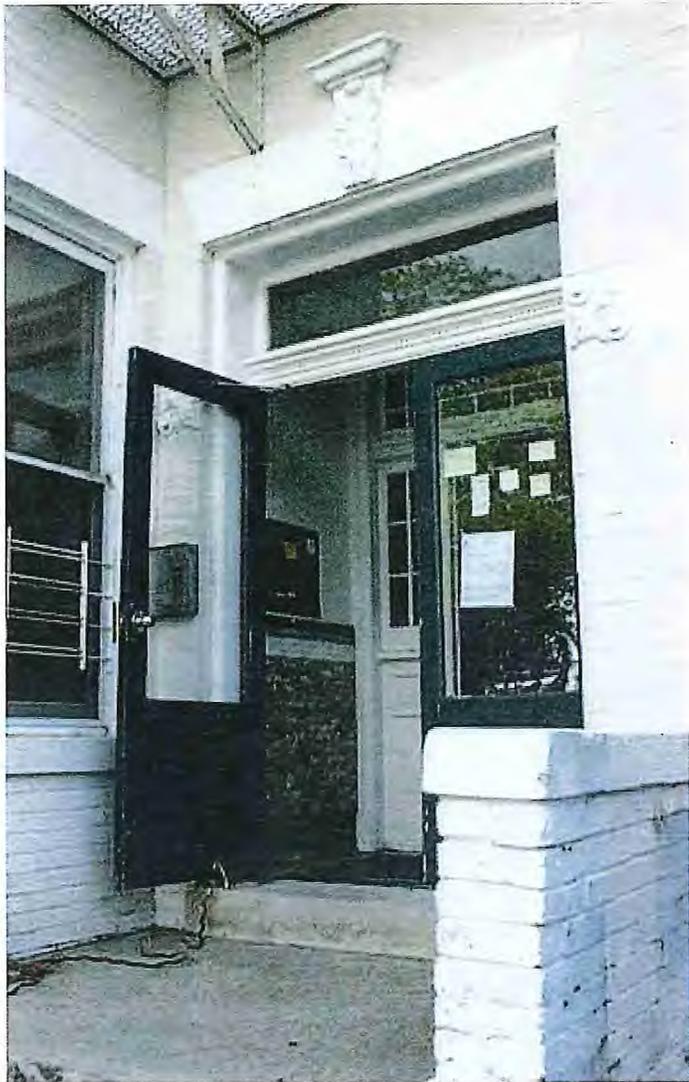
[11] A vestibule helps retain interior conditioned air in the living space in this historic row house.

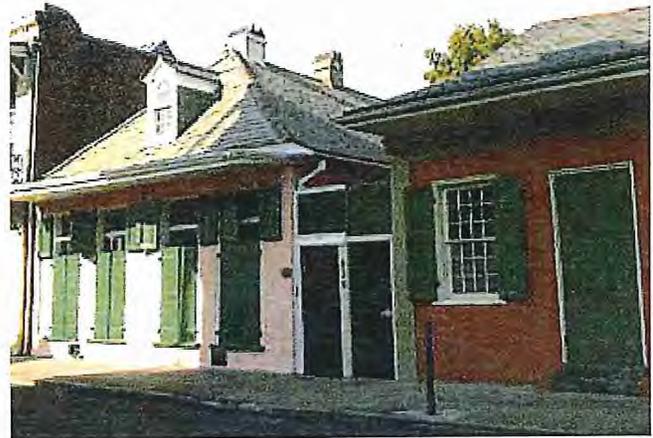
[10] Wood shutters provide natural light when open and keep interiors cool when closed in historic residential buildings.

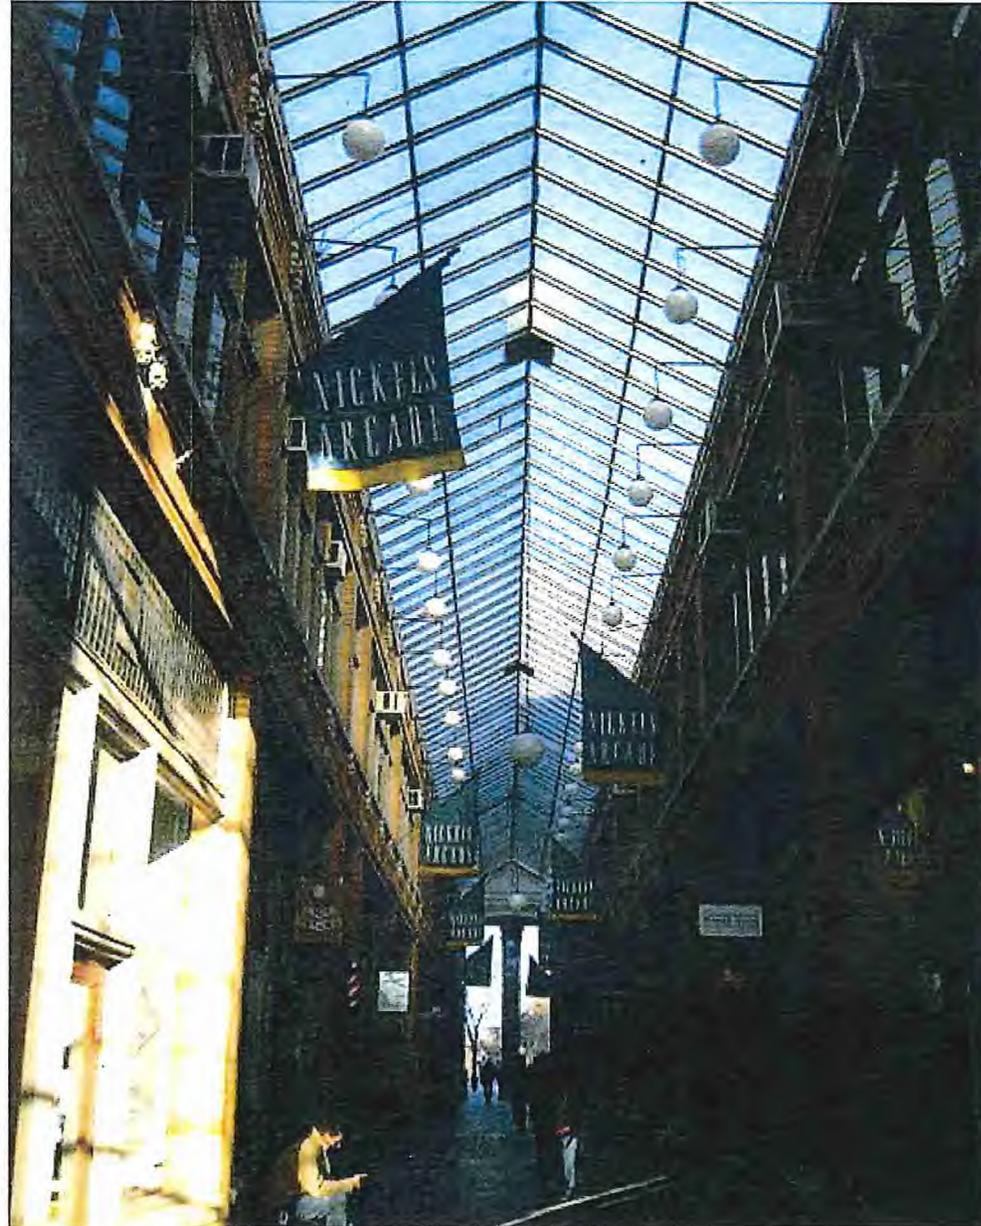
[15] Glass skylight illuminates historic shopping arcade.

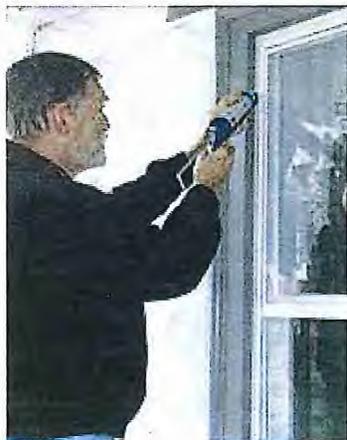
20

Recommended: [19] Caulking the gap between the aluminum storm window and wood window frame helps maximize thermal efficiency in this historic residence.

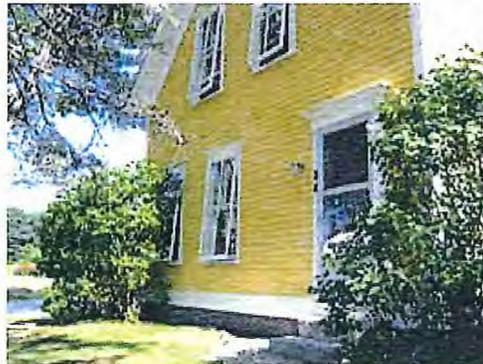
25

Not Recommended: [27] A broken sash cord can be repaired easily and does not justify replacement of the window.

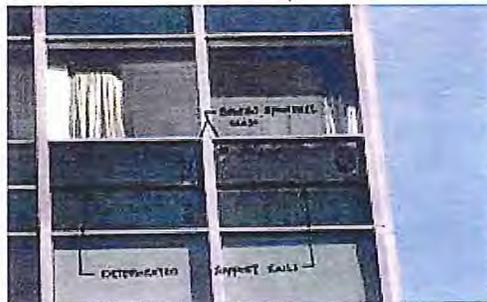
39

Recommended: [39-40] The original windows, which were deteriorated beyond repair, featured a dark tint. They were replaced with a slightly lighter-tinted glazing to improve daylighting in this mid-century modern office building.

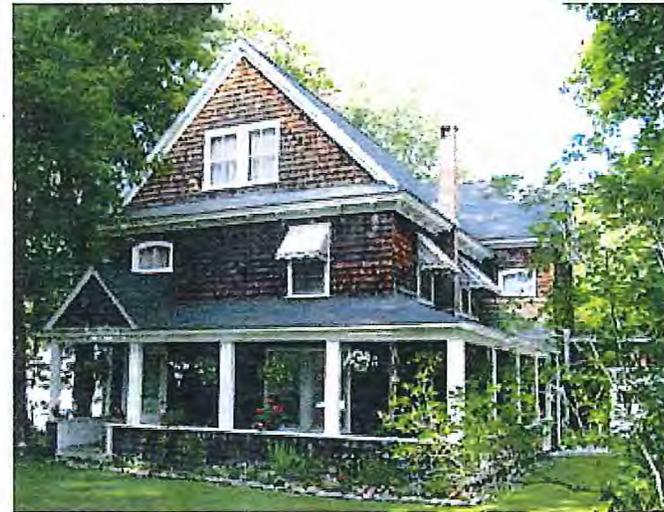
41

Recommended: [41] Traditional canvas awnings should be retained when they exist on historic buildings.

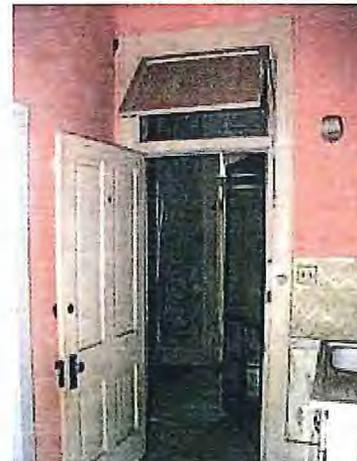
Recommended: [42] Transoms and screen doors are distinctive and practical features that provided cross ventilation in this historic hotel.

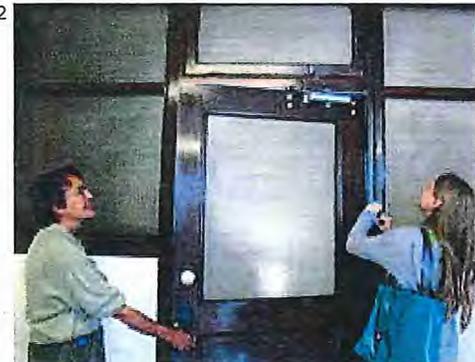
43

Recommended: [43] The wall and door glazing ensures that the corridor receives natural daylight and the operable transom helps air to circulate in this historic office building.

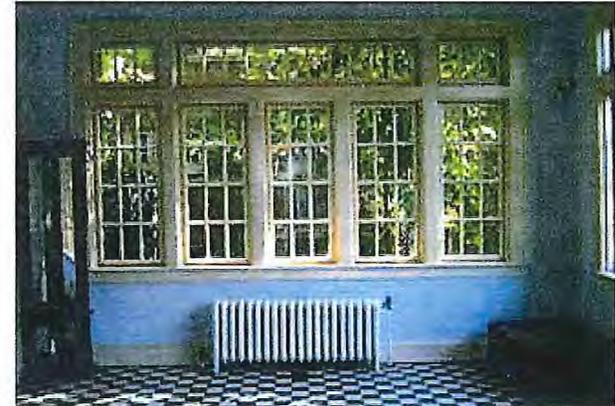
60

Recommended: [60] Original radiators that are still functional and efficient were retained in the rehabilitation of this historic house.

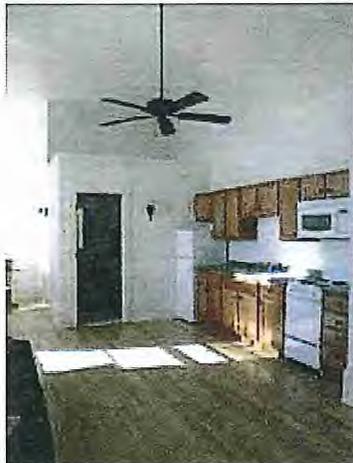
58

Recommended: [58] Ceiling fans enhance the efficiency of HVAC systems in historic buildings.

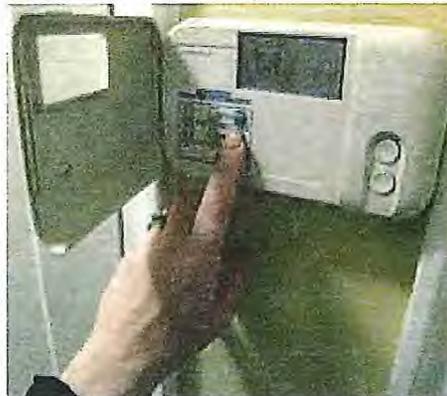
59

Recommended: [59] Installing a programmable thermostat can help existing systems to operate more efficiently.

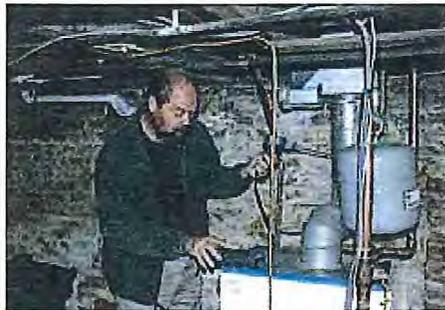
67

Recommended:[67] A professional energy auditor analyzes the performance of an existing furnace to ensure it is operating efficiently.

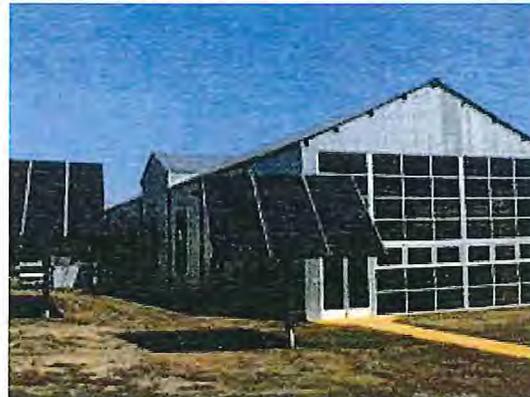
74

Recommended: [74] Free-standing solar panels have been installed here that are visible but appropriately located at the rear of the property and compatible with the character of this industrial site.

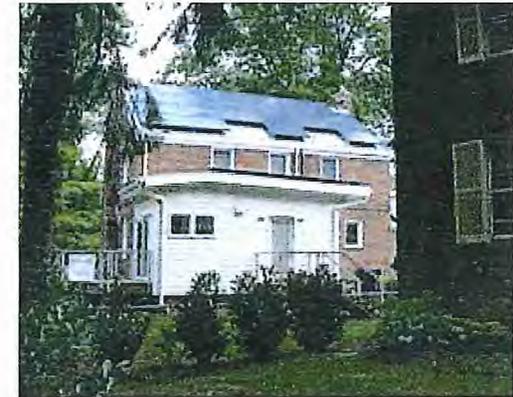
75

Not Recommended: [75] Solar roof panels have been installed at the rear, but because the house is situated on a corner, they are highly visible and negatively impact the character of the historic property.

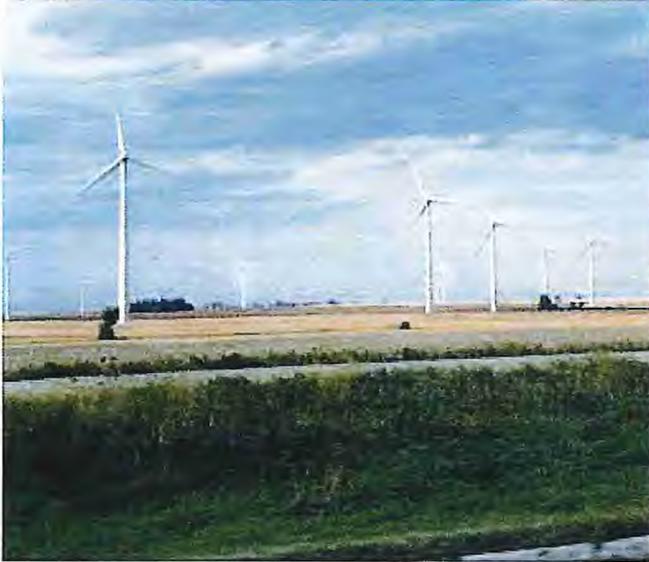
80

Recommended: [80] It is often best to install wind-powered equipment in off-site, rural locations to avoid negatively impacting a historic building and its site.

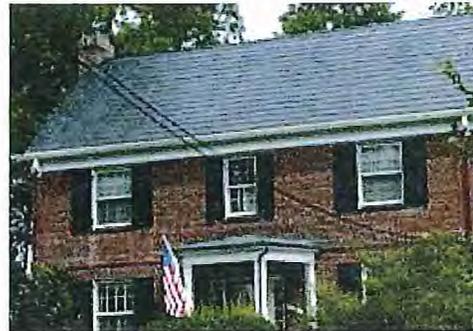
87

Not Recommended: [87] Historic roofing materials in good condition should be retained rather than replaced with another material perceived as more sustainable, such as, in this case, solar roofing shingles.

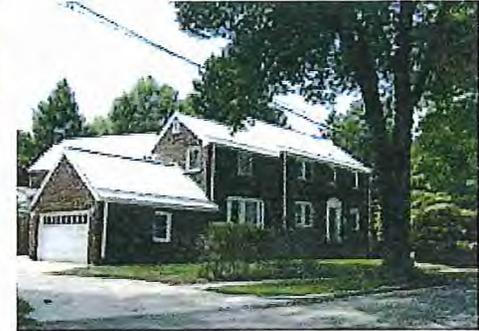
88

Not Recommended: [88] This new, cool white metal roof is not an appropriate material or color for this historic mid-20th century house.

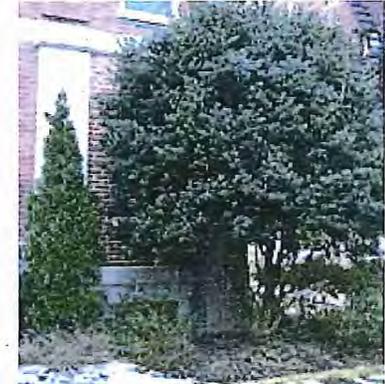
97

Not Recommended: [97] This tree, which was planted too close to the building, has caused the masonry wall to retain moisture that damaged the mortar and required that the brick be repointed in this area.

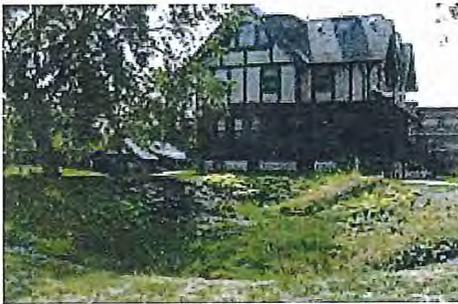
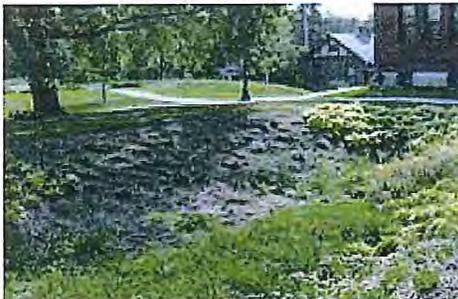
Recommended: [98-100] Rain gardens and rain-water collection tanks are features that may be added to a historic property to improve storm-water management and increase on-site water use.

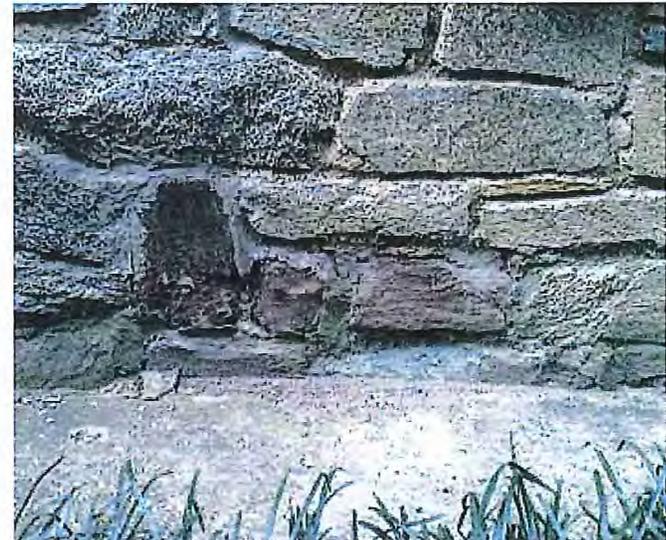
101

Not Recommended: [101] Splash back from the impermeable concrete paving next to the foundation is damaging these stones.

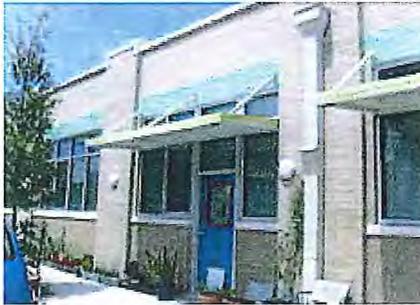
107

Recommended: [107] Traditional canopies compatible with the industrial character of this former factory building were installed when it was converted for residential use.

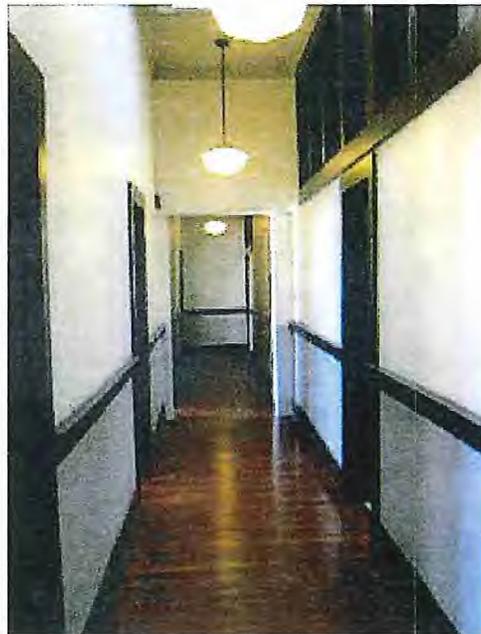
108

[108-109] The original, partially-glazed doors and office partitions, as well as skylights, that let natural light into the corridors were retained as part of the rehabilitation of this early-20th century building.
