# REPORT / RECOMMENDATION

**Subject:** Traffic Safety Committee Report of October 1, 2014

## Traffic Safety Report of October 2014

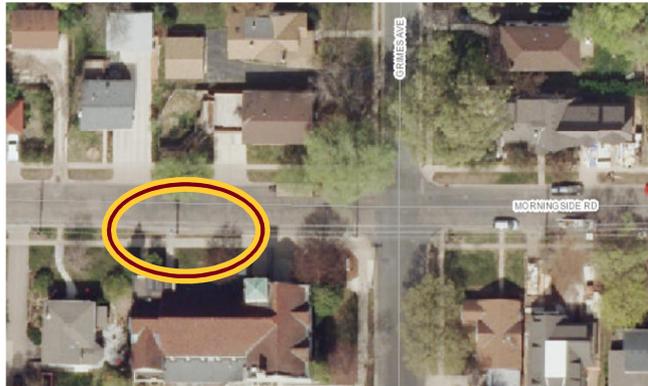
Map : Morningside Community Church

This request comes from the Edina Morningside Church, asking for parking spaces near the accessible entrance of the church to be marked as handicapped only parking. The requested area is along Morningside Road. Typically two parishioners drive themselves, or are escorted up to the church, for services, which leads the requestor to ask for two spaces be reserved for parking and another to be used as a drop off zone. Currently this area is signed as no parking, for 150 feet from the corner of Morningside and Grimes Avenue, which is all-way stop controlled. Morningside is 33 feet wide at this location and has a nearby traffic count from 2011, with 1859 ADT and 37.9 mph as the 85<sup>th</sup> percentile speed on weekdays, and 1389 ADT and 37.7 mph as the 85<sup>th</sup> percentile speed on Sundays. There is 115 feet from the edge of the pedestrian ramp to the stop sign, which equates to 80 feet of usable space (30 feet from a stop sign, 5 from a curb cut). There is currently parking on both sides of the street just to the west of this location, where there is a street width of 29.5 feet. Sidewalks are present on both sides of the street in this location.

**After review, staff recommends the placement of two handicapped parking stalls in this location, by placing handicapped parking only signs. To prevent abuses of the intersection, a no parking within 30 feet of sign placard shall be added to the post of the stop sign. Curbs**

should be painted blue and the area by the church's curb cut will should be marked with a hashing to prevent parking in the area.

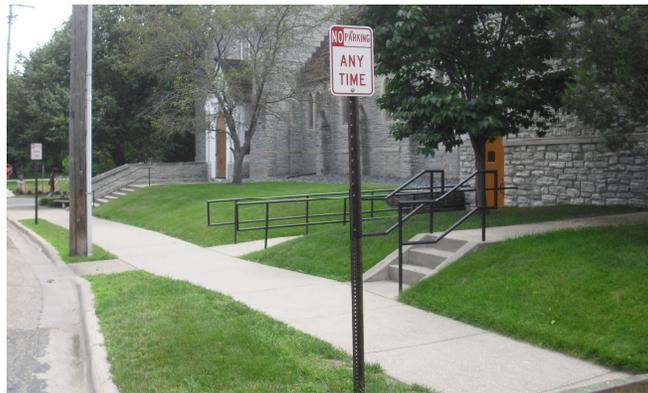
Photo : Morningside, looking east, towards Grimes

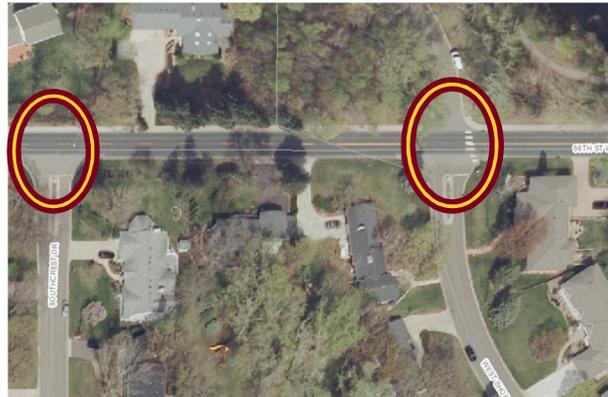
*Map : 66<sup>th</sup> and Southcrest (left), West Shore (right)*

This request was fielded by staff during a site visit to this location, connecting the neighborhood to the south of 66<sup>th</sup> with the sidewalk, park, and neighborhood on the north of 66<sup>th</sup>. Currently, West Shore has a signed and marked crosswalk in place, while Southcrest has no improvements. Pedestrian counts were taken on West Shore on the morning of August 5<sup>th</sup>, with the highest two hour count having 35 people crossing on the east leg from 7:30 to 9:30 AM and 35 people crossing the north leg from 8:45 to 10:45 AM. A gap study was performed on 66<sup>th</sup>, which found that during the morning peak hour, the minimum 5 minute interval for gaps totaling more than the required crossing time (20 seconds, based off width of street and reaction time) was 2 gaps at 7:45-7:50 AM, while the evening peak had a minimum of 0 gaps longer than the required crossing time from 4:30-4:35 PM, both peak hours met warrants for installation of an Rapid Rectangular Flashing Beacon. A pedestrian study was done on Southcrest for 24 hours, from 9 AM on August 12<sup>th</sup> to 9 AM on August 13<sup>th</sup>. The counts for pedestrians crossing 66<sup>th</sup> at Southcrest had a maximum value of eleven in a two hour period, this does not meet volume warrants for the City of Edina. Crosswalk warrants are attached in Appendix B.

**After review, staff recommends that an RRFB be placed at West Shore Drive, and no crosswalk be placed at Southcrest, based on warrants.**

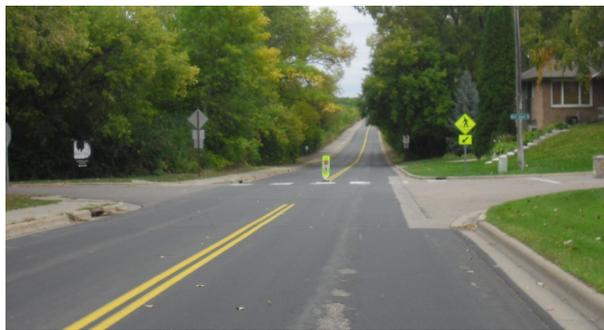
*Photo : Existing crosswalk at 66<sup>th</sup> and West Shore, looking east*

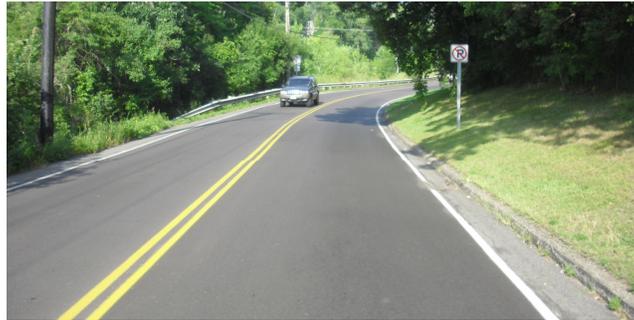
This request comes from a resident who feels that the bike lanes on Interlachen Blvd are dangerous as Interlachen approaches, and becomes Blake Rd, due to decreases in width and the state of repair of the road. Measurements of the lane widths were taken, and the lane for bicyclists reduces in width to 6 inches, while the state minimum for bicycle lanes is 4 feet, with at least 3 feet of width being free of obstacles and of consistent riding surface. Edge lines are warranted for use along grade separated roadways and on rural arterials which exceed 20 feet in width, and 3,000 in ADT, or elsewhere where an engineering study indicates a need for edge line markings. Interlachen has 9758 ADT and 85<sup>th</sup> percentile speeds of 35.6 mph (2013 MSA count), on the west end of this section and had 7846 ADT and an 85<sup>th</sup> percentile speed of 36.3 mph on the east side of this section (count done in 2005). No bicycle related accidents, and one rollover accident have been reported in the last five years. Further striping detail is in Appendix A, with visuals for possible alterations.

*Photo : Interlachen Blvd, east of Blake Rd, looking west*

**After review, staff recommends restriping Interlachen and placing signs at this location as is shown in the visuals in the Appendix. This recommendation is based off the requirements for bike lanes, their current condition, and standards for vehicle lane widths.**

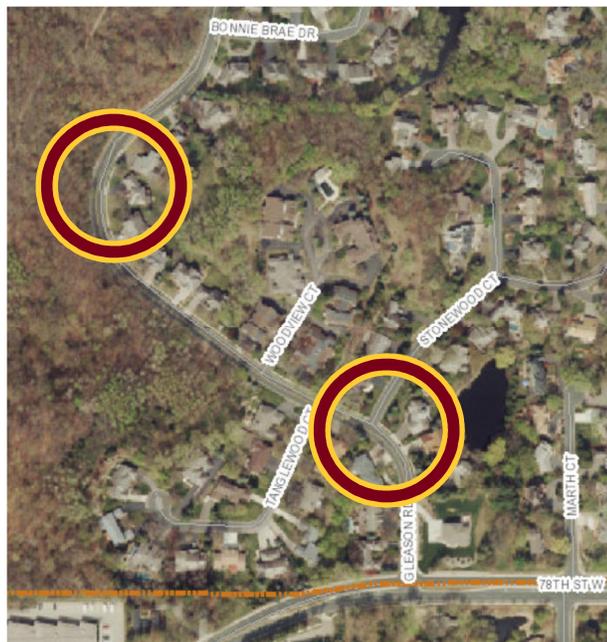
*Map : Gleason Rd curves investigated*

in the last five years. The curves in this location were analyzed using the AASHTO Green Book design manual, and found to have design speeds significantly lower than the 30 mph speed limit, with the southern curve having a design speed of 24.3 mph and the northern curve having a design speed of 28.5 mph. Curve warning signs are already in place at these locations. Parking is prohibited on the east side of Gleason. A counter was placed on Gleason between the two curves, with a volume of 1395 AADT and an 85<sup>th</sup>-percentile speed of 32.3 mph.

**After review, staff recommends placing advisory speed signs beneath the curve signs already in place, and adding a curve sign to the southbound side of the road. Other curves should also be investigated up Gleason to Valley View to ensure that the area is safe for travel at the current speed limit.**

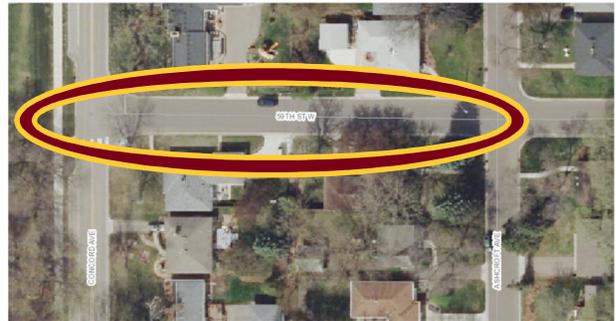
*Map : 59<sup>th</sup> from Concord to Ashcroft*

This request has come from multiple parents in the walking zone of Concord school, who are concerned about their children’s safety as they walk on 59<sup>th</sup> Street, especially at school release. The concern is that vehicles parked to pick up children are forcing the walkers to move to the center of the street towards the one remaining travel lane. An onsite investigation was conducted on September 5<sup>th</sup>, from 2:40-3:30 P.M. the street is 30 feet wide, with parking on both sides, no sidewalk, but with a crosswalk from the school to the south side of 59<sup>th</sup> Street, 54 pedestrians(13 on the north side, 41 on the south side), 17 bikes (1 on the north side, 16 on the south side), and 57 vehicles (43 eastbound and 14 westbound) used the street, while 6 vehicles parked in the first block from the school to pick up children, as opposed to using the bays on Concord. Discussing with the school district, there is the ability for school buses to alter routes if the City requests such action. Typical speeds from vehicles on the street were 15-25 mph. Schools in the area start at 7:40-8:30 A.M. and end school from 2:40-3:05 P.M.

**After review, staff recommends restricting parking along the south side of the road during school times (7:00 AM-4:00 PM, School days), as well as asking the school district to reroute buses to 58<sup>th</sup> street, which has a sidewalk along its north side.**

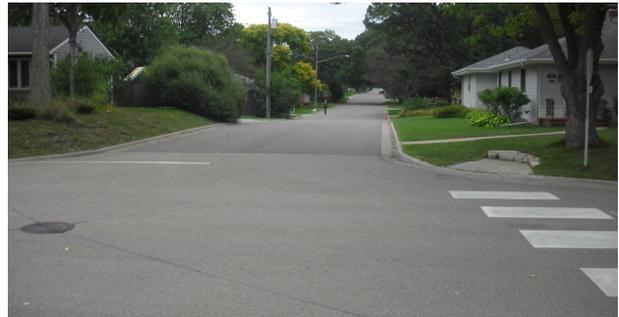
*Photo : 59<sup>th</sup> Street, from Concord, looking east*

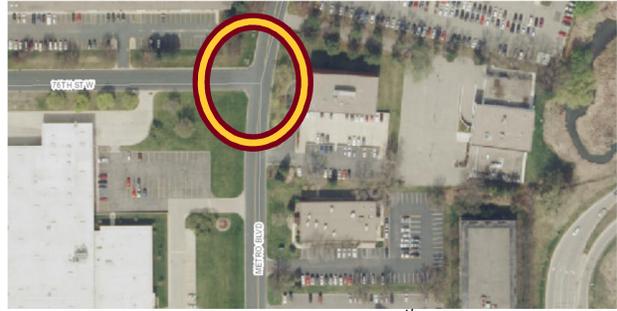
Map : 76<sup>th</sup> St and Metro Blvd

A request was made for a crosswalk across Metro Blvd. at 76<sup>th</sup> St. A pedestrian count was taken from 10:30 AM on August 18<sup>th</sup>, to 4:00 PM on August 19<sup>th</sup>. The maximum pedestrian count for pedestrians across Metro in a two hour period in this time was 18 crossings, with 61 crossings taking place during the study, 38 of which were on the south side of 76<sup>th</sup> St. This crossing does not meet the volume warrant for a crosswalk. Crosswalk warrants are attached in Appendix B.

After review, staff recommends denial of this request based on not meeting volume warrants for a marked crosswalk.

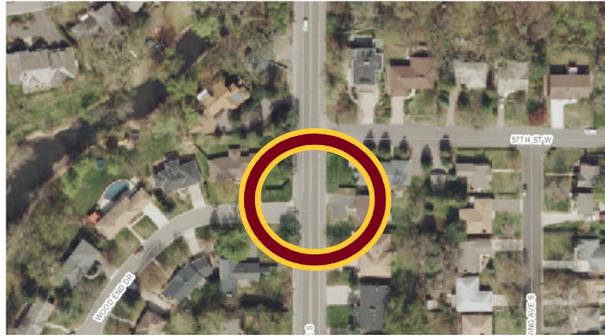
*Map : 57<sup>th</sup> and France*

Requestor states that crossing France at 57<sup>th</sup> Avenue is difficult and deserves to have a crosswalk installed at the location. A 24-hour video study was conducted, with the peak 2-hour pedestrian volumes of 11. The crosswalk did not meet pedestrian volume warrants. Crosswalk warrants are attached in Appendix B.

**After review, staff recommends denial of this request, based on a lack of warrants met.**

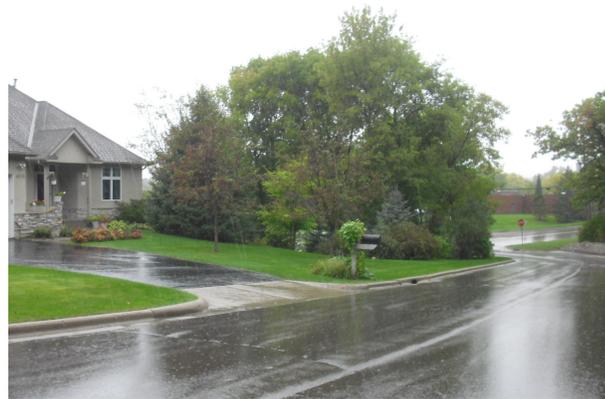
A resident requests clarification on city policy regarding “Blind Driveway” signs. The resident’s driveway is close to the intersection of Lincoln and Malibu, and a thicket of trees at the intersection obscures the driveway. Resident was informed that the city does not typically install such signs, and resident asked if he could place his own, such as along Valley View, west of Gleason.

*Photo : Driveway and thicket, looking west, towards Lincoln*

**After review, staff recommends denial of this request, based on city policy for not placing such signs, and Minnesota Statute that does not allow other entities to place different signs where they may be seen from the roadway.**

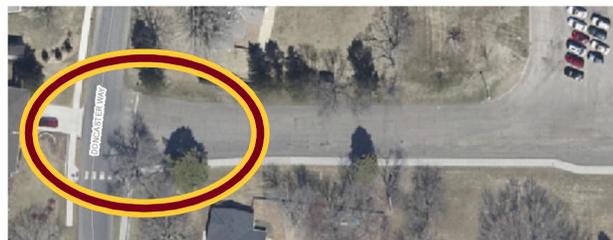
*Map : Highlands School driveway at Doncaster*

A request came in for repainting a crosswalk across the driveway for Highlands School. There had previously been a crosswalk, and when the driveway was resurfaced, the crosswalk was not repainted. Currently there is a sidewalk on the south side of the driveway, and across Doncaster Way from the driveway, with a marked crosswalk and crossing guards across Doncaster Way. The driveway is said to handle up to three lanes of traffic and was measured as being over 59 feet wide.

**After review, staff recommends that the schools paint this crosswalk, based on liability concerns and the small amount of crossings that would likely come from a marked crosswalk would not warrant a marked crosswalk. Requestor was given contact information for Edina Public Schools maintenance office.**

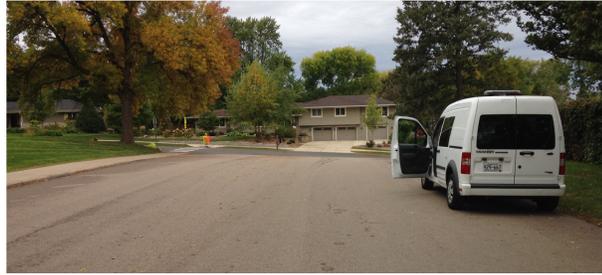
*Photo : Driveway for Highlands School*

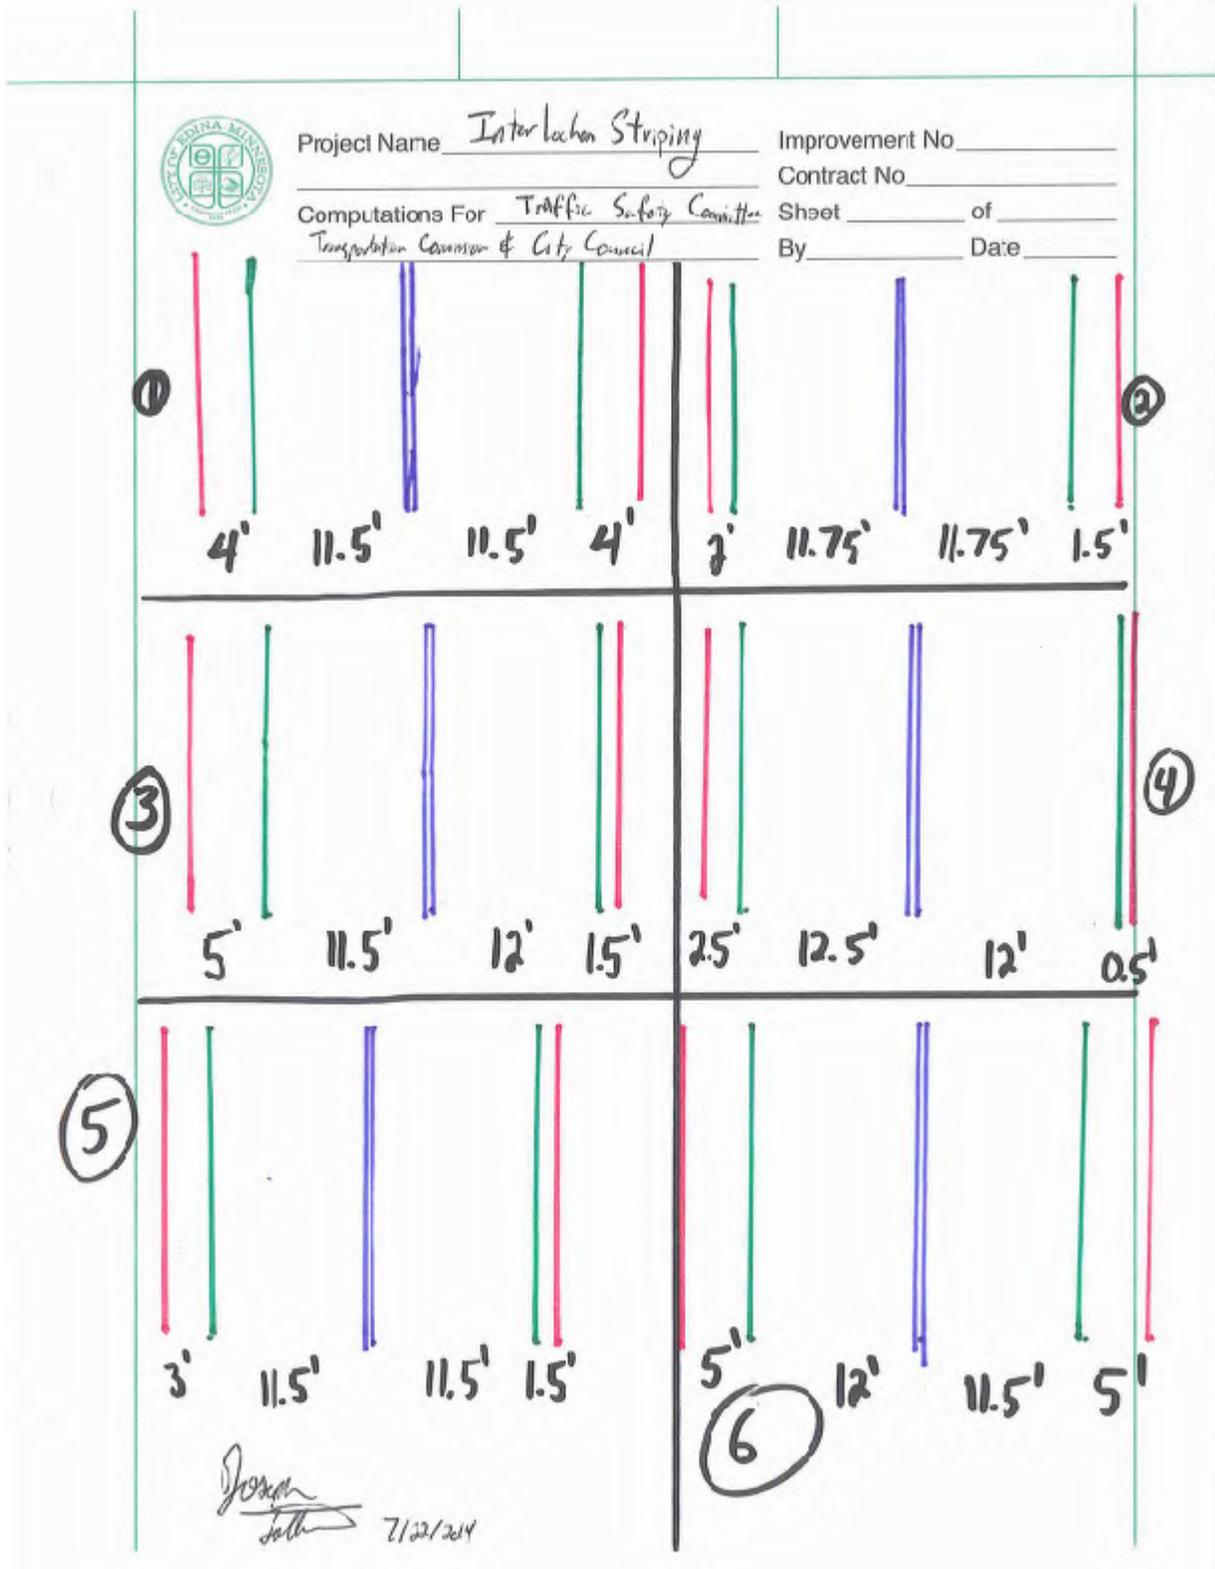
Striping plans, red = curb or edge of pavement, green = white line, blue = yellow.

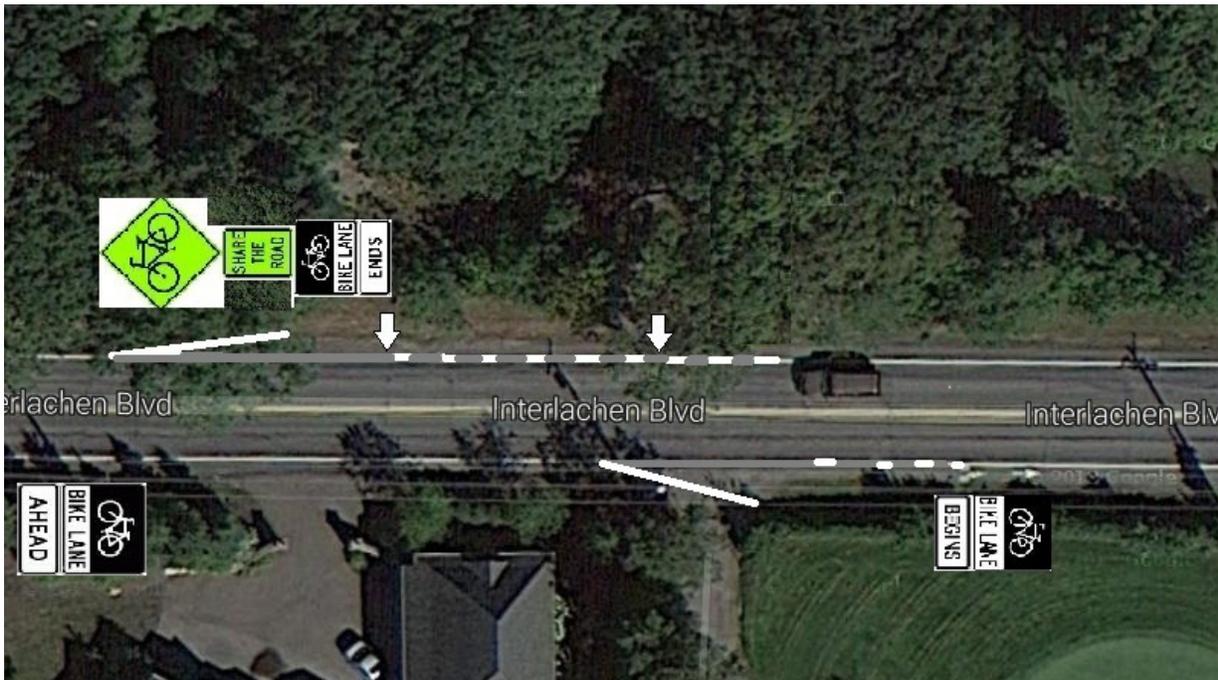
Possible signage and striping, at points 1 and 5 (approximately), based off MNMUTCD designs for a through, motor-vehicle lane drop.

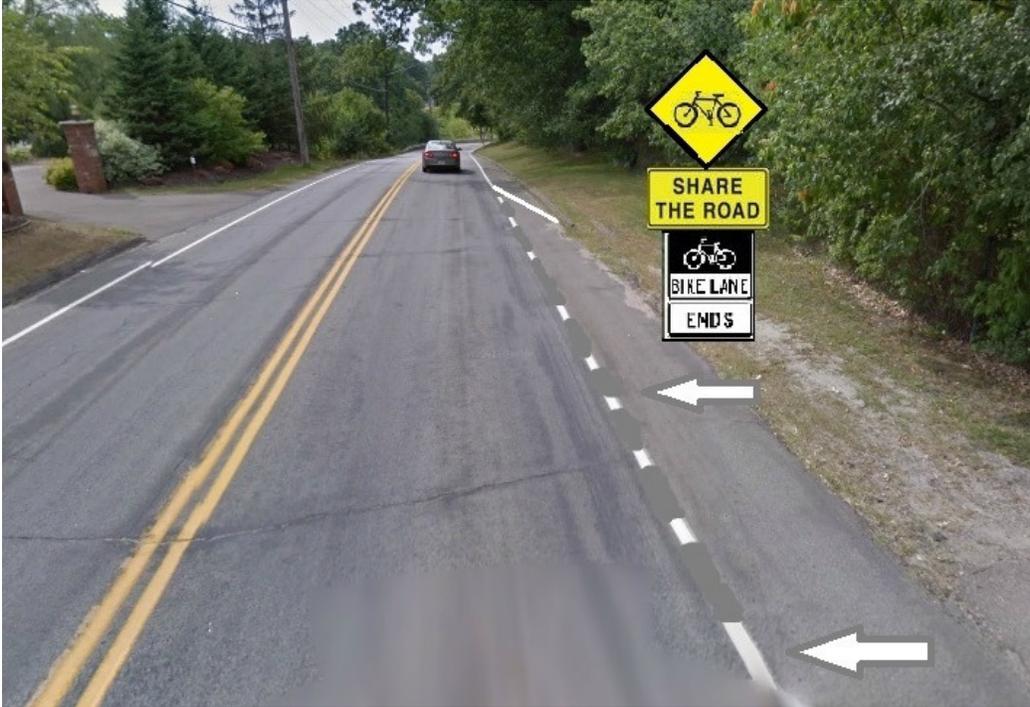
Possible signage and striping from a vehicle's perspective.
