Subject: Traffic Safety Committee Report of January 7, 2015

Traffic Safety Report

Wednesday, January 07, 2015

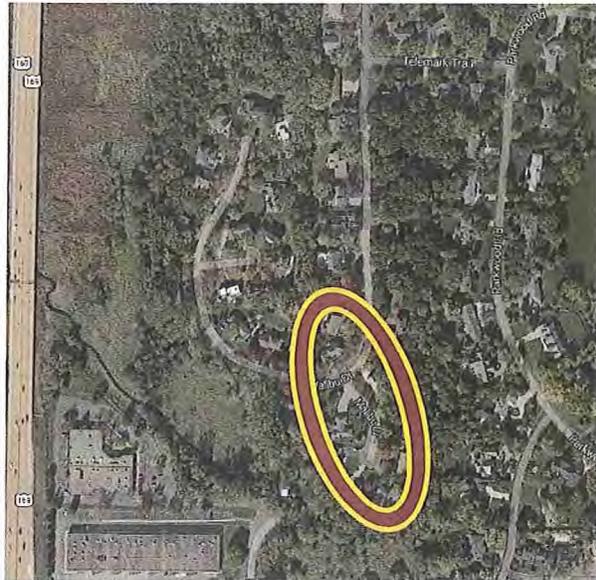
Map : Malibu Drive at Malibu Drive

This request comes from a resident of Malibu Drive, south of the intersection where Malibu Drive starts to branch off into three separate cul-de-sacs, all named Malibu Drive. The requestor is concerned with speeds on Malibu Drive, believing that high speeds at the intersection and nearby hill lead to a dangerous roadway. The requestor also asks for a nameplate for Malibu Drive in order for visitors, deliveries, and school buses to find the homes in the southern cul-de-sac easier. Finally, the requestor asks that the cul-de-sac be renamed. As a numbered nameplate would not feel neighborly, and requested that the city look into a new name for the entire cul-de-sac to clarify confusion.

After review, staff recommends placing of a street name placard to signify the house numbers within this cul-de-sac, as well as other cul-de-sacs on Malibu drive which are not a continuation of the main road. This decision was based on guidance from Public Safety and the difficulty to find some addresses in this area. Staff will advise the requestor to bring to City Council a resolution to change the street name if they wish. In regards to the speeding in this area, the attempted speed counts failed due to weather and low traffic conditions, but the police do seasonally enforce this area and a speed study of this area will be conducted in the spring to more efficiently enforce speeds.

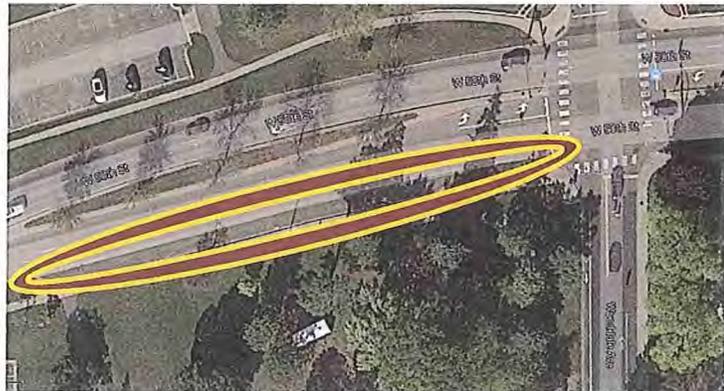
Map : 50th Street at Wooddale Avenue, parking bays.

This request comes from a resident who drives 50th street often. The concern is that in low light, drivers begin a merge into the parking bay west of the intersection with Wooddale, and when they recognize that the lane does not continue until the intersection the drivers will swerve back into the right lane. The requestor would like some signage or painted curb which would reflect back to drivers to signify that this is not a driving lane. Currently there is a concrete gutterpan between the parking bay and the driving lane, signifying this is not a typical roadway segment. There is no reflector or other sign to signify the end of the parking bay. A video study was performed, and this procedure was observed, however only one half of the drivers who infringe on the parking lane turned right at the intersection. This indicated the issue is more likely due to people simply drifting into the lane. An appropriate sign would be from the object marker (OM) series, either a class 2 or class 3 marker to signify the end of the parking bay.

After review, staff recommends approval of this request. Staff recommends placement of a OM-3R object marker to signify the end of the parking bay. While this may not prevent all of these encroachments from occurring, it has the ability to warn drivers sooner than current conditions.

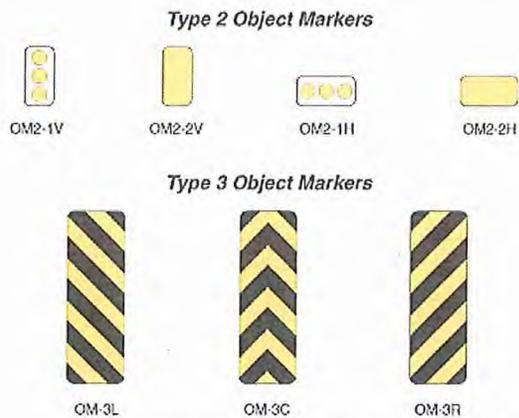
Image : Type 2 and 3 Object Markers

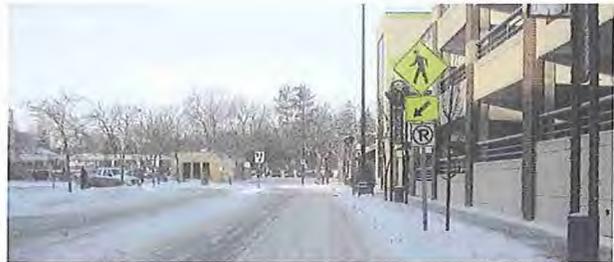
This request comes from the business association at 50th and France, noting the ineffectiveness of the continuous flashers along 50th St. and the signed only crosswalks along 49th ½ St. On 50th Street, the east crossing was observed, with less than two gaps per five minutes in the typical peak hour. Most westbound traffic yielded to pedestrians waiting to cross, or in the crosswalk. On 49th ½ St. there were 4.5 gaps in the typical five minute segment. Both of these meet warrants for improvement to actuated pedestrian signals. In addition, on 50th Street, the street light immediately before the east crossing obstructs the current flashers with a place-making banner. 50th St. is considered an augmenter arterial in the city's 2008 Comprehensive Plan (an A level arterial), which according to the City's sidewalk policy would require some sort of signalization for installation of a crosswalk. Research has shown that continuous flashers do not increase long term pedestrian safety, as drivers grow accustomed to their presence. Pedestrian actuated flashers have higher rates of yielding as they are not flashing except when drivers are expected to yield. The city's crosswalk policy is located in Appendix B.

Photo : 50th and France area, current crosswalk on 49th 1/2

After review, staff recommends a split approval of this request. Staff recommends that pedestrian push-button actuation and Rapid Rectangular Flashing Beacons be placed on the two crossings on 50th Street. Further study is needed on how many beacons can be placed in close proximity, and if all of the three crosswalks that are starred in the image above meet the warrants for pedestrian actuation. Thus the crosswalks on 49th ½ St. will be an item on a future report, and are not recommended for approval here.

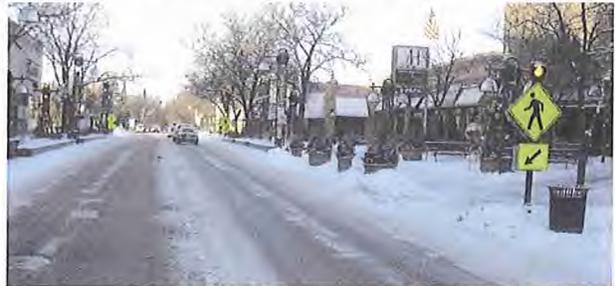
Photo : 50th and France area, current crosswalk on 50th

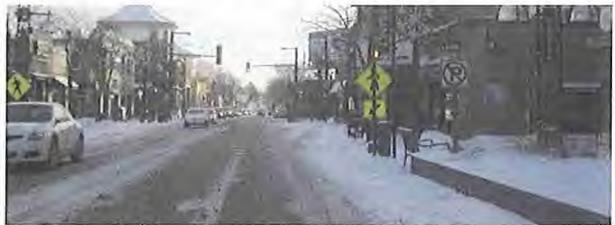
Photo : 50th and France area, current crosswalk on 50th.
Note the beacon is obstructed by the light.

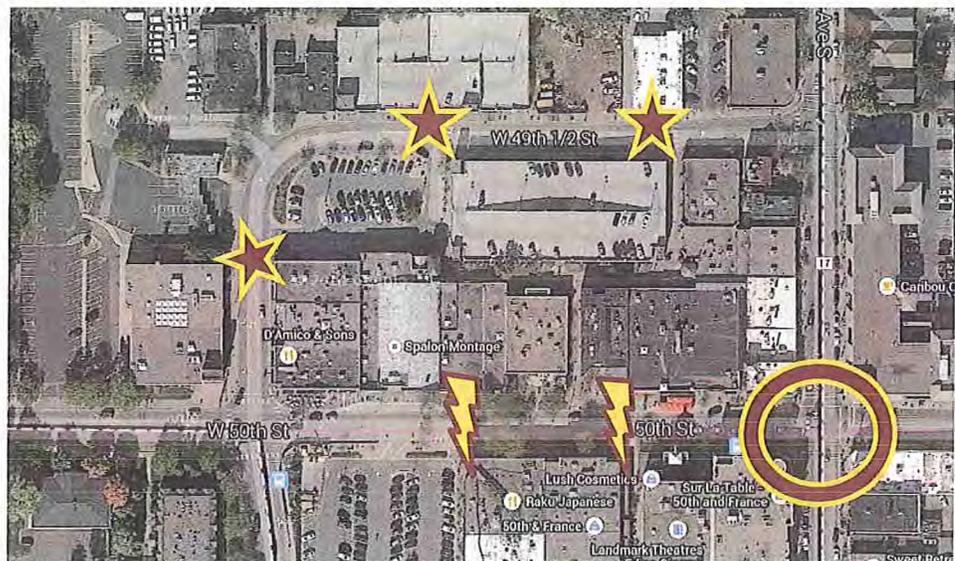
Map : 50th and France area, stars are locations of crosswalks with static signs, continuous beacons are marked with lightning, and the intersection of 50th and France is circled.

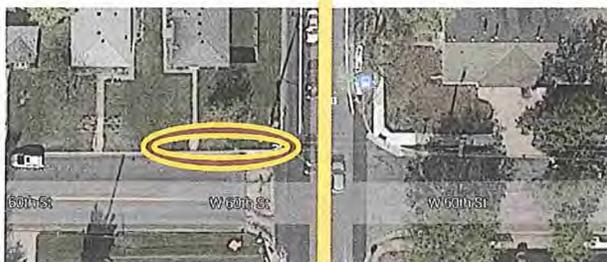
This request comes from a resident who is concerned at the frequency with which the stairs to her house are blocked by disabled vehicles. This concern stems from the requestor's daughter having a disability, and the steps being the only reliably safe way for her to access the house (alley gets icy and is harder to keep clear than the front walk). Therefore, the requestor asked for the implementation of a handicapped parking zone, such that a school bus front door could line up with her steps, facilitating her daughter's movements to and from school.

Map : 60th and Xerxes, city boundary is marked, and the area for the parking restriction is circled

After review, staff recommends approval, installing the signs in this location in the spring.

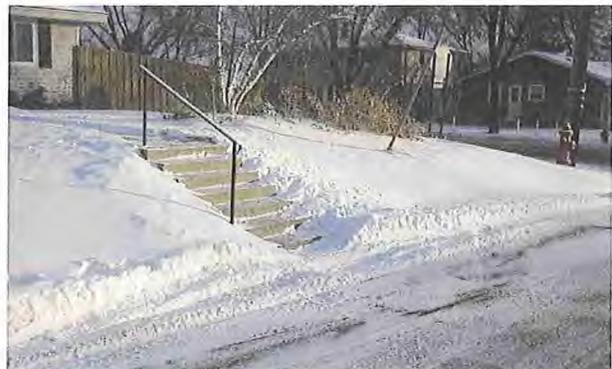
Photo : Stairs which should be left clear for schoolbuses and other handicapped accessible vehicles

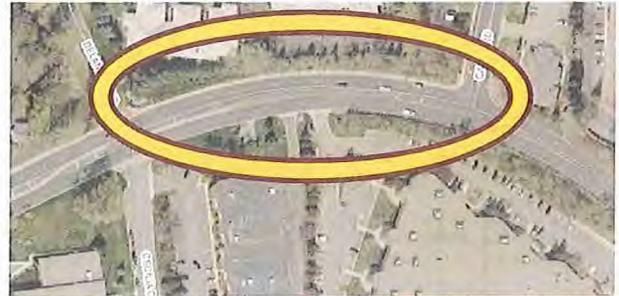
Map : 78th Street, between Cecelia and Cahill

This request comes from a property owner on 78th Street, who says tenants in the building have trouble turning out of the driveway due to Cecelia traffic turning right on red, removing gaps. A gap study was performed, and during evening rush hour left turns would have been restricted such that acceptable gaps would not be present for 5 minutes. However, this lack of gaps was not due to right on red, but instead due to the queue from the light at 78th and Cahill blocking the property’s driveway. When vehicles were exiting the driveway, vehicles in the queue were courteous and allowed exiting vehicles to turn. After further study, it was found that right turns on red from Cecelia correlated slightly with a greater number of acceptable vehicle gaps, and the main correlation with a reduced number of acceptable gaps was the 15-minute volumes. Graphs of these correlations can be seen in Appendix A.

After review, staff noted that the volume and timing of the light at Cahill were larger detriments to the area than right turns on red at Cecelia Cir., and thus recommends denial of this request.

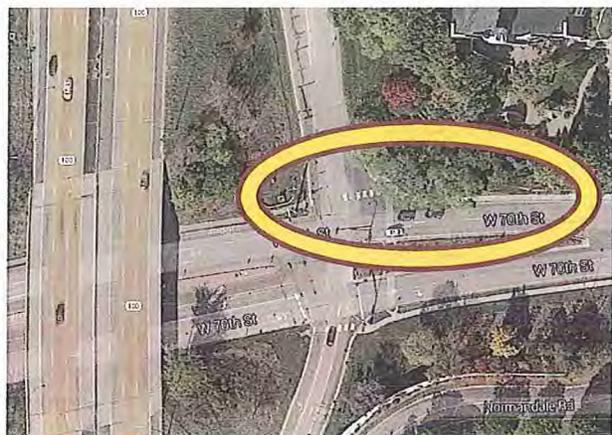
This request comes from a parishioner at the church in the northeast corner of this intersection. The requestor believes that at peak hours, as well as after church functions most of the traffic that is westbound is trying to turn onto Highway 100 northbound, and thus the roadway should be expanded to accommodate a right-turn-only lane. A study of the intersection from 8 AM to 6 PM, found that during morning peak hours, it is not unusual for more vehicles to be turning right than going straight at this intersection. The study also found that this behavior of traffic does not continue past the noon hour, with significantly more through traffic than right turns in the afternoon and evening. Overall 42 percent of all traffic in this location was turning right. The current layout of the approach has one through lane and one shared lane for through and right turning traffic.

Map : 70th and Normandale/Trunk Highway 100, the location of the proposed turn lane.

After review, staff recommends denial of this request based on the fact that the queue of vehicles typically clears during the signal phase.

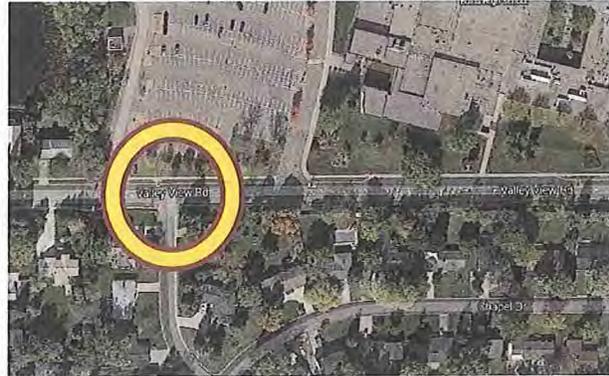
Map : Valley View Road and Chapel Lane

This request comes from a resident who is concerned for safety during morning hours as school enters session. The concern is that left turning vehicles from westbound Valley View Road to southbound Chapel Lane obstruct the views of children crossing the street. When investigated, a person in the crosswalk was unable to be seen by drivers while they were at the required stopping sight distance, for approximately the central third of the roadway.

After review, staff recommended further study of this issue. Observations for this report were unable to observe several crossings due to the severe cold, or precipitation. A video study and gap analysis is recommended to be performed when the weather is warmer.

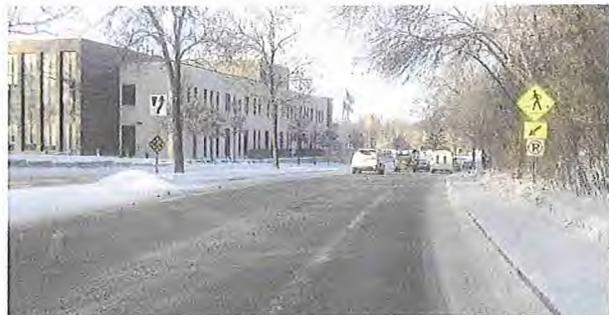
Photo : Crosswalk at 50th and Eden

This request comes from a resident, who lives in the Grandview Area. The requestor states that the crosswalk that is present in this location is inadequate for safety of pedestrians. The crosswalk is marked with special, brick style, pavement markings and static signs. The crosswalk does not meet the Crosswalk Policy, as the policy states that crosswalks will not be placed on arterial roads unless in conjunction with signalization, and the 2008 Comprehensive Plan for the city has 50th St. labeled as an Augmenter Arterial (A-minor arterial). There are two crashes in this location within the last five years, but neither was an accident type that would indicate a pedestrian was involved. The city's crosswalk policy is located in Appendix B.

After review, staff recommends further study (a full gap analysis) to ensure that the area met warrants for the addition of an actuated signal.

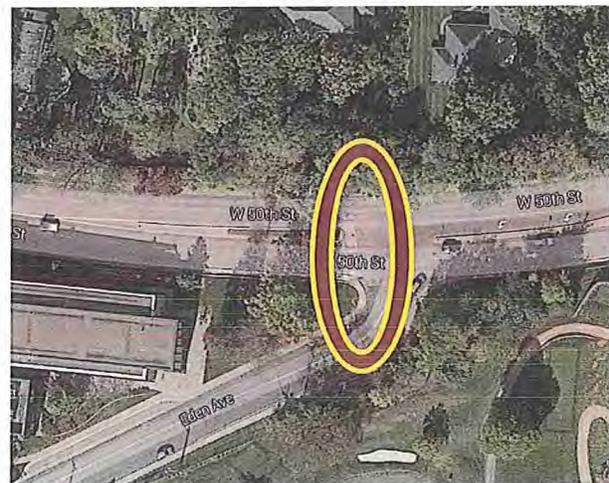
Map : Crosswalk at 50th and Eden, city hall is shown in the lower left corner of the map.

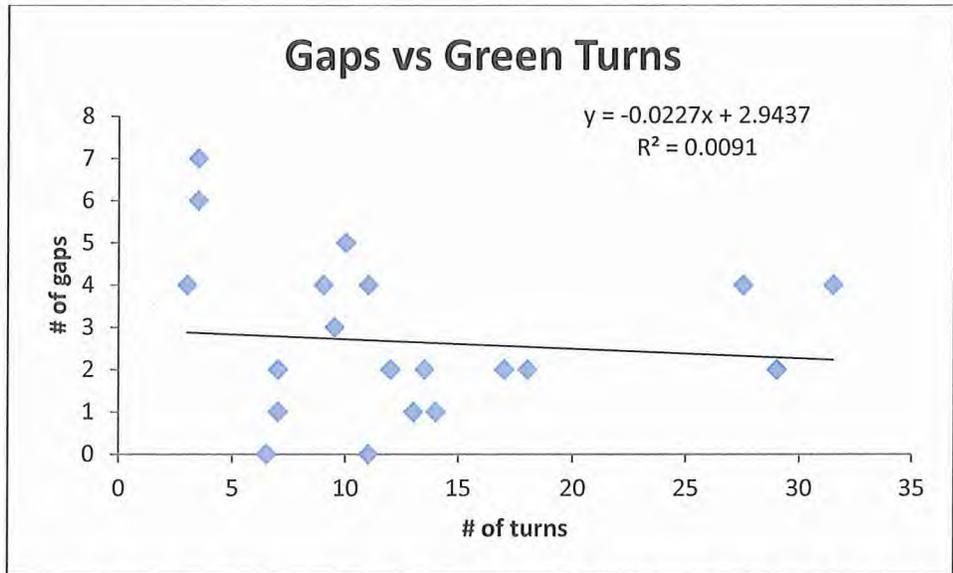
This graph displays the number of acceptable left turn gaps from the driveway (per 5 minute interval) vs the number of people who turn onto 78th Street from Cecilia.

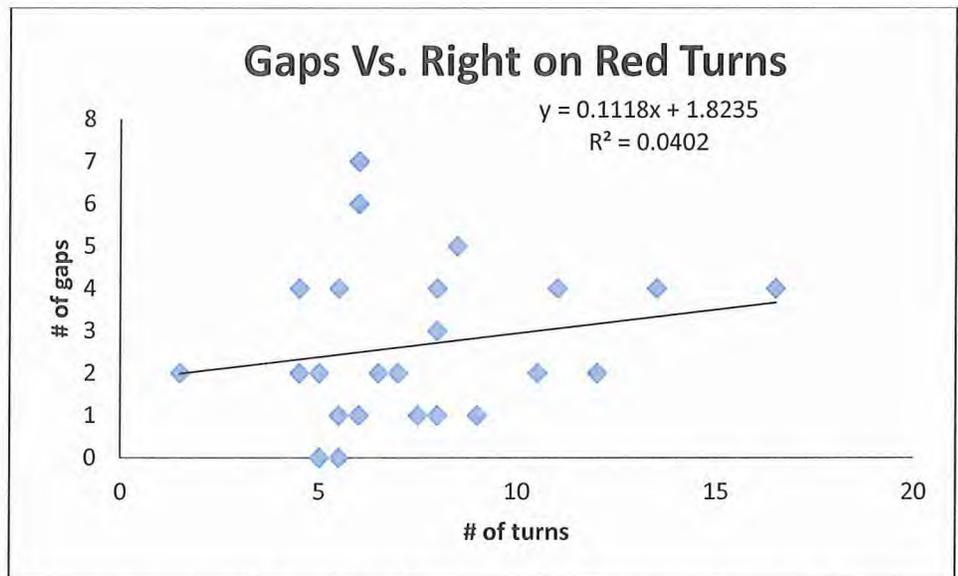
This graph displays the number of acceptable left turn gaps from the driveway (per 5 minute interval) vs the number of turns on red from Cecilia.

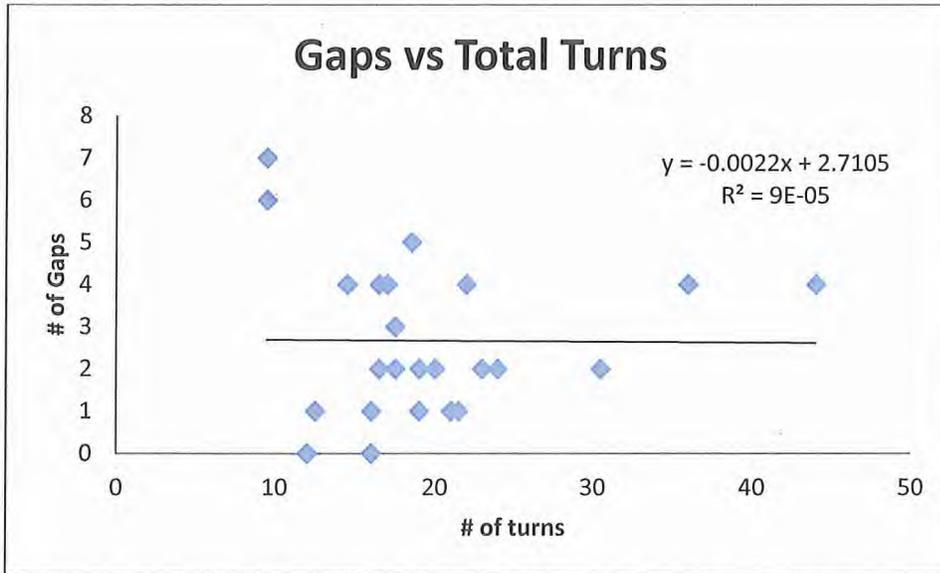
This graph displays the number of acceptable left turn gaps from the driveway (per 5 minute interval) vs the number of turns from the driveway.

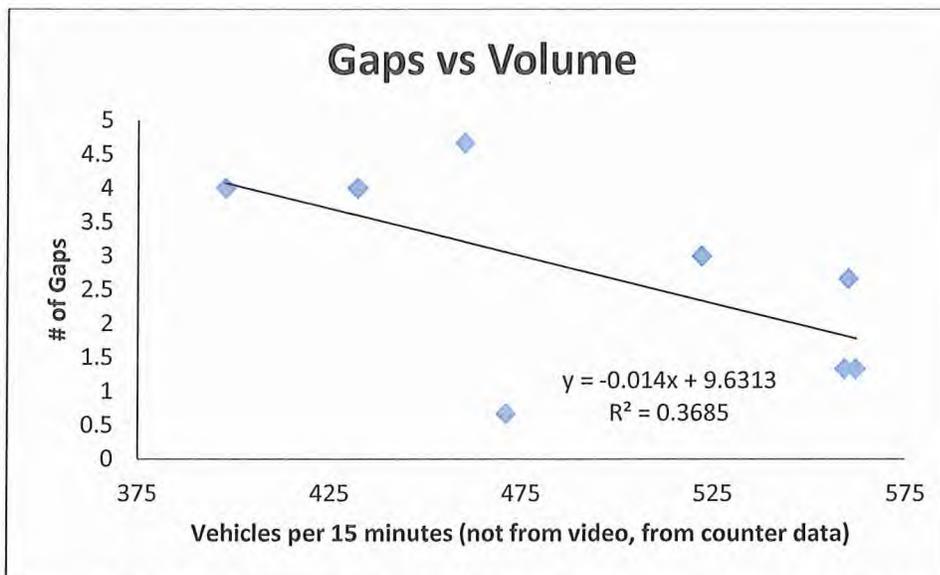
This graph displays the number of acceptable left turn gaps from the driveway (per 15 minute interval) vs the volume of vehicles carried on 78th street.
