Subject: Public Hearing – Modifying Southeast Edina Redevelopment Plan, Establishing Pentagon Park Tax Increment Financing District and Adopting Tax Increment Financing Plan; Resolution No. 2014-23

**Pentagon Park TIF District
Edina, Minnesota**

**PENTAGON PARK REDEVELOPMENT TIF DISTRICT
CODE/CONDITION DEFICIENCY REPORT**

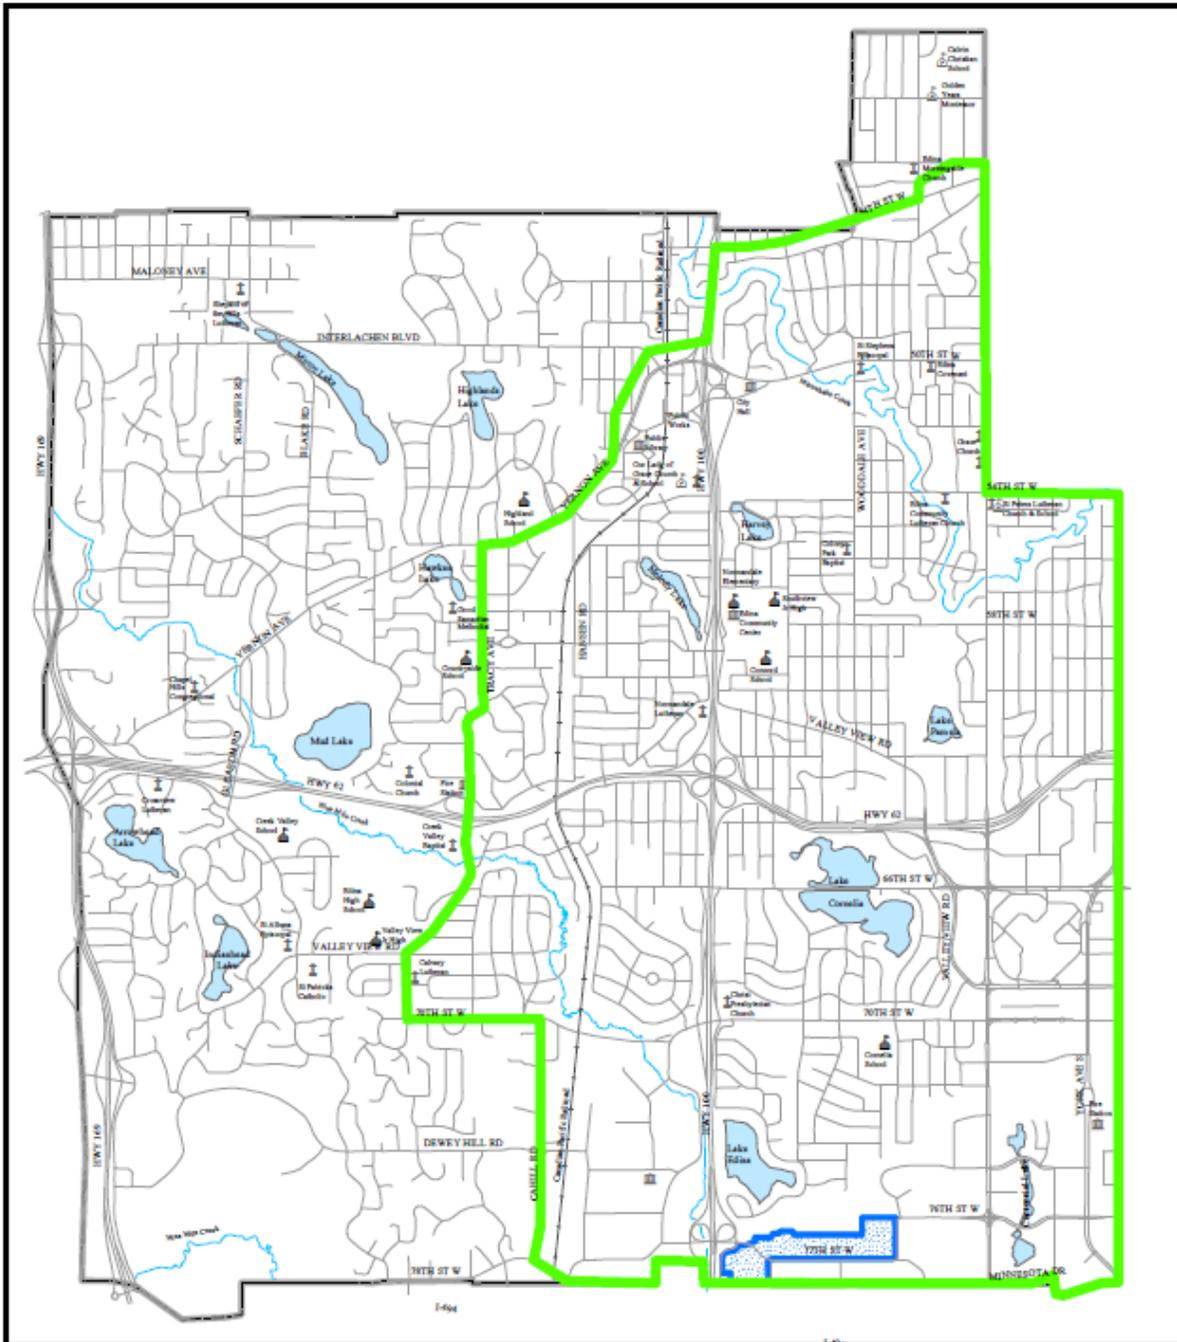
MAP OF THE SOUTHEAST EDINA REDEVELOPMENT PROJECT AREA AND THE PENTAGON PARK TAX INCREMENT FINANCING DISTRICT

**Southeast Edina Redevelopment Project Area
and Proposed Pentagon Park TIF District**

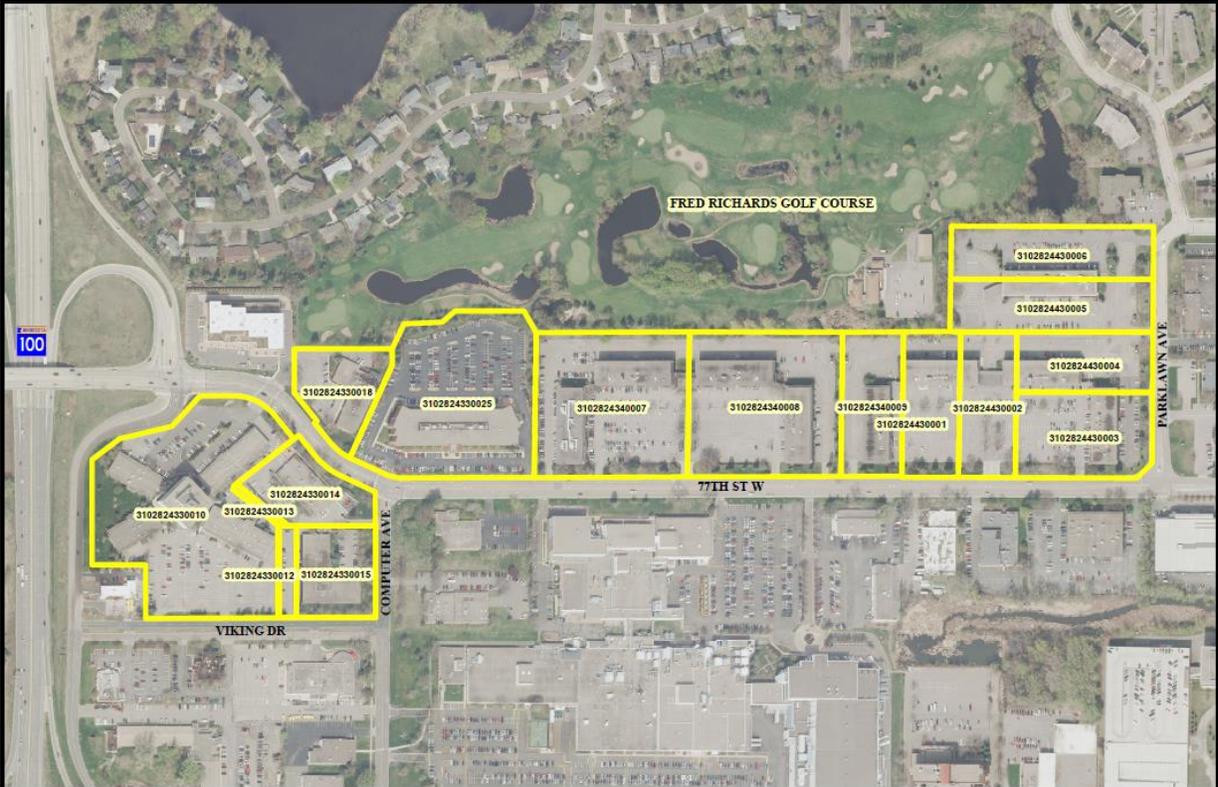
MAP OF THE PENTAGON PARK TAX INCREMENT FINANCING DISTRICT

Proposed Pentagon Park TIF District

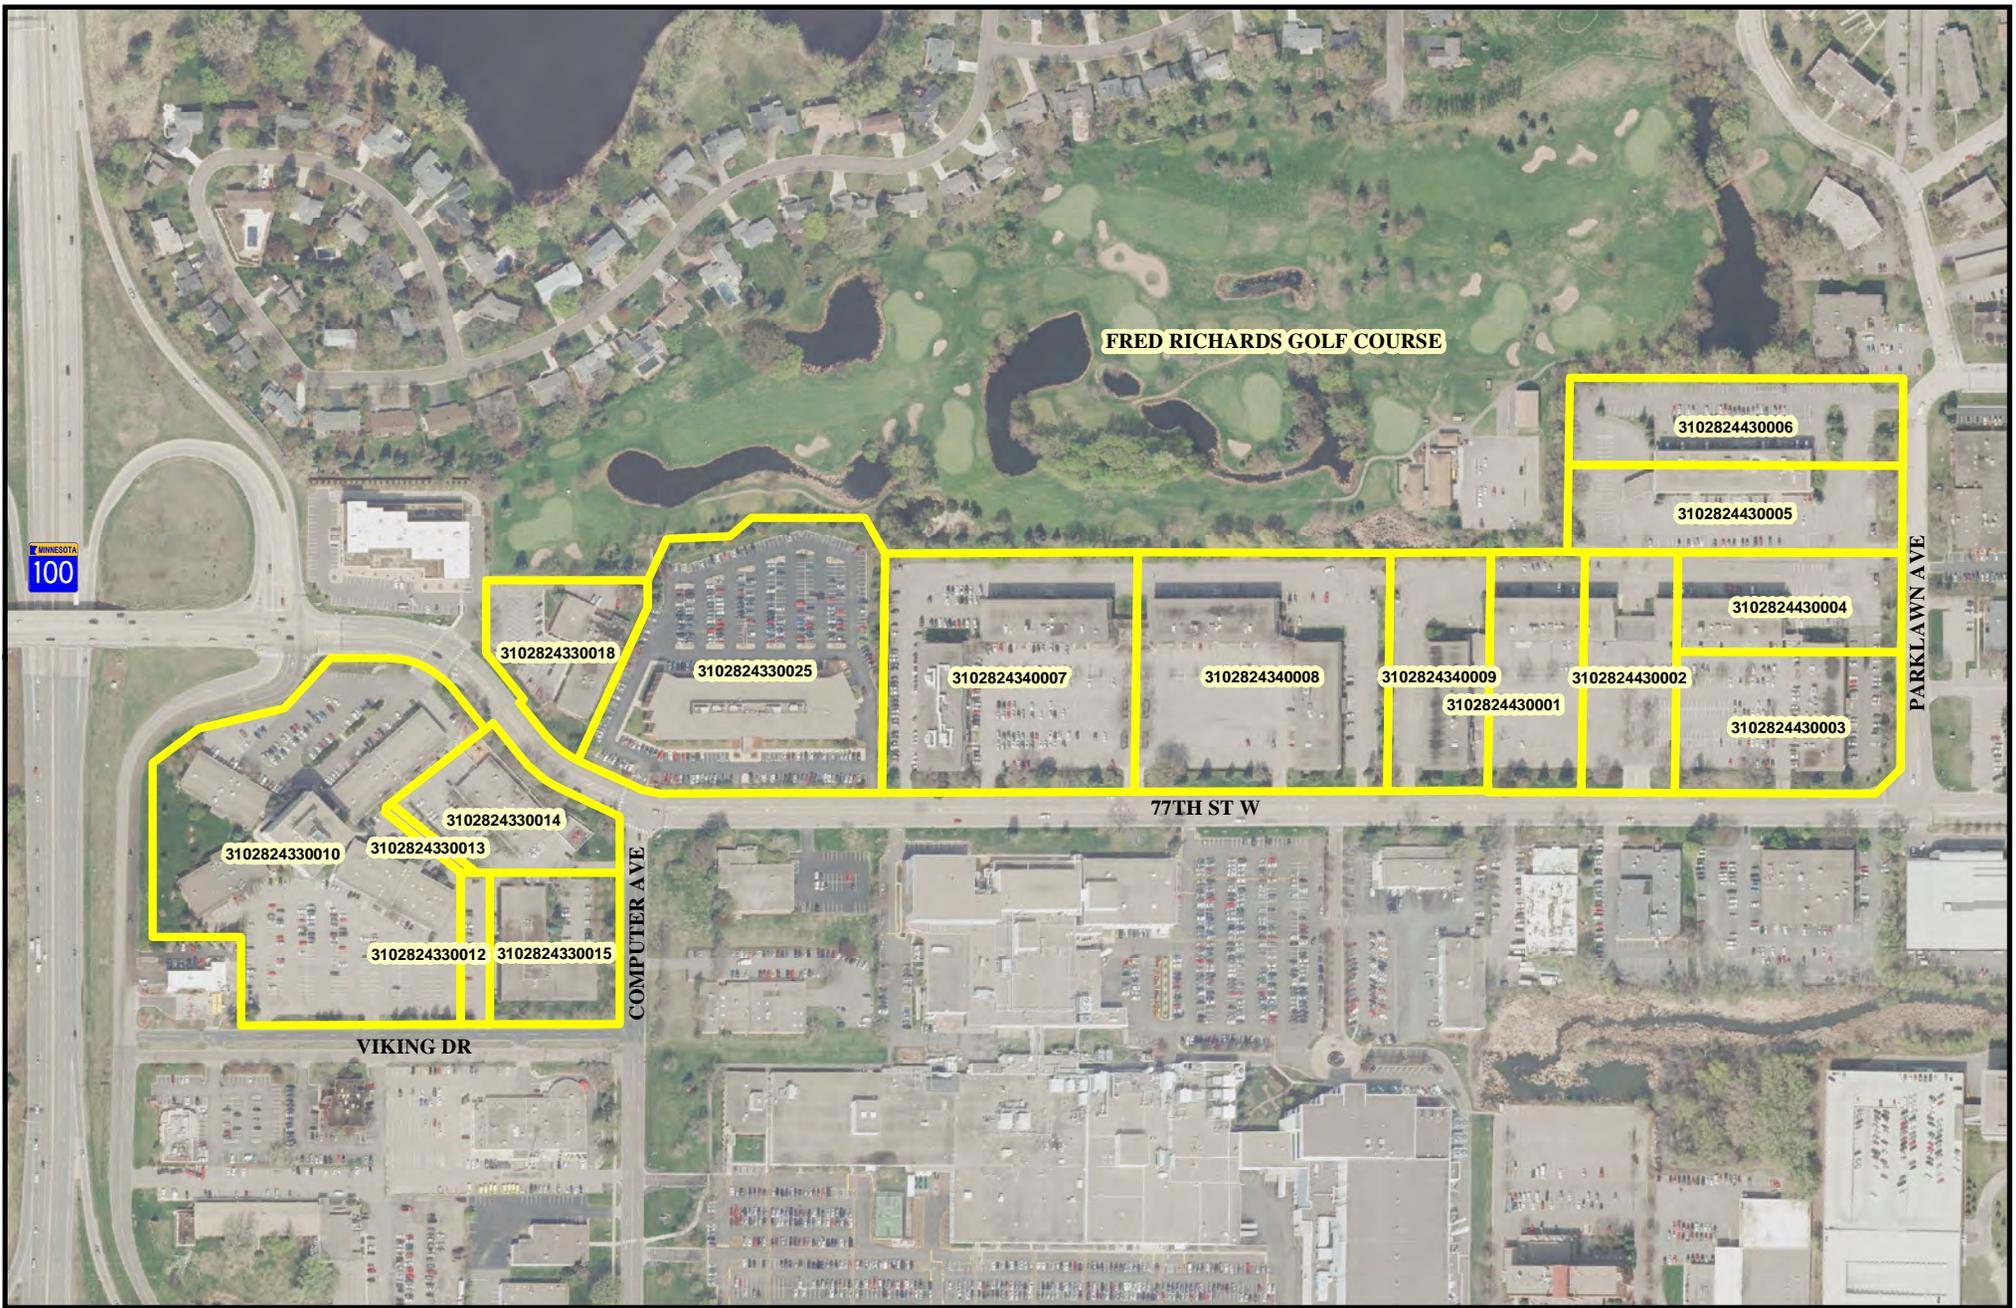
Maps of the Southeast Edina Redevelopment Project Area and the District

Proposed Pentagon Park TIF District

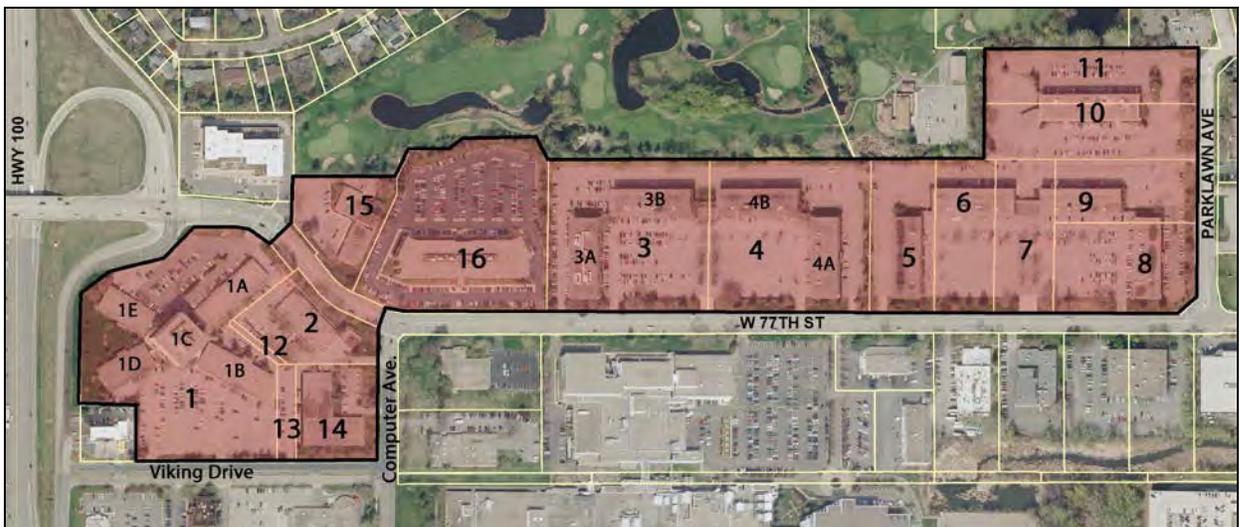
Diagram 1 – Proposed TIF District

LHB was hired by the City of Edina to inspect and evaluate the properties within a Tax Increment Financing Redevelopment District (“TIF District”) proposed to be established by the City. The proposed TIF District is concentrated along West 77th Street and is roughly bounded by Parklawn Avenue to the east, Fred Richards Golf Course to the North, and Highway 100 to the west (Diagrams 1). The purpose of LHB’s work is to determine whether the proposed TIF District meets the statutory requirements for coverage, and whether the eighteen (18) building’s on sixteen (16) parcels, located within the proposed TIF District, meet the qualifications required for a Redevelopment District.

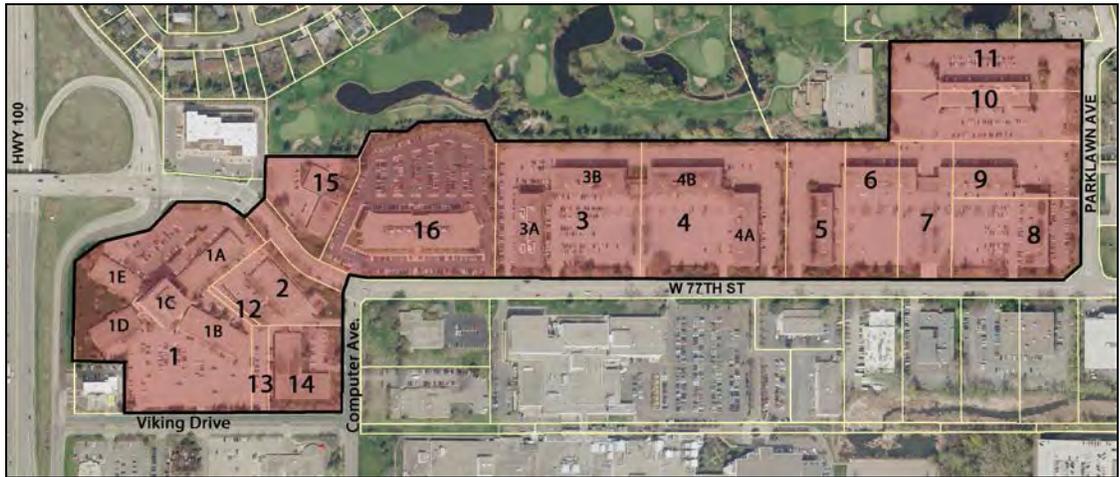
Diagram 2 – Coverage Diagram

The proposed TIF District met the coverage test under *Minnesota Statutes, Section 469.174, Subdivision 10(e)*, which resulted in parcels consisting of 100 percent of the area of the proposed TIF District being occupied by buildings, streets, utilities, paved or gravel parking lots, or other similar structures (Diagram 2). This exceeds the 70 percent area coverage requirement for the proposed TIF District under *Minnesota Statutes, Section 469.174, Subdivision (a) (1)*.

Shaded area depicts a parcel more than 15 percent occupied by buildings, streets, utilities, Paved or gravel parking lots or other similar structures

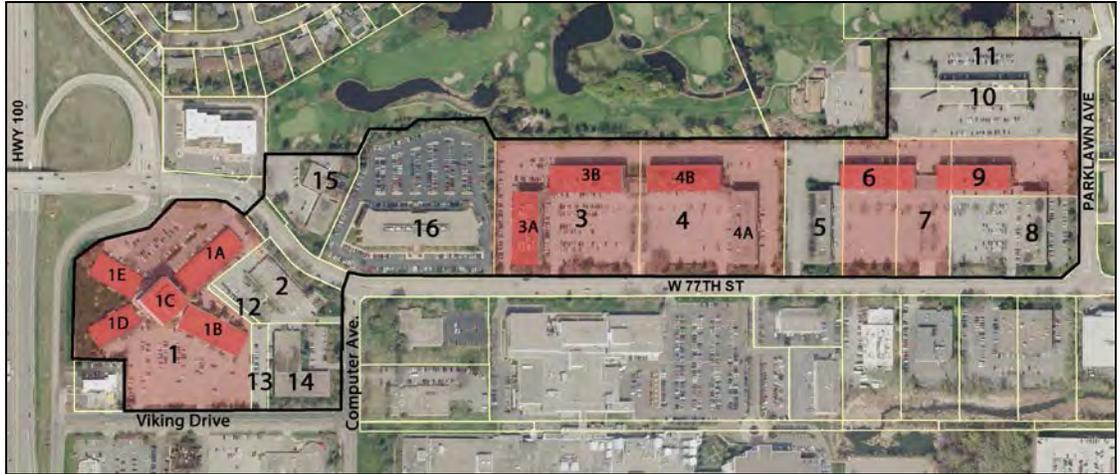
Diagram 3 – Substandard Buildings

The substandard buildings are reasonably distributed throughout the geographic area of the proposed TIF District.

Light Red shaded area depicts parcels with substandard buildings –
Darker Red shade depicts substandard buildings

Much of this report has focused on the condition of individual buildings as they relate to requirements identified by *Minnesota Statutes, Section 469.174, Subdivision 10*. It is also important to look at the distribution of substandard buildings throughout the geographic area of the proposed TIF District (Diagram 3).
