**Modification to the Redevelopment Plan
for the Southeast Edina Redevelopment Project Area**

**the Pentagon Park Tax Increment Financing District
(a redevelopment district)**

**Pentagon Park TIF District
Edina, Minnesota**

January 13, 2014

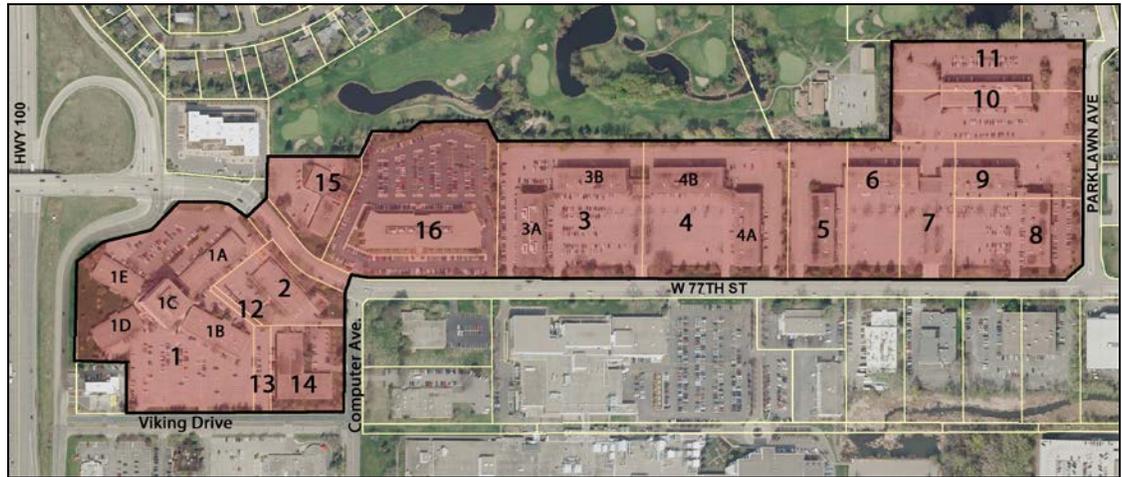
Diagram 2 – Coverage Diagram

The proposed TIF District met the coverage test under *Minnesota Statutes, Section 469.174, Subdivision 10(e)*, which resulted in parcels consisting of 100 percent of the area of the proposed TIF District being occupied by buildings, streets, utilities, paved or gravel parking lots, or other similar structures (Diagram 2). This exceeds the 70 percent area coverage requirement for the proposed TIF District under *Minnesota Statutes, Section 469.174, Subdivision (a) (1)*.

Shaded area depicts a parcel more than 15 percent occupied by buildings, streets, utilities, Paved or gravel parking lots or other similar structures

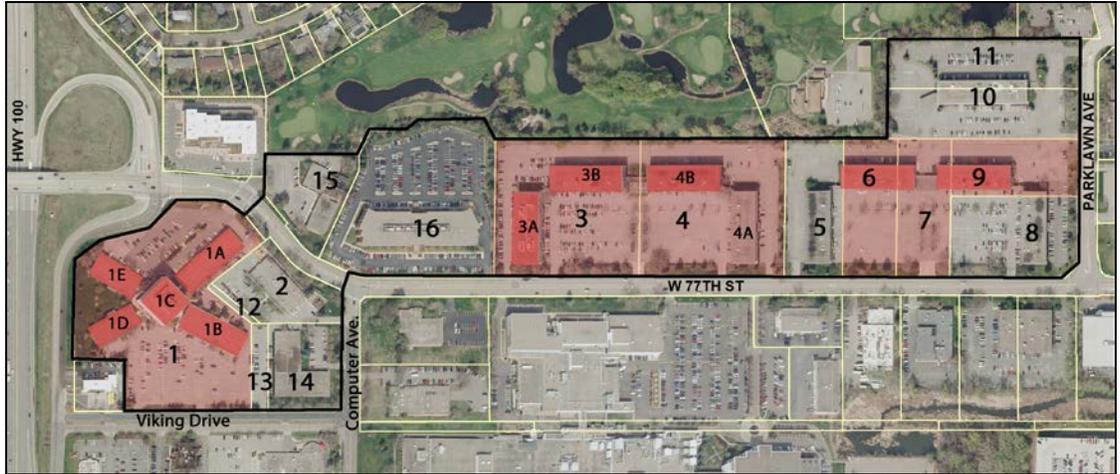
Diagram 3 – Substandard Buildings

The substandard buildings are reasonably distributed throughout the geographic area of the proposed TIF District.

Light Red shaded area depicts parcels with substandard buildings –
Darker Red shade depicts substandard buildings

Much of this report has focused on the condition of individual buildings as they relate to requirements identified by *Minnesota Statutes, Section 469.174, Subdivision 10*. It is also important to look at the distribution of substandard buildings throughout the geographic area of the proposed TIF District (Diagram 3).
