FINAL REPORT | December 31, 2014

FHWA Request to Experiment 2014 Final Evaluation Report

Prepared for
City of Edina
Department of Public Works
7450 Metro Boulevard
Edina, MN 55439

Prepared by
Alliant Engineering, Inc.
233 Park Avenue S, Suite 300
Minneapolis, MN 55415
612-758-3080

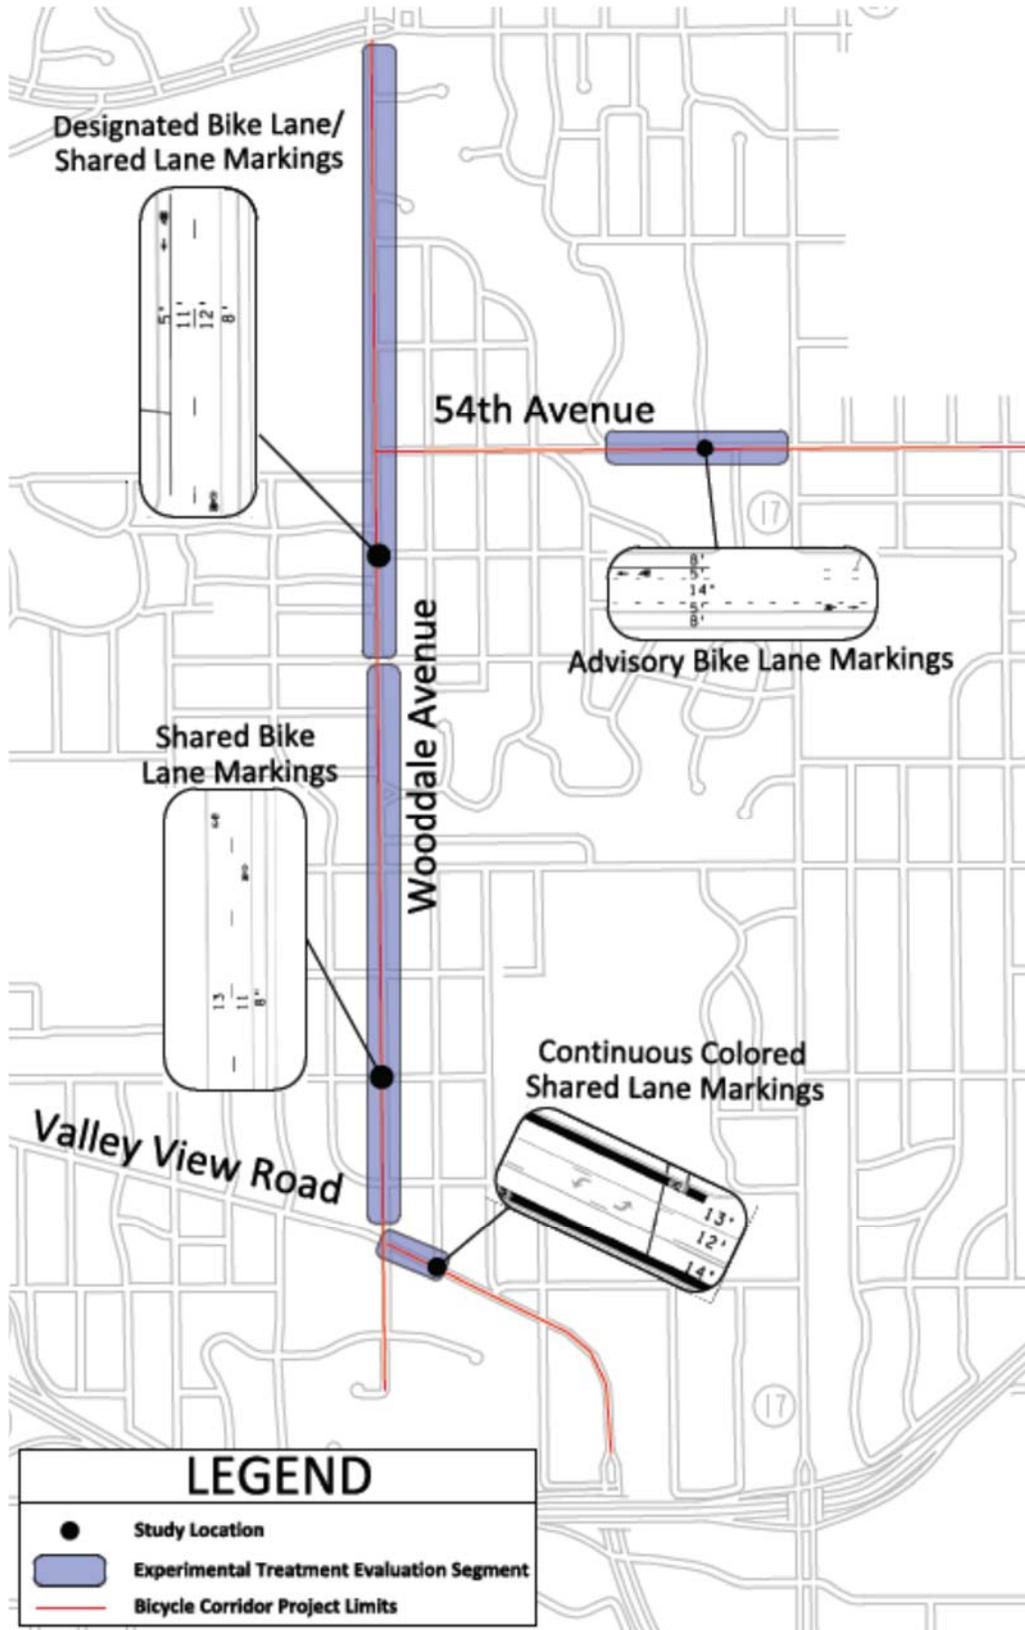
Figure 1. Experimental Pavement Markings and Study Locations

To evaluate and compare the experimental treatments, vehicle and bicycle data was collected at four locations. The four study locations and their respective street typical sections are illustrated in Figure 1. The data analysis included the following:

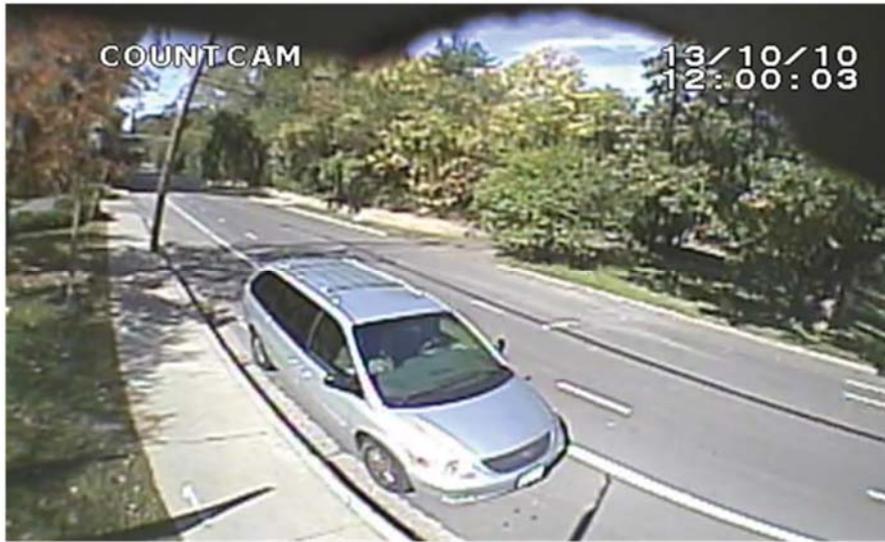
West 54th Street has symmetric lane geometry, consisting of an 8 foot parking lane with a solid white stripe and a 5 foot wide bike lane. The bike lane has a bicycle symbol with arrow message and a dashed white stripe on the left side of the lane. The two-way traffic center space is 14 feet wide and does not have a centerline.

Figure 2. West 54th Street near Halifax Avenue Camera View

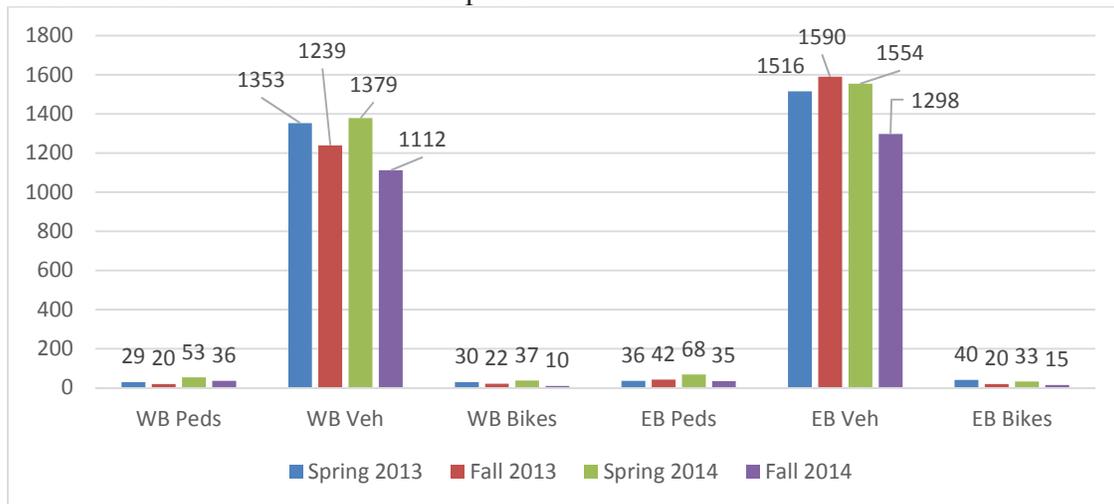
Figure 3 shows the 24-hour vehicle, pedestrian and bicycle volumes collected on West 54th Street for each of the evaluation periods.

Figure 3. West 54th Street 24-Hour Volumes

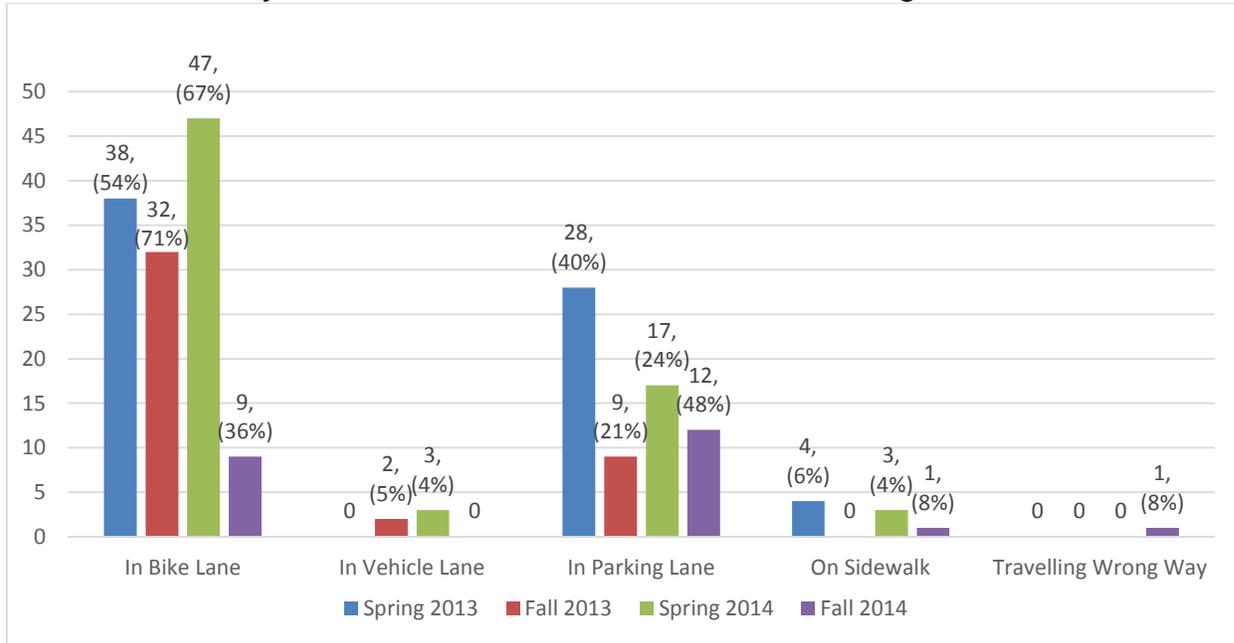
Figure 4 summarizes the observed bicyclist lane positioning. The study found that the majority of bicyclists used the bike lane, however a large percentage still traveled in the parking lane as long as there was no vehicle present. This is acceptable as the extra space allows for a greater perceived safety by the bicyclists. The study also shows that a very small number of bicyclists travel on the sidewalk or travel in the wrong direction.

Figure 4. West 54th Street Bicycle Lane Positioning

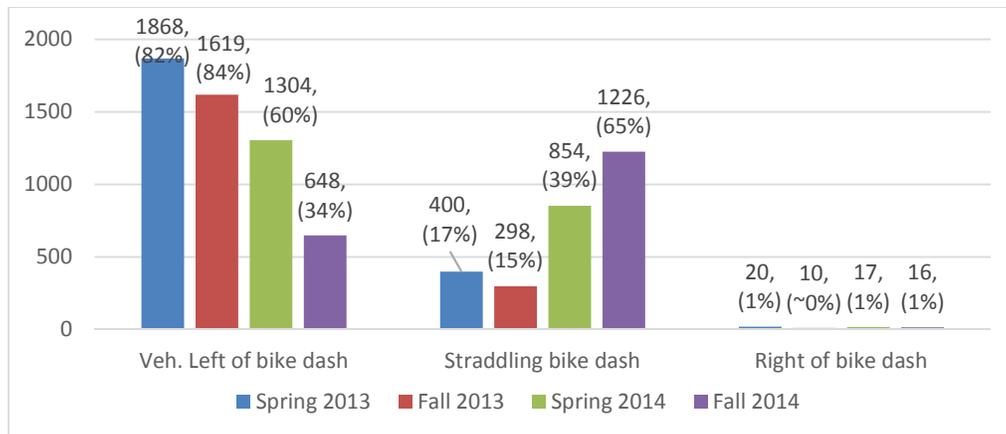
Figure 5 summarizes the motor vehicle lane positioning when only one vehicle is present (no conflict). The data shows that over time, vehicles that lie completely to the left of the bike dash reduce, while the number of vehicles that straddle the bike dash increases. This change represents a growing comfortability with the design that complies with the intended operation (vehicles can use advisory lanes, so long as no bicycles are present). This occurrence may have an indirect correlation with more bicyclists riding in the parking lane.

Figure 5. West 54th Street Single Vehicle Behavior

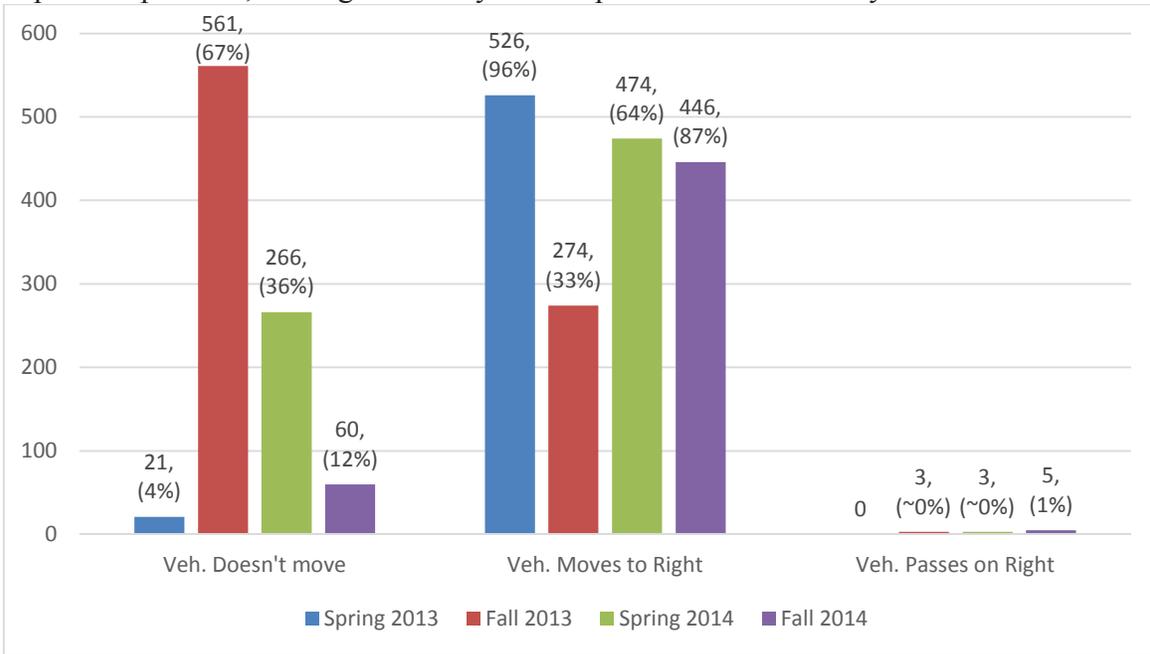
Figure 6 summarizes the motorist’s behavior when approaching an oncoming vehicle. The data does not show a consistent trend; however, for the most part the motorist moves to the right when meeting an oncoming vehicle. This complies with the intended and expected operation, so long as no bicycles are present in the advisory lane.

Figure 6. West 54th Street Vehicle Meeting Oncoming Vehicle Behavior

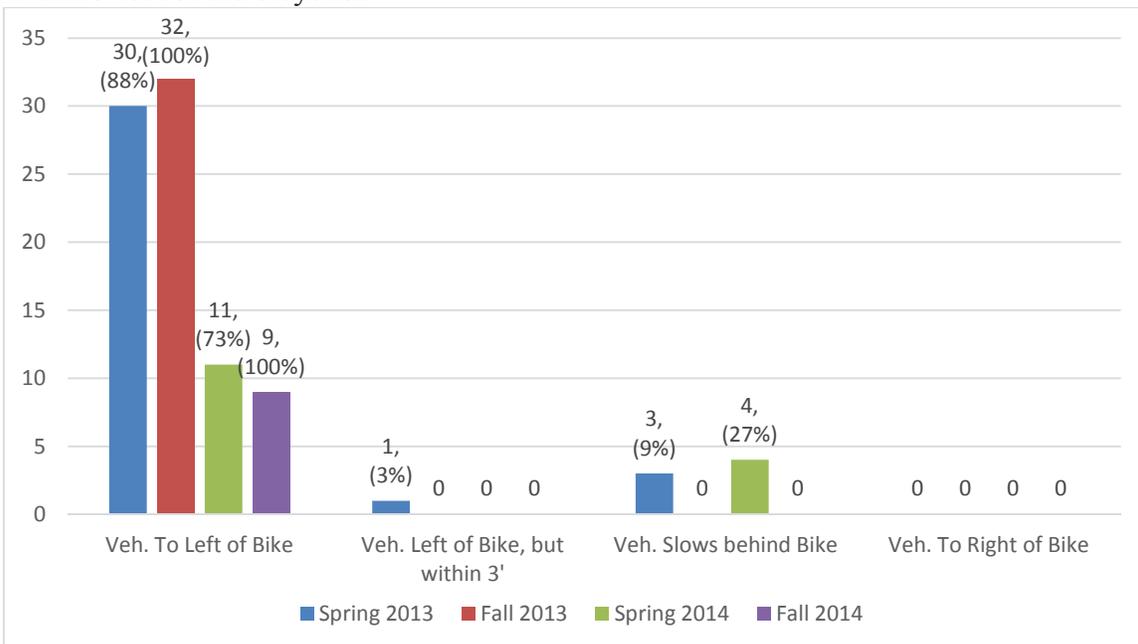
Figure 7 summarizes the vehicle behavior when a bicycle is present. The data shows an excellent compliance with the intended operation, with only one vehicle observed passing within 3 feet of the bicyclist.

Figure 7. West 54th Street Vehicle Meeting Bicycle (in Same Direction)

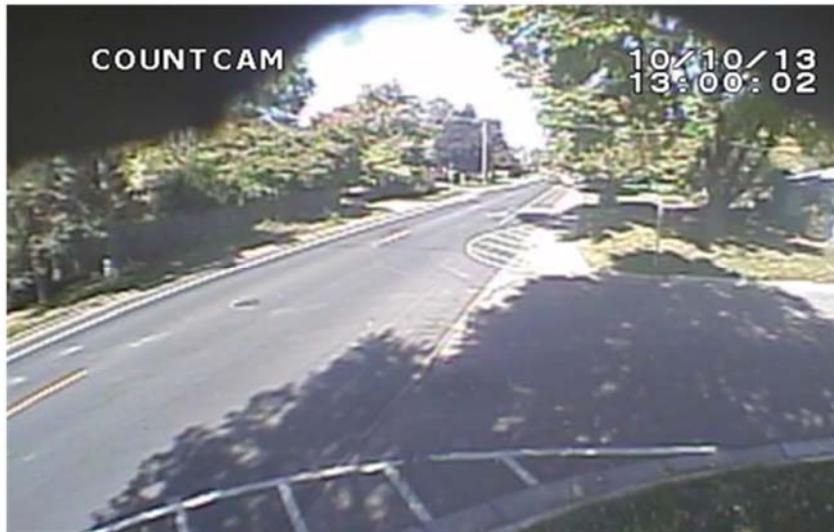
Wooddale Avenue was evaluated under two separate design scenarios – advisory bike lanes and shared lane markings. The Spring 2013 evaluation period consisted of an advisory bike lane design, with the parking on the northbound side of the road only. The section evaluated under the Fall 2013-Fall 2014 period consisted of an asymmetric geometry, with the northbound direction containing an 8 foot vehicle parking lane with a solid white line to designate the end width, and a shared lane marking within the 12 foot travel lane. The southbound direction has a 5 foot designated bicycle lane (with white bicycle symbol and arrow), and an 11 foot vehicle travel lane. A dashed yellow centerline is present.

Figure 8. Wooddale Avenue at West 55th Street Camera View

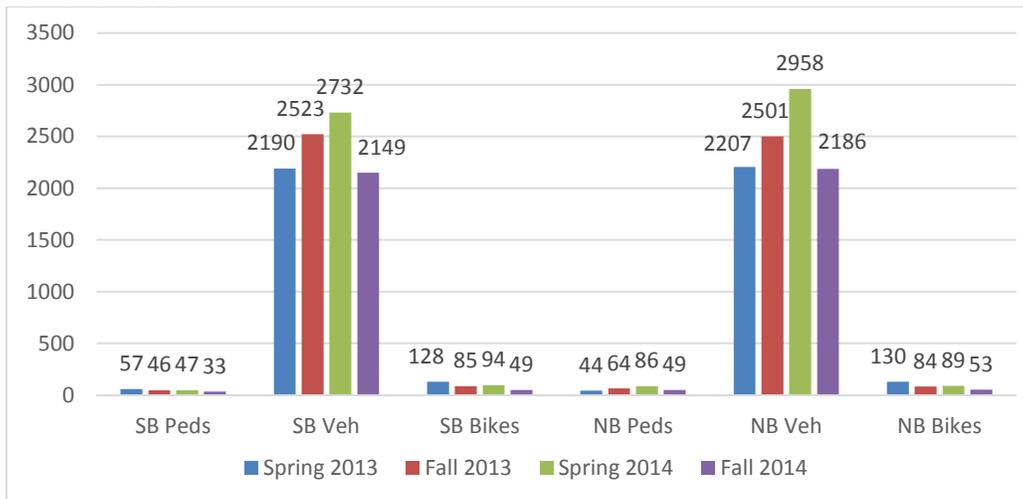
Note: Advisory bike lanes were in place during the Spring 2013 evaluation period. Figure 9 shows the 24-hour vehicle, pedestrian and bicycle volumes collected on Wooddale Avenue.

Figure 9. Wooddale Avenue at 55th Street 24-Hour Volumes

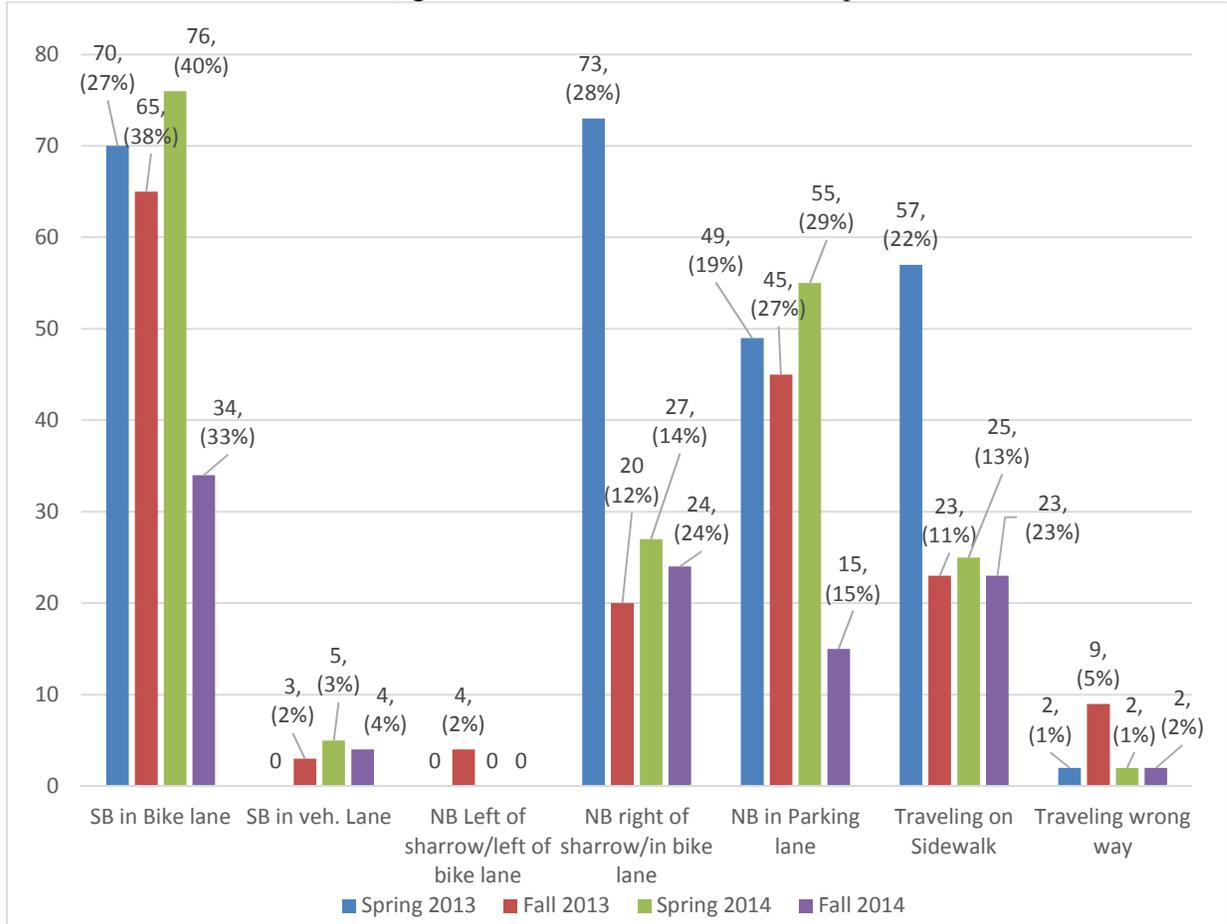
Figure 10 summarizes the observed bicyclist lane position by direction. The data shows excellent compliance by bicycles in the southbound direction, with the strong majority of southbound bicyclists using the bike lane. In the northbound direction, the data shows a large number of bicyclists using the parking lane when no vehicles were parked, with a much higher percentage occurring under the shared lane markings design. This seems to be caused by an increase in the perceived safety of the bicyclists by offering additional buffer clearance from vehicles, given a dedicated bike lane is not provided.

Figure 10. Wooddale Avenue at 55th Street Bicycle Lane Positioning

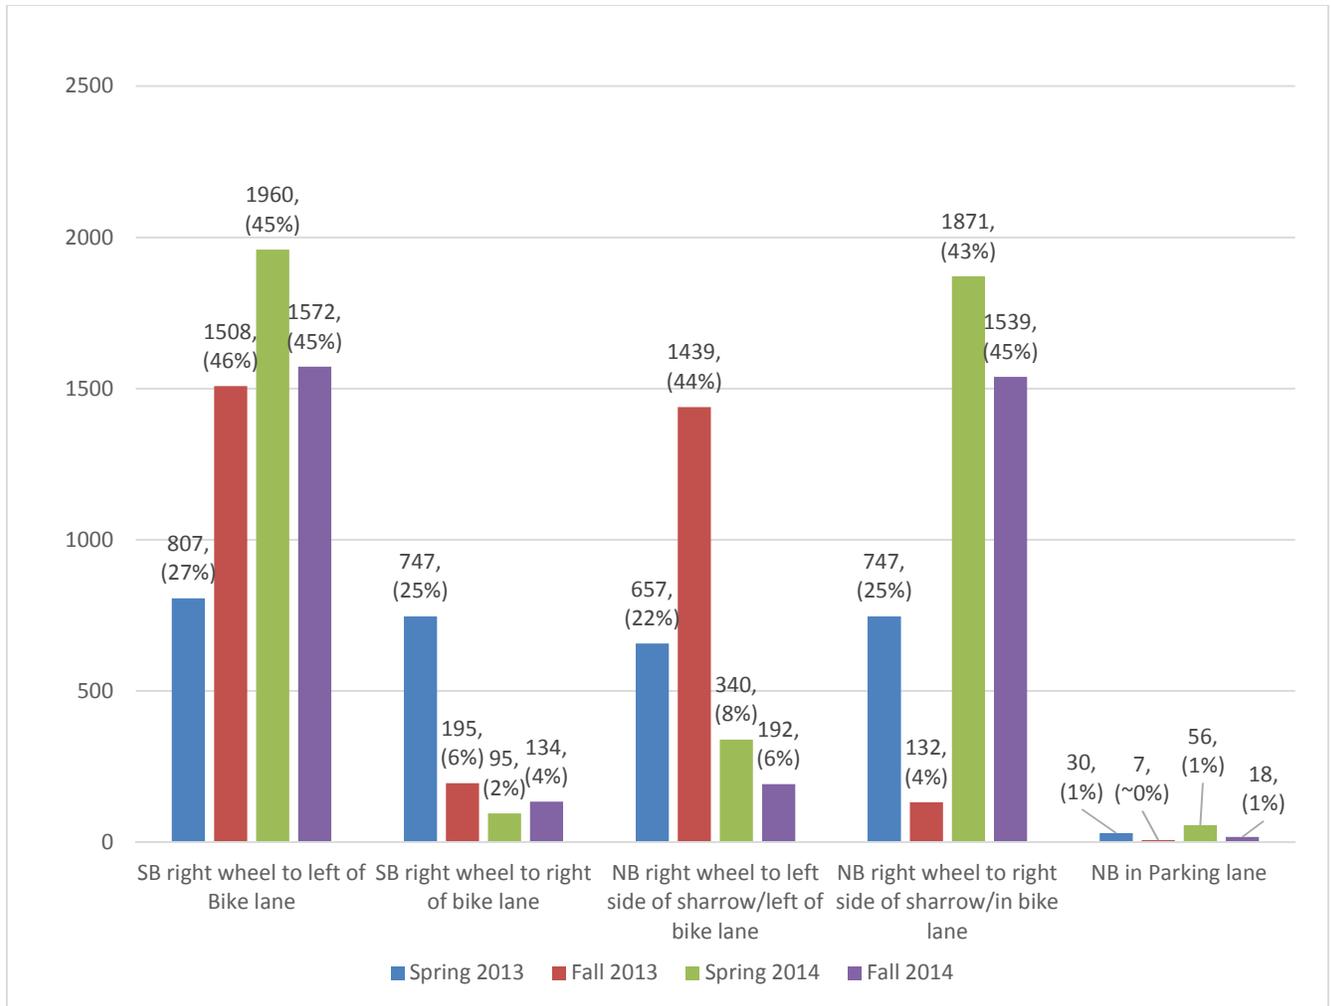
Figure 11 summarizes the motorist behavior when no other vehicles or bicyclists were present. In the southbound direction, compliance with the intended operation (vehicles traveling in the center of the travel lane) increases over time as vehicles become more comfortable with the design. The same was observed in the northbound direction. At the time of the shared lane marking implementation (Fall 2013), most northbound vehicles drove to the left of the shared lane marking, but over time the motorist position shifted rightward (i.e. traveling in the center of the drive lane as long as no bicyclists were present).

Figure 11. Wooddale Ave at 55th Street Single Vehicle Behavior

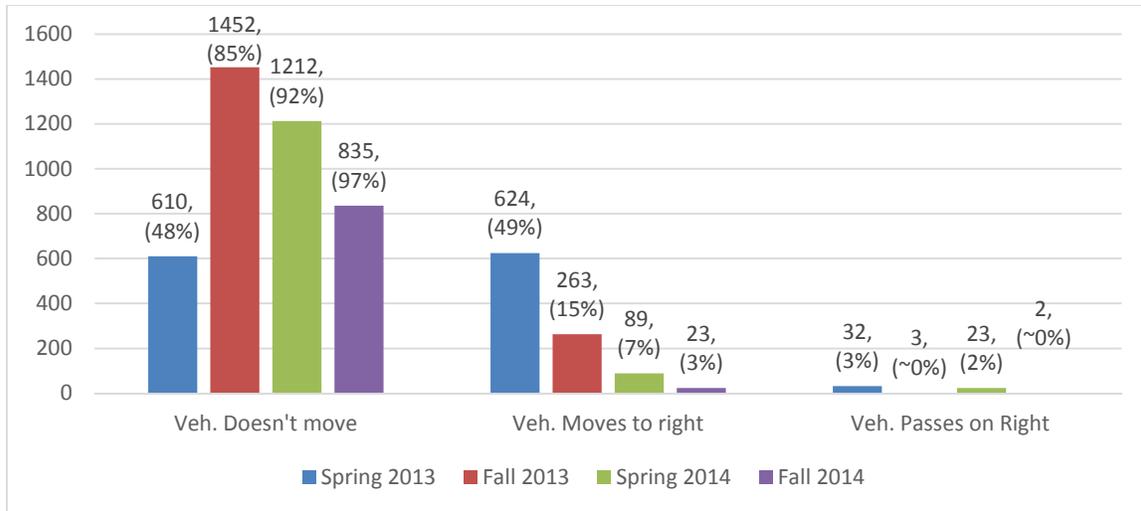
Figure 12 summarizes how the motorists reacted to another oncoming vehicle. A broken yellow centerline was in place during the Fall 2013 – Fall 2014 evaluation periods. As a result, the data shows motorists experienced a much improved sense of comfort in the travel lane, though still less than 100 percent. The data shows that over time, fewer vehicles move to the right when an oncoming vehicle approaches, suggesting the drivers have become more comfortable with the space provided.

Figure 12. Wooddale Avenue at 55th Street Vehicle Meeting Oncoming Vehicle Behavior

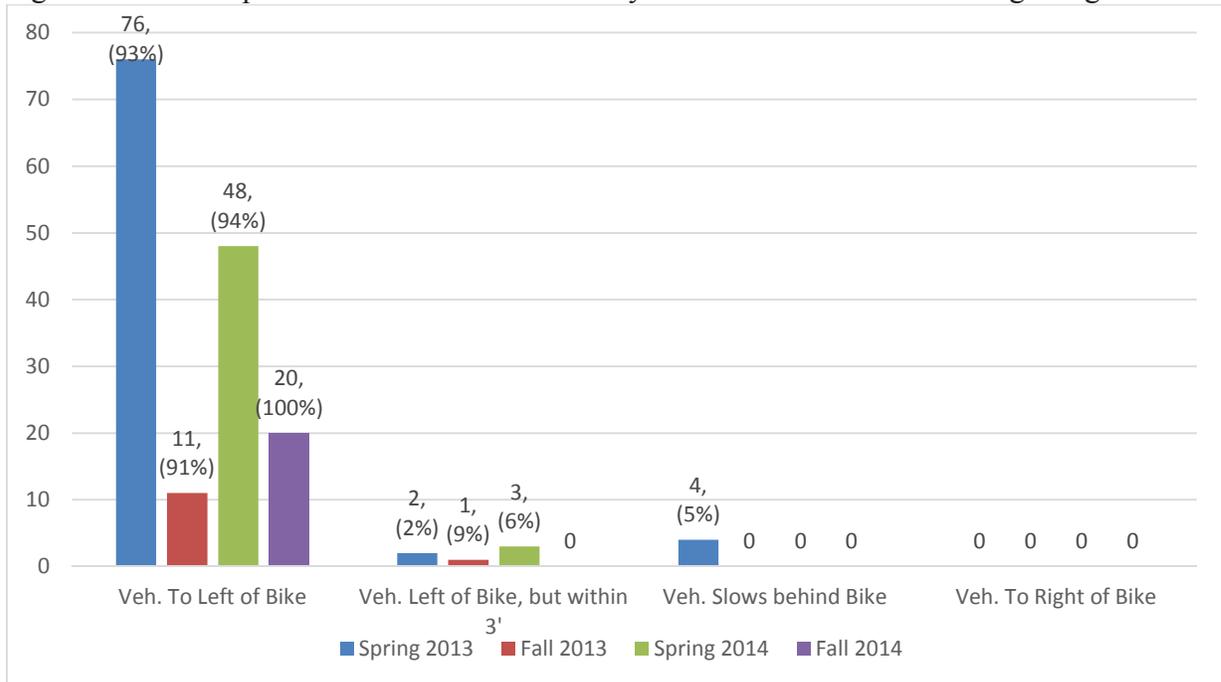
Figure 13 summarizes the occurrences of vehicles reacting to bicyclists. The data shows high levels of compliance under both the advisory lane and shared lane marking designs.

Figure 13. Wooddale Avenue at 55th Street Vehicle Meeting Bicycle (in Same Direction)

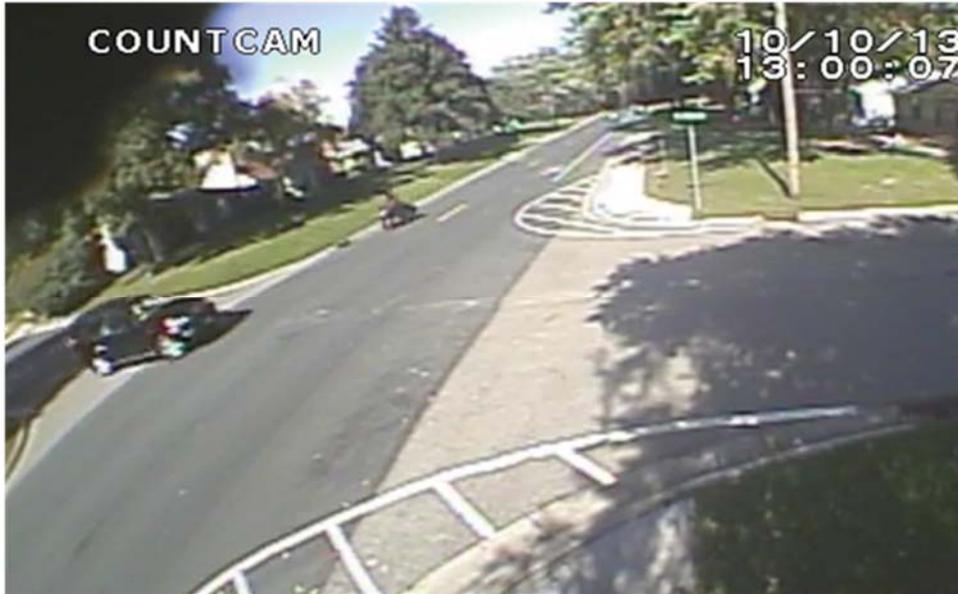
Wooddale Avenue was evaluated under two separate design scenarios – advisory bike lanes and shared lane markings. The Spring 2013 evaluation period consisted of an advisory bike lane design, with the parking on the northbound side of the road only. The section evaluated under the Fall 2013-Fall 2014 period consisted of an asymmetric geometry with both the northbound and southbound vehicle travel lanes containing a shared lane marking. An 8 foot parking lane is provided in the northbound direction. Parking does not exist in the southbound direction, so the shared lane marking is located approximately 4 feet from the face of curb. A dashed yellow centerline is present.

Figure 14. Wooddale Avenue at West 60th Street Camera View

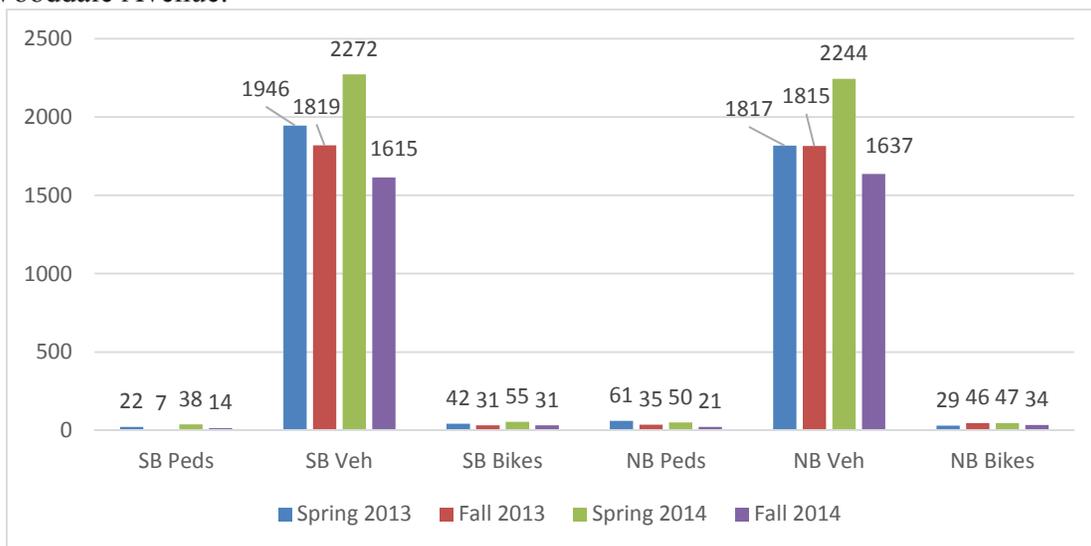
Figure 15 shows the 24-hour vehicle, pedestrian and bicycle volumes collected on Wooddale Avenue.

Figure 15. Wooddale Avenue at 60th Street Volumes

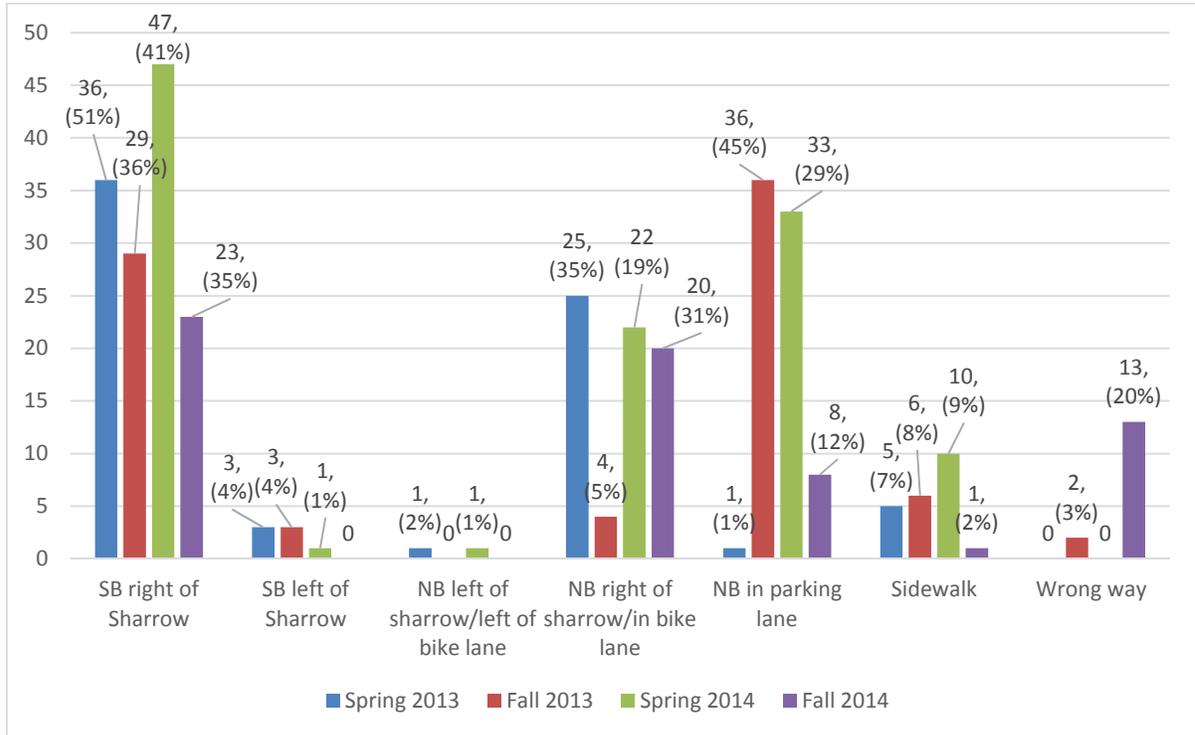
Figure 16 summarizes the observed bicyclist lane positions by direction. The data shows that the bicyclists were best positioned under the advisory lane design. At the time of the switch to the shared lane markings, it can be suggested that bicycle position improved over time, as shown by the decreasing number of bicyclists riding in the parking lane; however, bicyclists appear to be less comfortable riding in the shared travel lane.

Figure 16. Wooddale Avenue at 60th Street Bicycle Lane Positioning

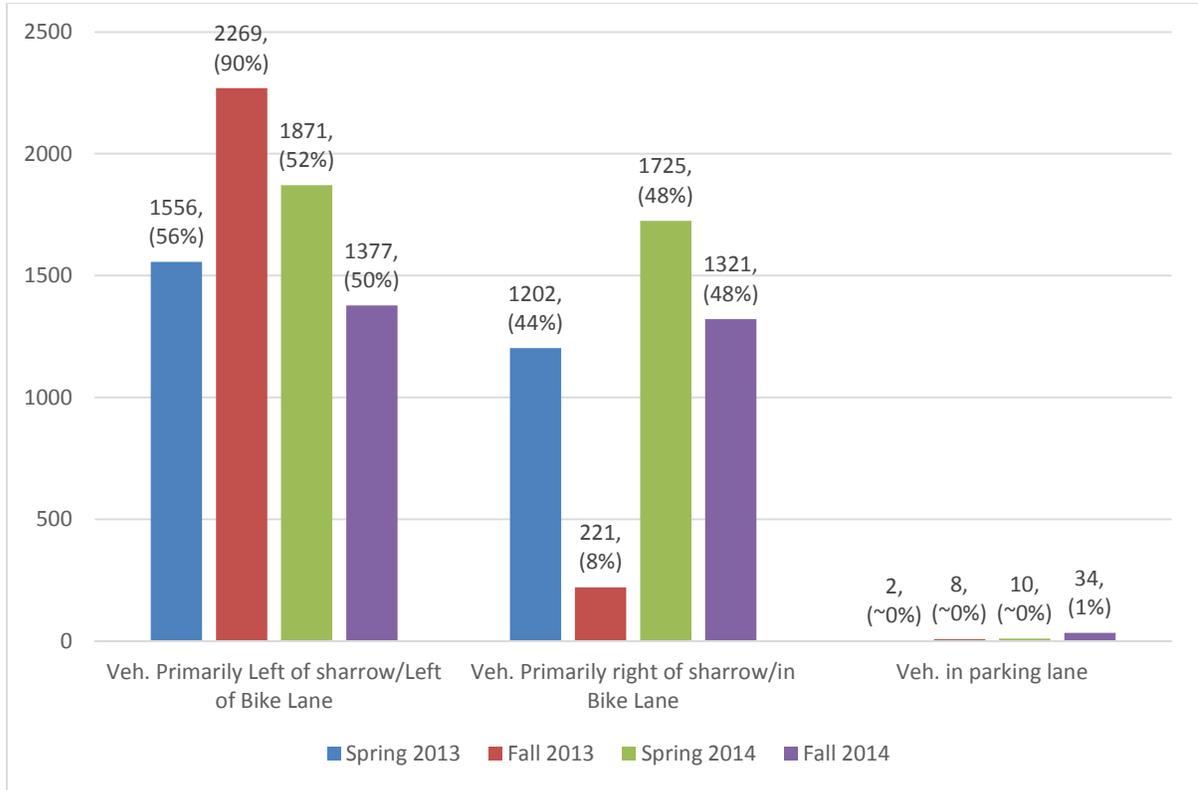
Figure 17 summarizes the motorist’s behavior when no other vehicles or bicyclists are present. In the southbound direction, the motorists tended to navigate rightward in the lane over time. The Fall 2014 evaluation period found the motorists traveling in similar position on the roadway between the advisory lane and shared lane marking conditions. The same observation was found for the northbound direction.

Figure 17. 60th and Wooddale Single Vehicle Behavior

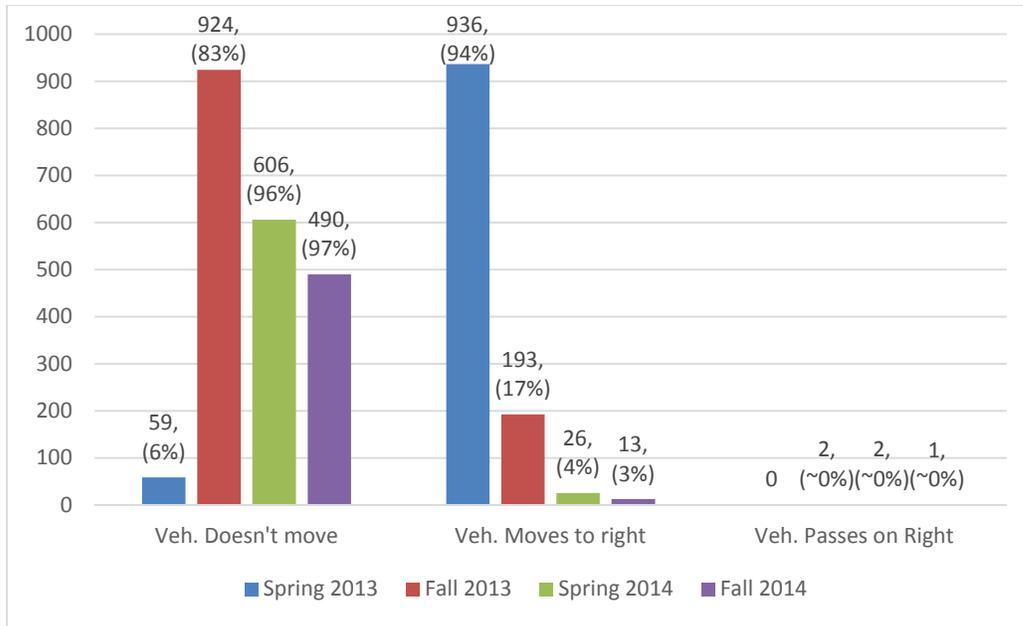
Figure 18 summarizes the behavior of motorists that approached oncoming vehicles. Although the overall travel way space is the same, it can be seen from the percentages that the presence of a yellow centerline has a dramatic influence on the perceived comfort of the motorist. Under the shared lane marking design, the motorists tended to not adjust their lane position, whereas the majority of motorists on the advisory lane tended to drift rightward.

Figure 18. Wooddale Avenue at 60th Street Vehicle Meeting another Oncoming Vehicle Behavior

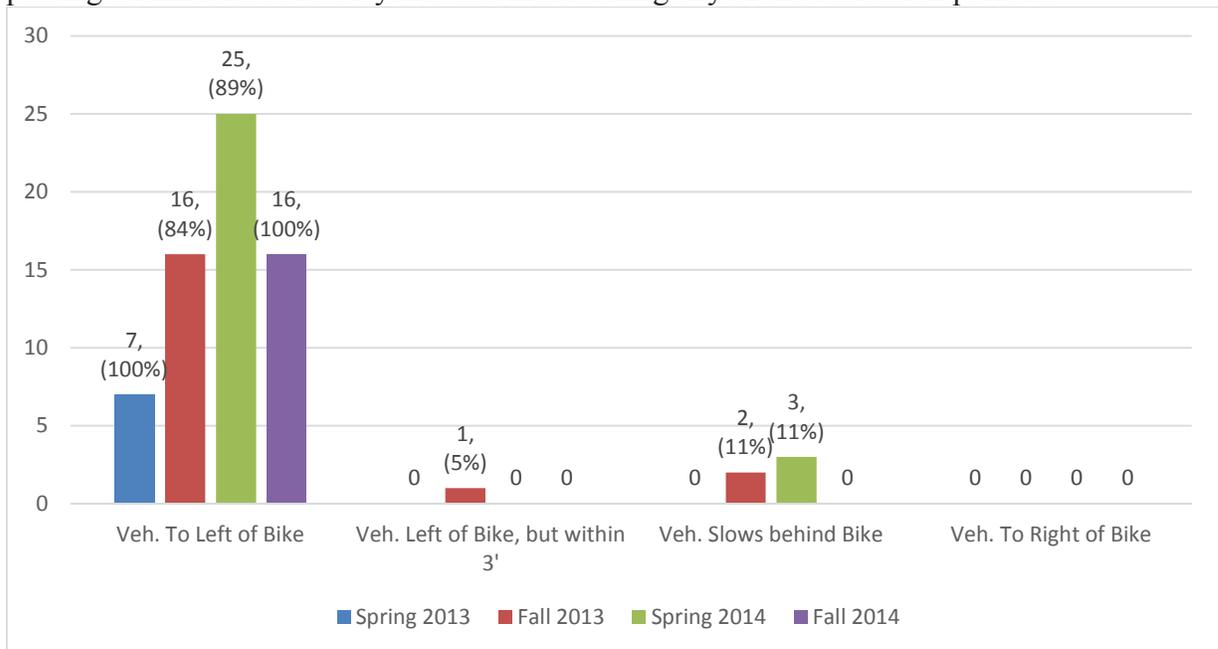
Figure 19 summarizes the occurrences of when a motorist approached a bicycle and how they reacted. The data shows excellent compliance under both the advisory lane and the shared lane marking designs. It is also noted that only one observation of a motorist passing within 3 feet of a bicyclist was made during any of the evaluation periods.

Figure 19. Wooddale Avenue at 60th Street Vehicle Meeting Bicycle (in Same Direction)

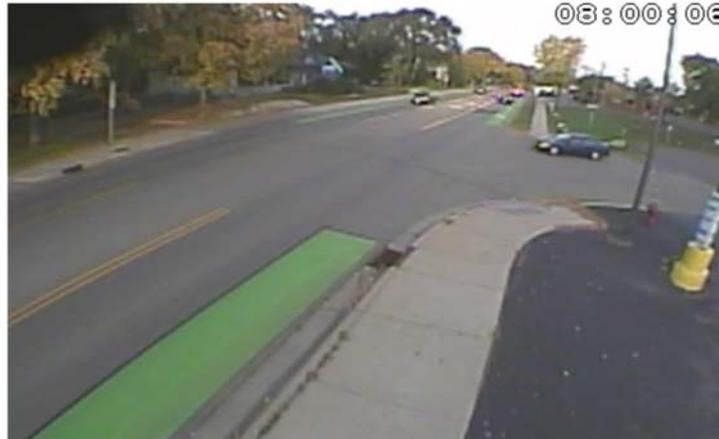
The segment of Valley View Road between Wooddale Avenue and Kellogg Boulevard consists of a three lane cross-section (two way center left turn lane) and a four foot wide green colored continuous shared bicycle lane located within the 14 foot wide eastbound and westbound travel lanes.

Figure 20. Valley View Road Camera View

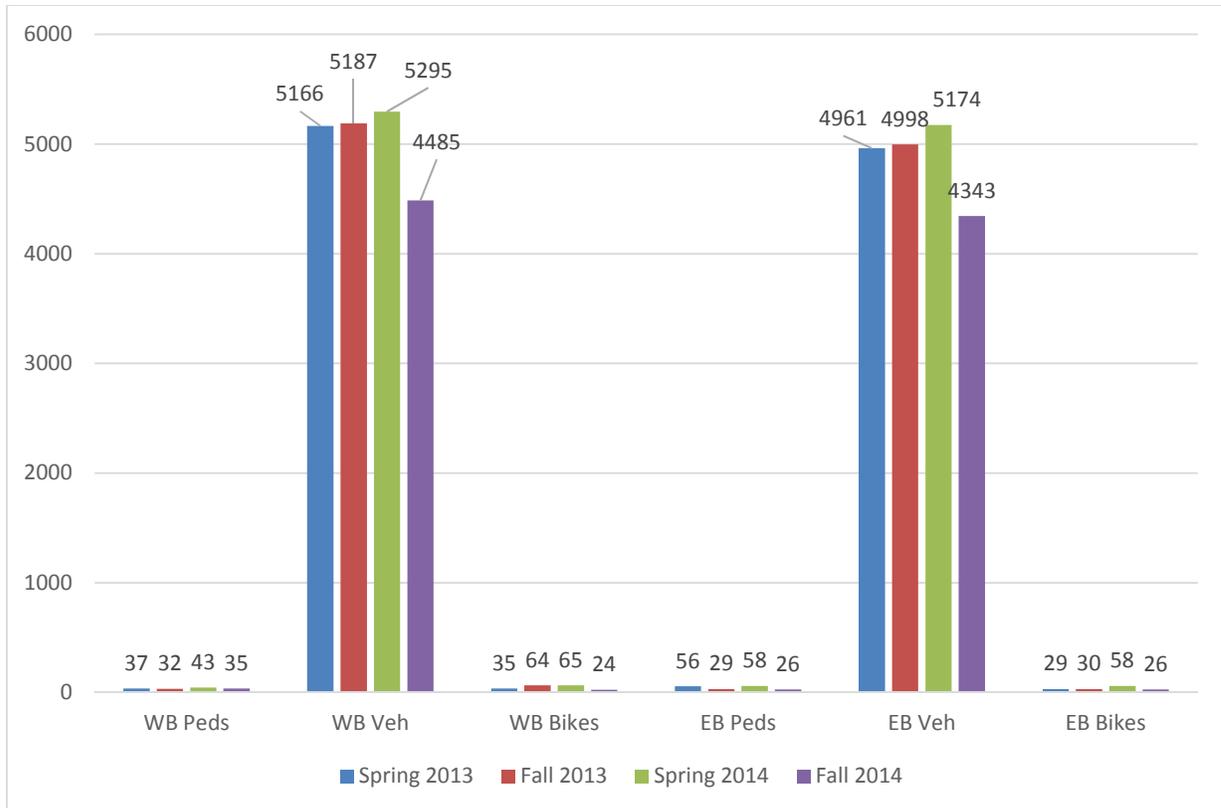
Figure 21 shows the 24-hour vehicle, pedestrian and bicycle volumes collected on Valley View Road.

Figure 21. Valley View Road Volumes

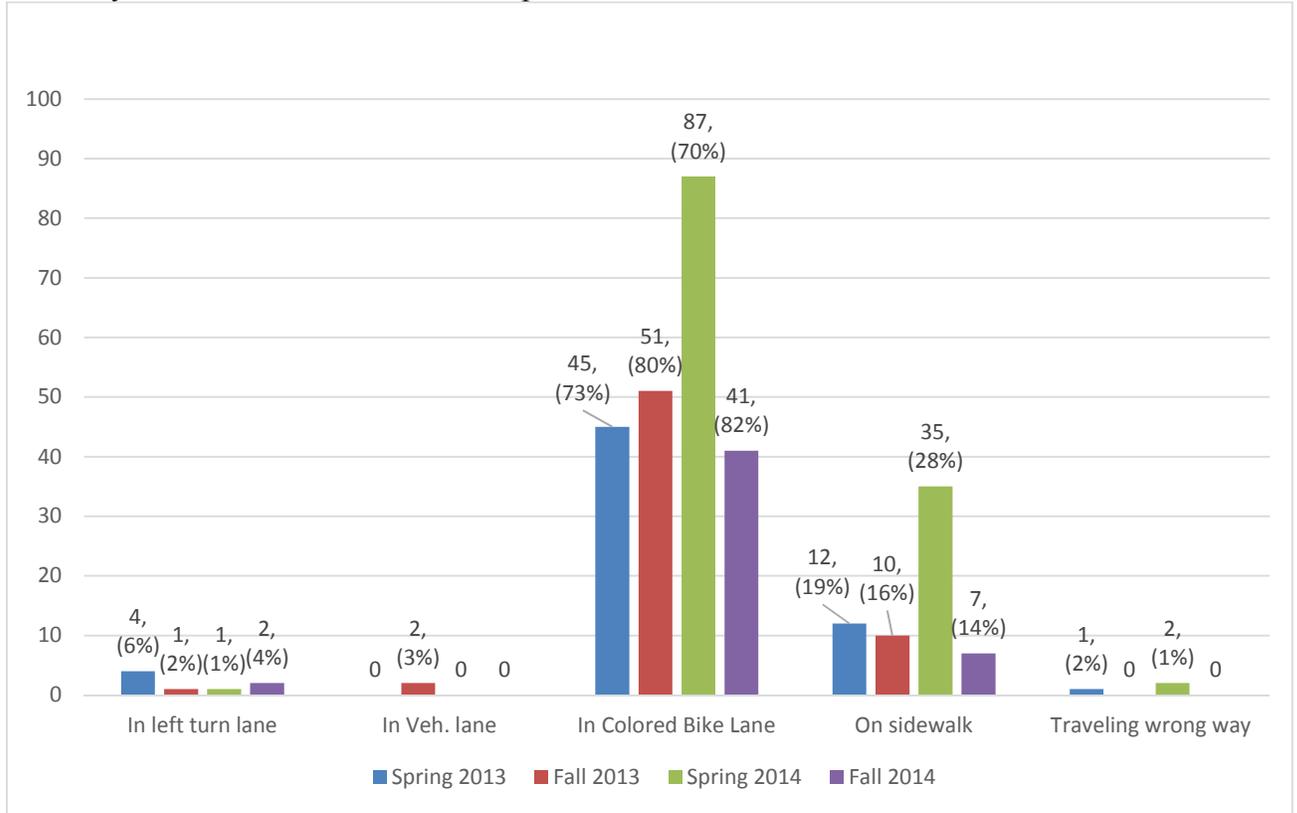
Figure 22 summarizes the observed bicyclist lane positions, which was found to be relatively consistent over the evaluation periods.

Figure 22. Valley View Rd and Kellogg Bicycle Lane Positioning

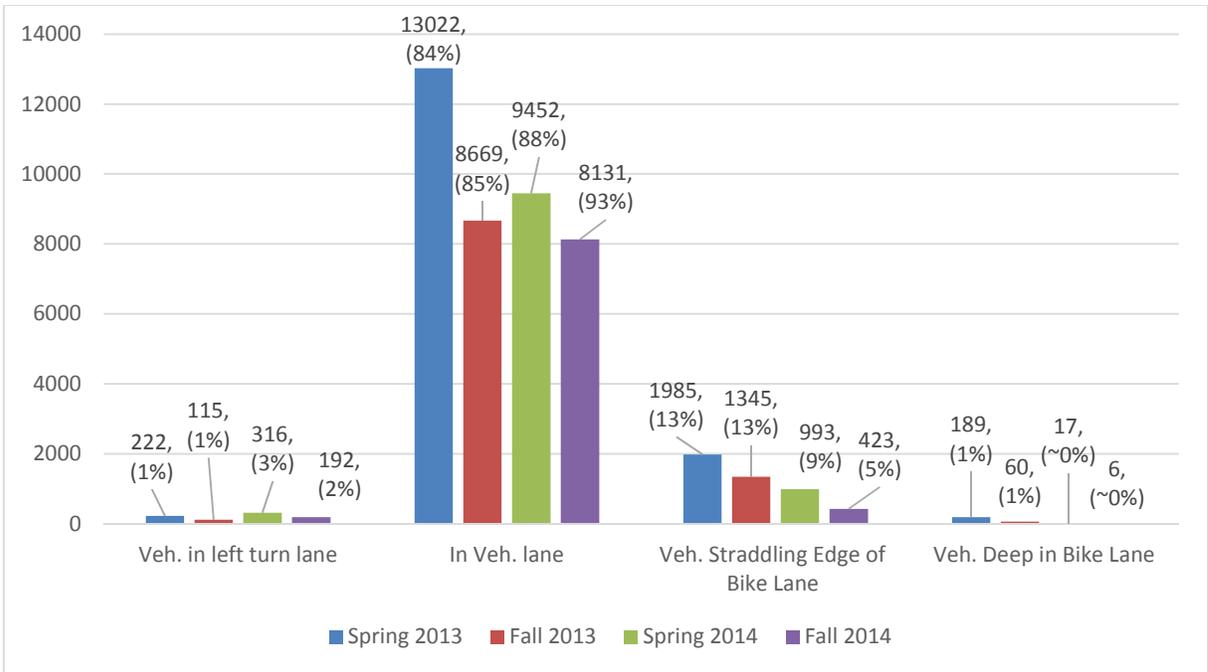
Figure 23 summarizes the behavior of single vehicle motorists along Valley View Road. As shown by the data, the motorist travels predominately to the left of the colored shared bike lane markings. Comparing this observation with observations of shared lane markings on Wooddale Avenue, the colored shared lane exhibits much improved vehicle lane position. However, this observation may be skewed due to the presence of an adjacent two way center left turn lane as opposed to an opposing through lane.

Figure 23. Valley View Road Single Vehicle Behavior

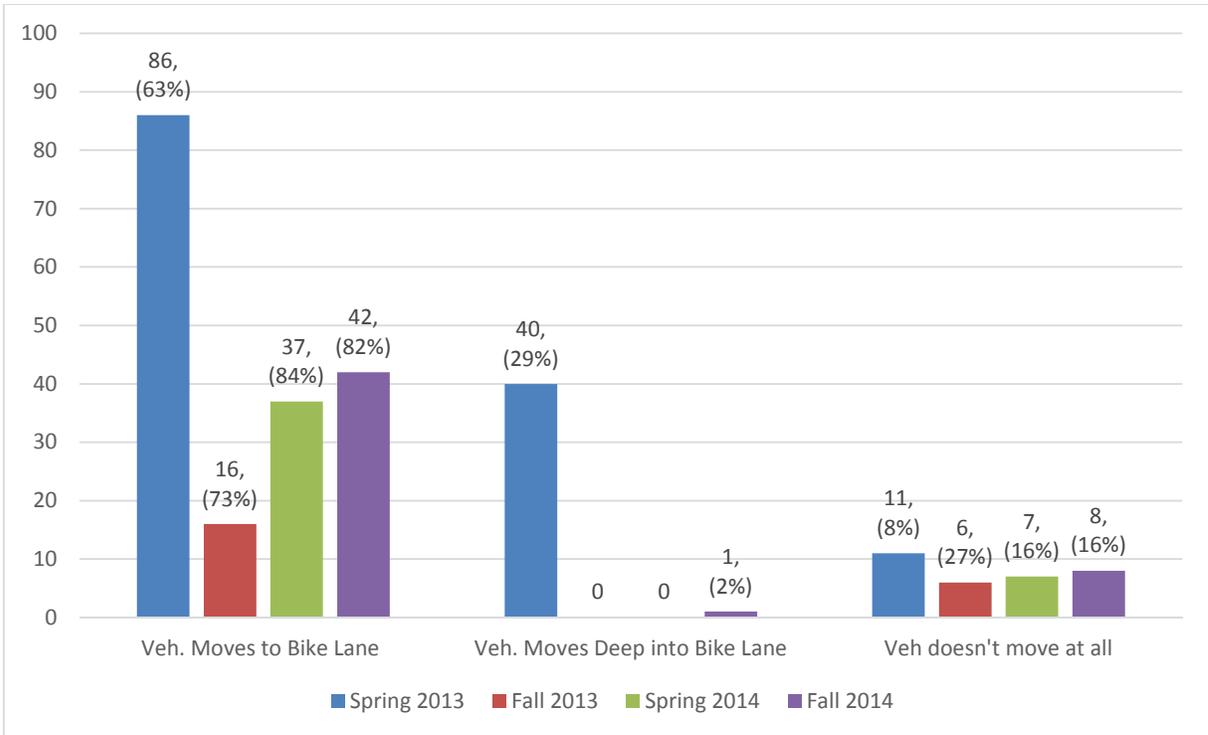
Figure 24 summarizes the reactions of motorists to oncoming vehicles using the center left turn lane.

Figure 24. Valley View Road Vehicles Reacting to Left Turning Vehicles

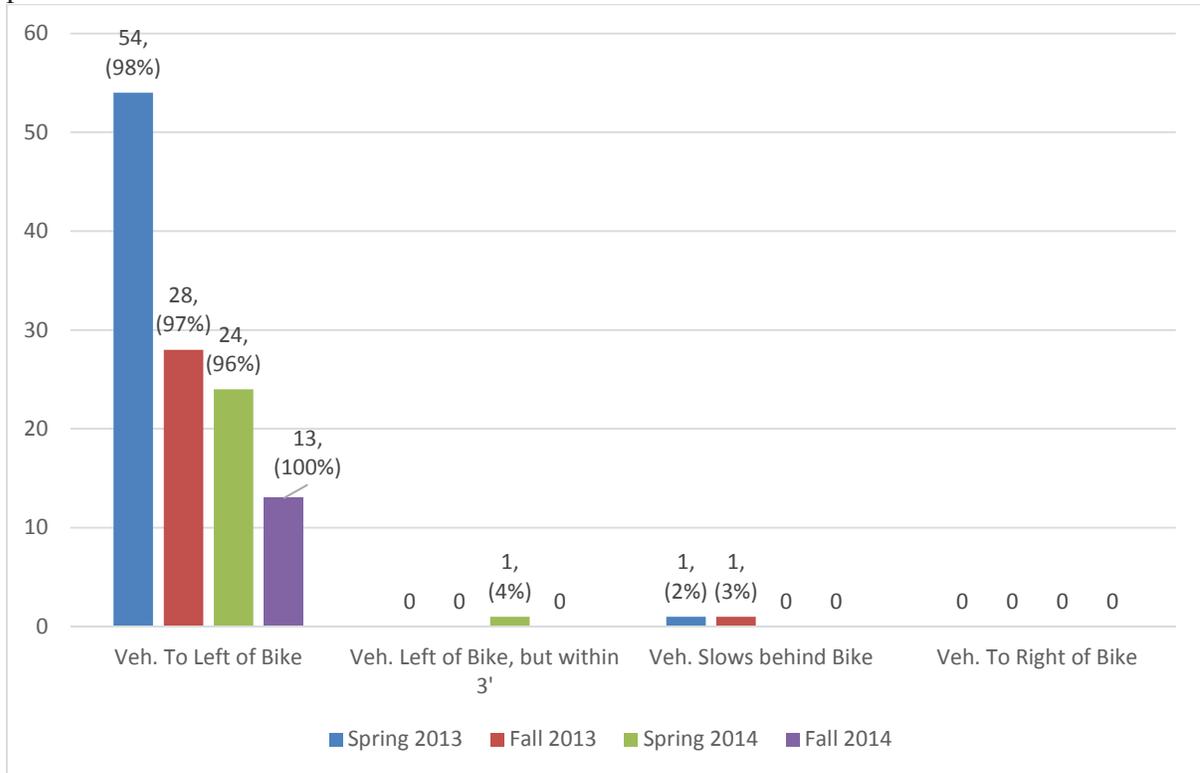
Figure 25 summarizes the behavior of motorists when approaching a bicyclist. As shown by the percentages, motorists are observed safely passing bicyclists. Only 1 observation of a motorist passing a bicyclist within 3 feet was made over the two year evaluation period.

Figure 25. Valley View Road Vehicle Meeting a Bicyclist (in Same Direction)
