Subject: Appeal of the Certificate of Appropriateness issued for a new detached garage and changes to the street facing façade of the home at 4505 Arden Avenue. File # H-Resolution No. 2014-43

Adopt the attached Resolution upholding the March 11, 2014 decision of the Heritage Preservation Board approving a Certificate of Appropriateness for a new detached garage and changes to the street facing façade of the home at 4505 Arden Avenue.

March 11, 2014
Plans

PROPOSED RECONSTRUCTION/ADDITION
 WITH ALTERED STREET FACADE;
 4505 ARDEN AVE. COUNTRY CLUB DISTRICT, EDINA

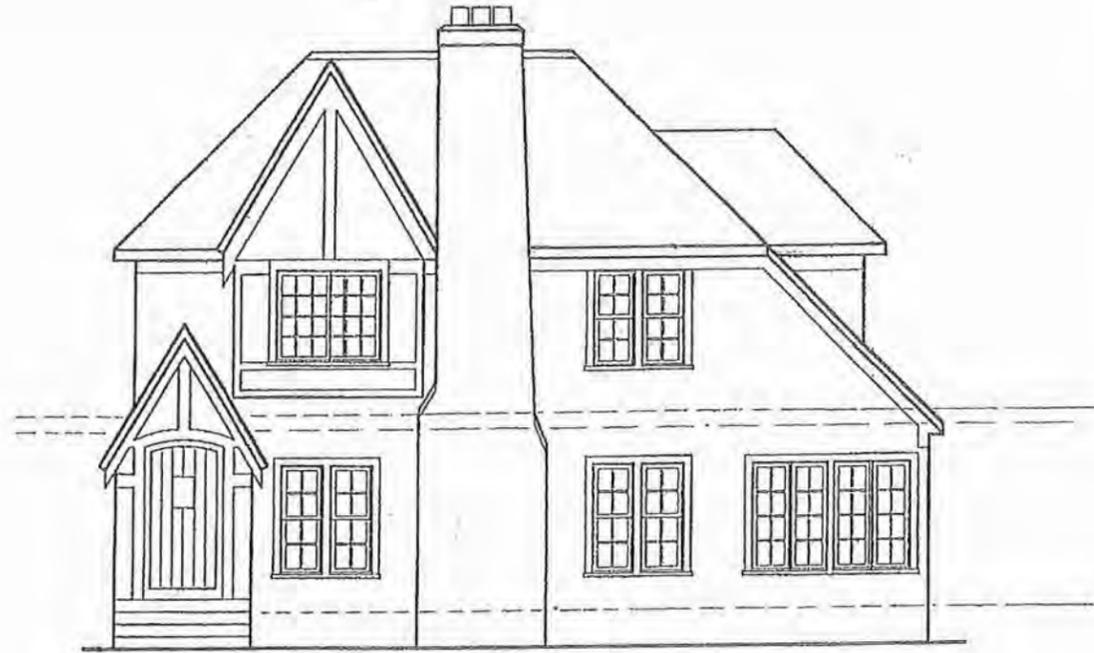
EXISTING ENTRY / WEST ELEVATION
1/8" = 1'-0"

- ASPHALT SHINGLE ROOF
- EXISTING & PROPOSED OVERHANDS
- MIRATEC FACIA 6" TYP OR MATCH EXISTING
- MIRATEC SOFFIT
- MIRATEC 1/2" TIMBER TRIM BOARDS & WINDOW TRIM
- NATURAL STUCCO
- SYNTHETIC BRACKETS PAINTED TO MATCH TRIM & 1/2" TIMBER
- MARVIN CLAD WINDOWS
- NATURAL STONE @ ENTRY & CHASE
- WOOD / STAINED ENTRY DOOR
- CONCRETE ENTRY STOOP W/ BRICK EDGING

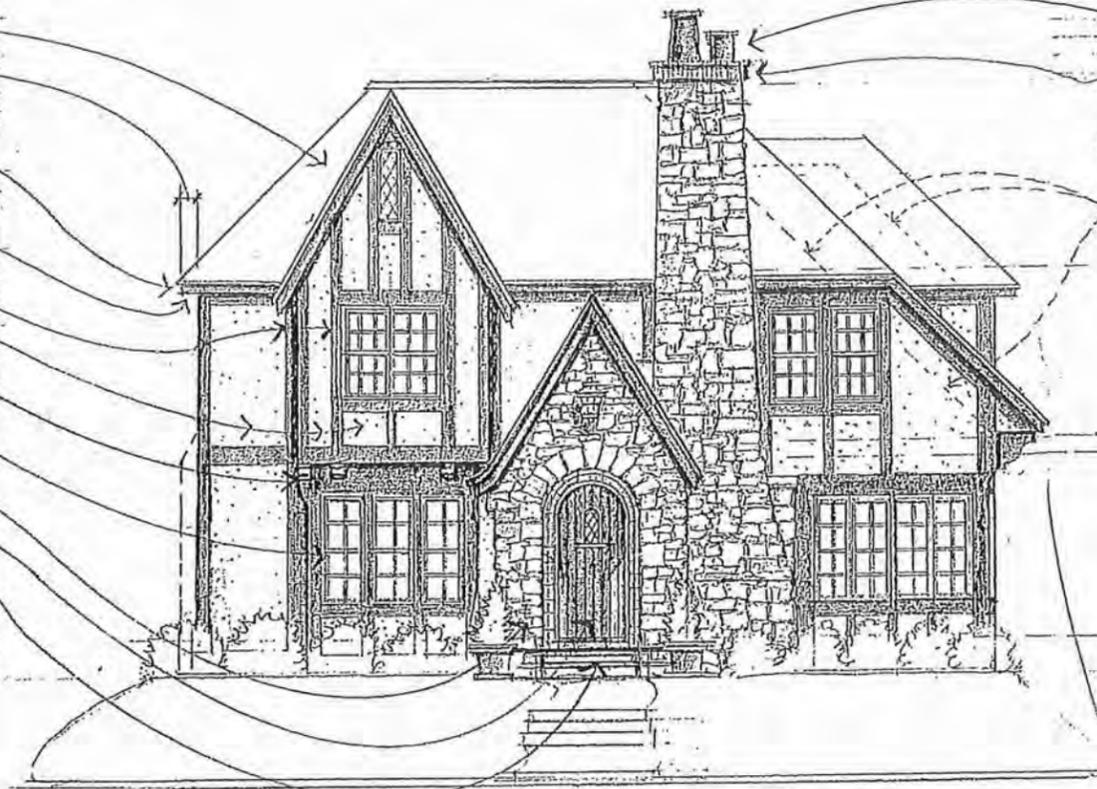
PROPOSED WEST ELEVATION
1/4" = 1'-0"

- OPTION COPPER OR CLAY CHIMNEY CAPS
- BRICK
- SYNTHETIC BRACKET PAINTED TO MATCH TRIM & 1/2" TIMBER
- EXISTING ROOF

EXIST. TYP 8'-4"
EXIST. TYP 10" 8'-1"

- The new entry will maintain a gable peak, but will be clad in stone like the proposed chimney. The plan has changed from front entry canopy open on the sides that projected 5 feet from the front building wall that was presented at the February meeting. In keeping with the plan of treatment guidance that "Entrances, porches, and other projections should relate to the pattern of existing adjacent historic homes and respect the rhythm and continuity of similar features along the street", the front entry canopy has been removed, replaced with an entrance that remains consistent with the front setback of the homes on either side.

- The existing undersized chimney that has been deteriorating to the point that it is now pulling away from the structure. It will be rebuilt and moved slightly to the south to accommodate the relocated entry. The new chimney will be enhanced with stone and brick, and topped off with a clay or copper chimney cap - consistent with Tudor design. Also, the roof structure on the south side of the home will be slightly altered to accommodate the new chimney location.

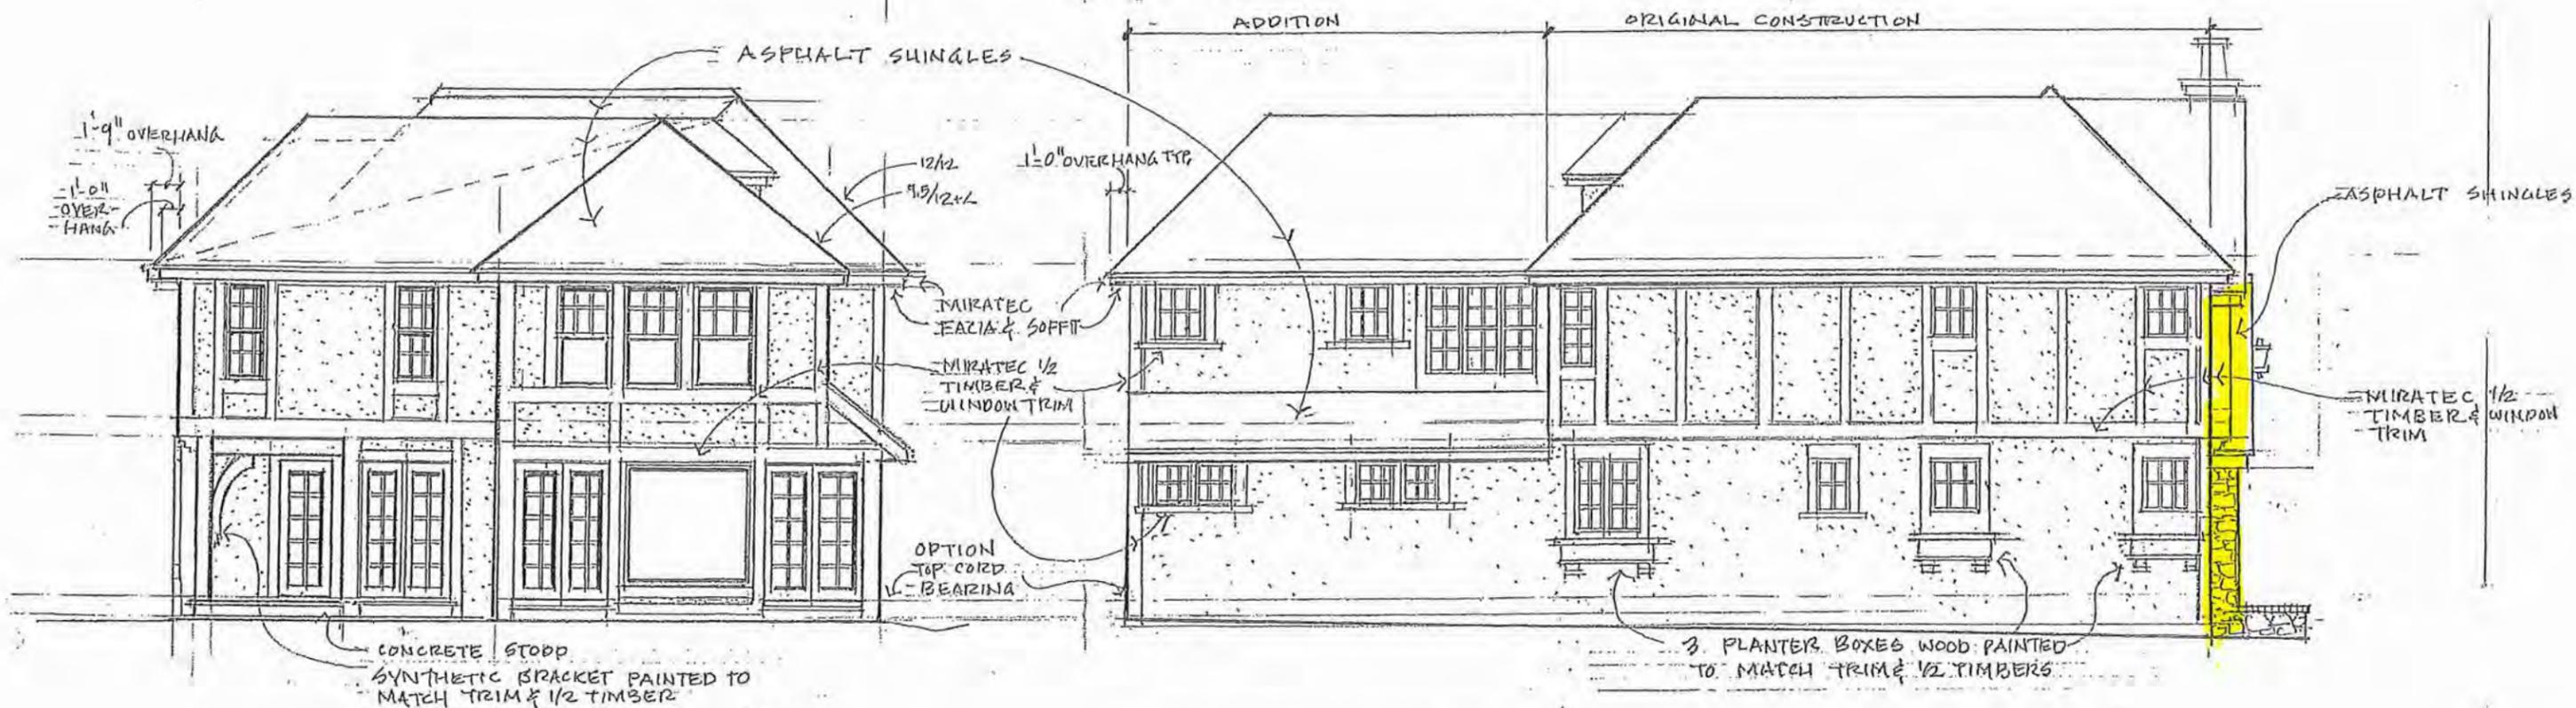
PROPOSED EAST ELEVATION
 $\frac{1}{8}'' = 1'-0''$

PROPOSED NORTH ELEVATION
 $\frac{1}{8}'' = 1'-0''$

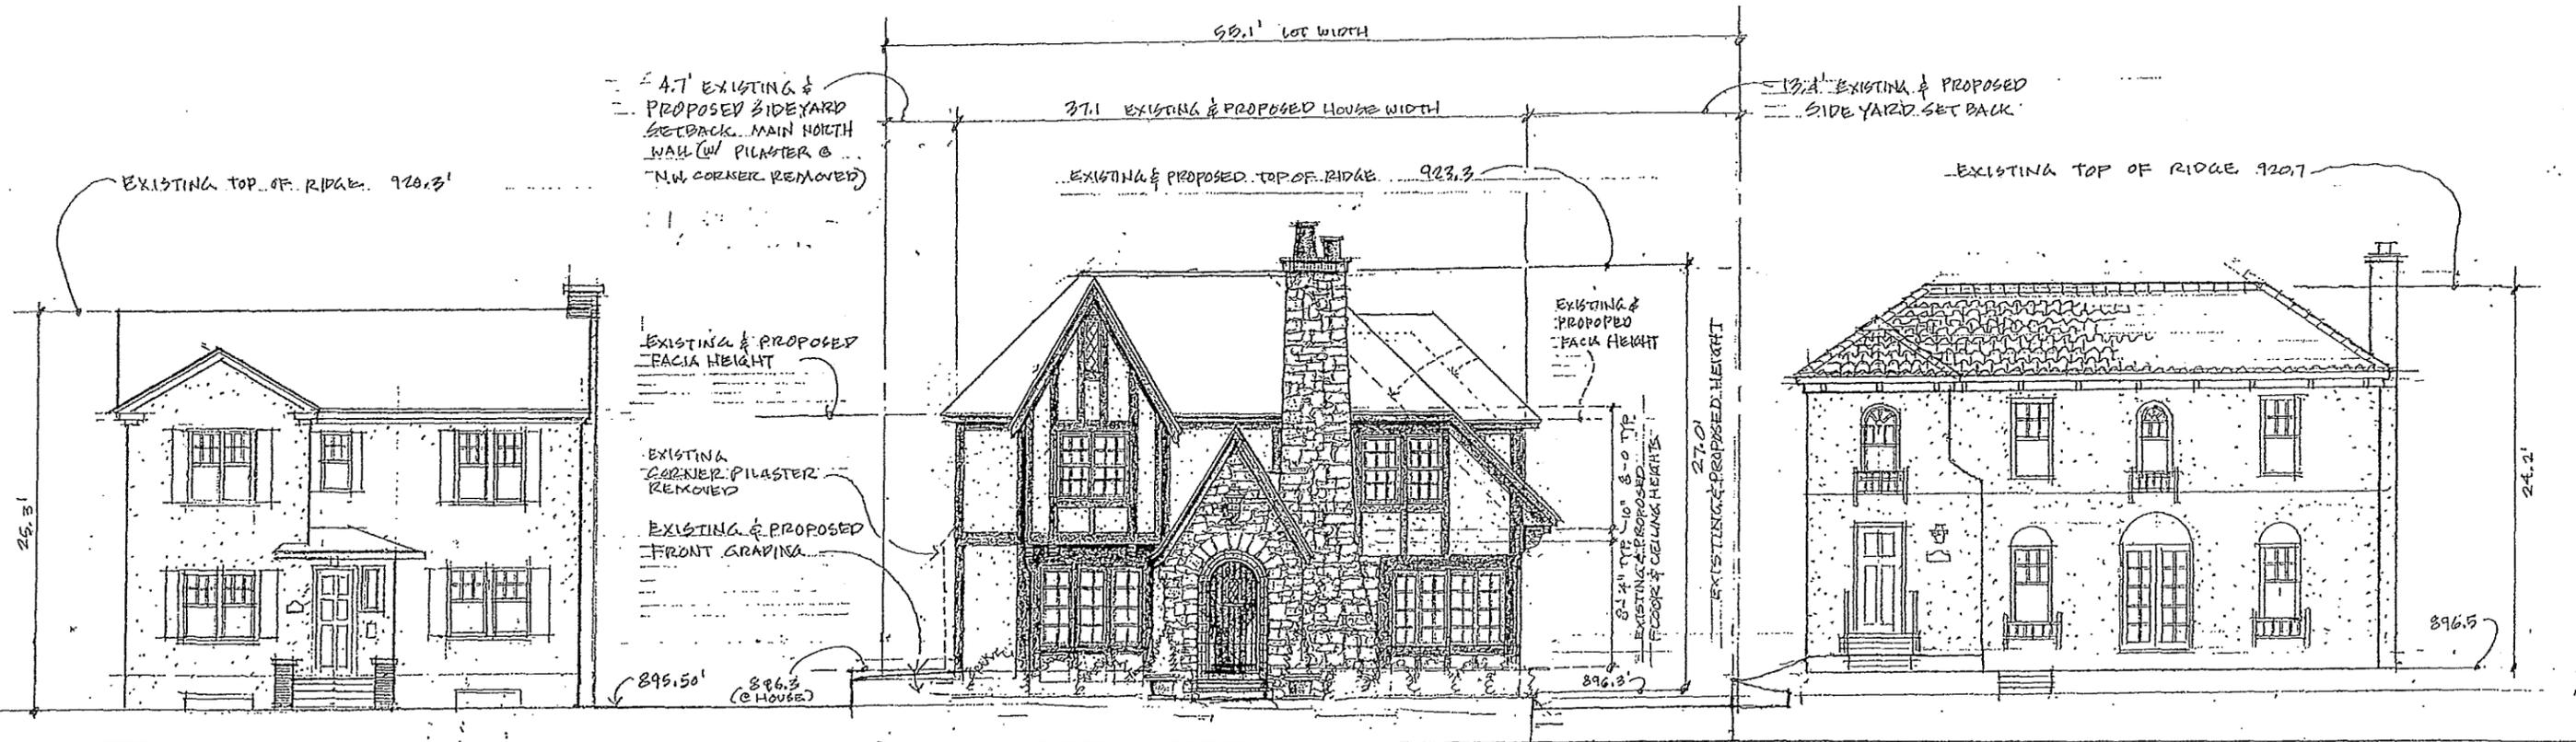
PROPOSED 4505 ARDEN AVE
STREET ELEVATION 18"=1'-0"

4503 ARDEN AVENUE (EXISTING HOME)

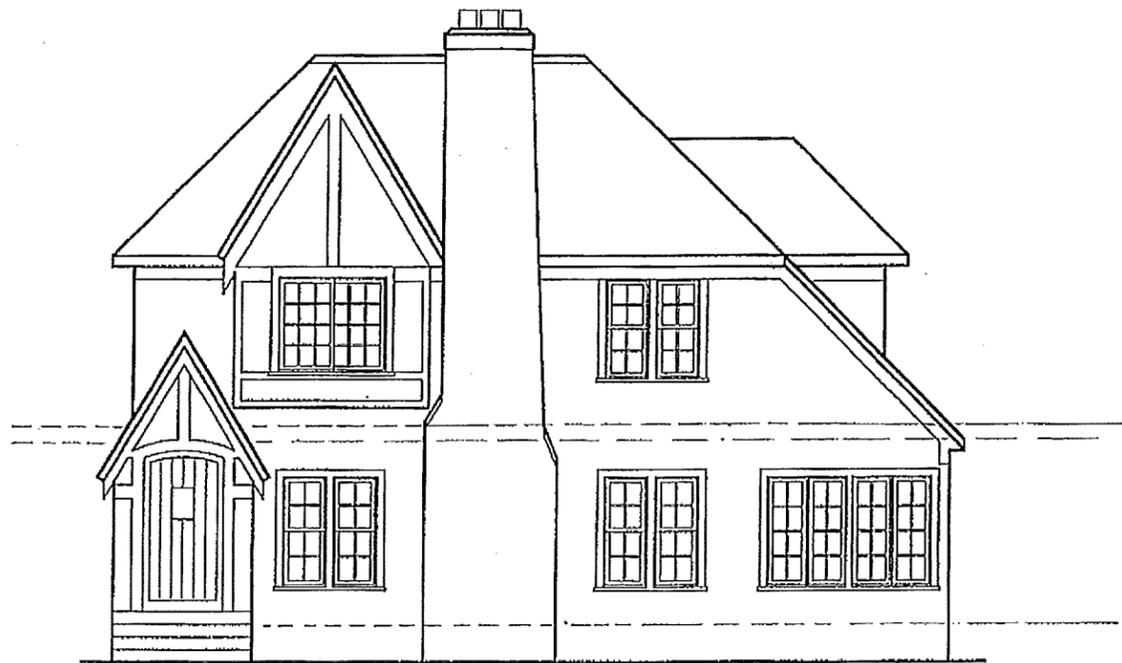
EXISTING ENTRY / WEST ELEVATION
 $\frac{1}{8}'' = 1'-0''$

- ASPHALT SHINGLE ROOF
- EXISTING & PROPOSED OVERHANDS
- MIRATEC FACIA 6" TYP OR MATCH EXISTING
- MIRATEC SOFFIT
- MIRATEC 1/2" TIMBER TRIM BOARDS & WINDOW TRIM
- NATURAL STUCCO
- SYNTHETIC BRACKETS PAINTED TO MATCH TRIM & 1/2" TIMBER
- MARVIN CLAD WINDOWS
- NATURAL STONE @ ENTRY & CHASE
- WOOD / STAINED ENTRY DOOR
- CONCRETE ENTRY STOOP W/ BRICK EDGING

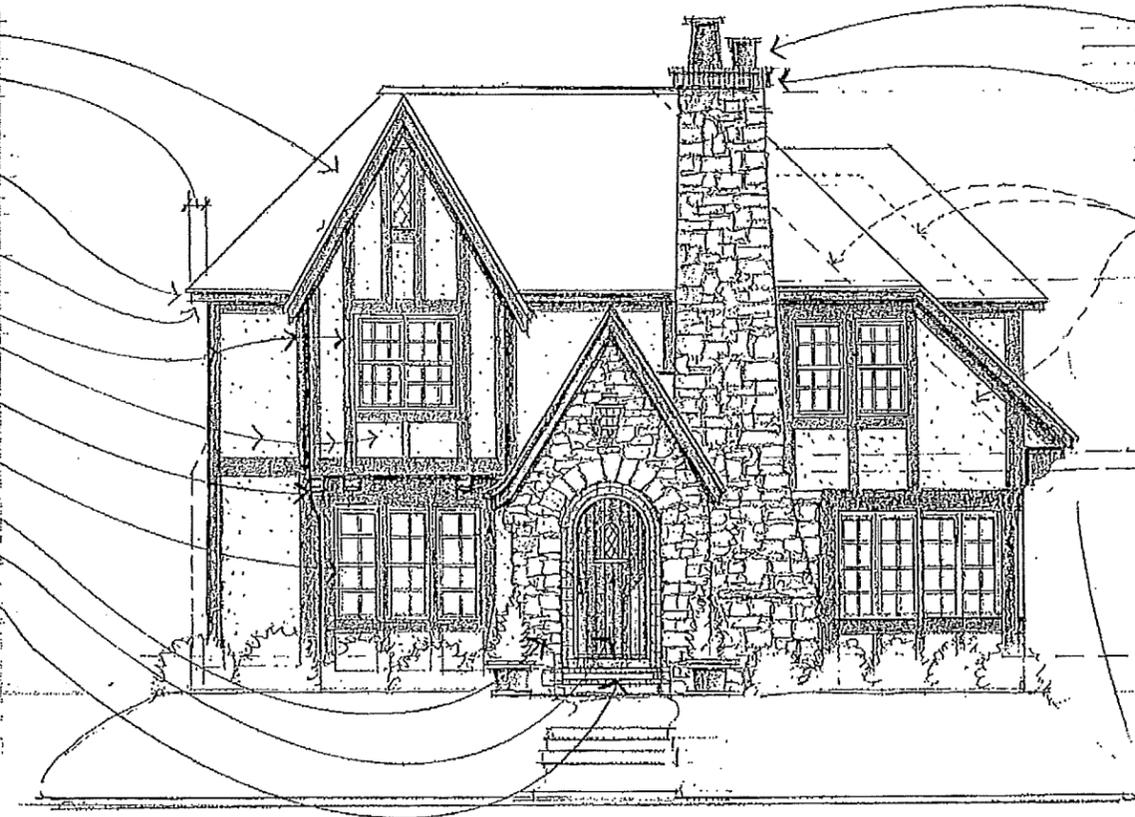
PROPOSED WEST ELEVATION
 $\frac{1}{8}'' = 1'-0''$

- OPTION - COPPER OR CLAY CHIMNEY CAPS
- BRICK
- SYNTHETIC BRACKET PAINTED TO MATCH TRIM & 1/2" TIMBER
- EXISTING ROOF

EXIST. TYP 8'-11"
 10"
 EXIST. TYP 8'-4"

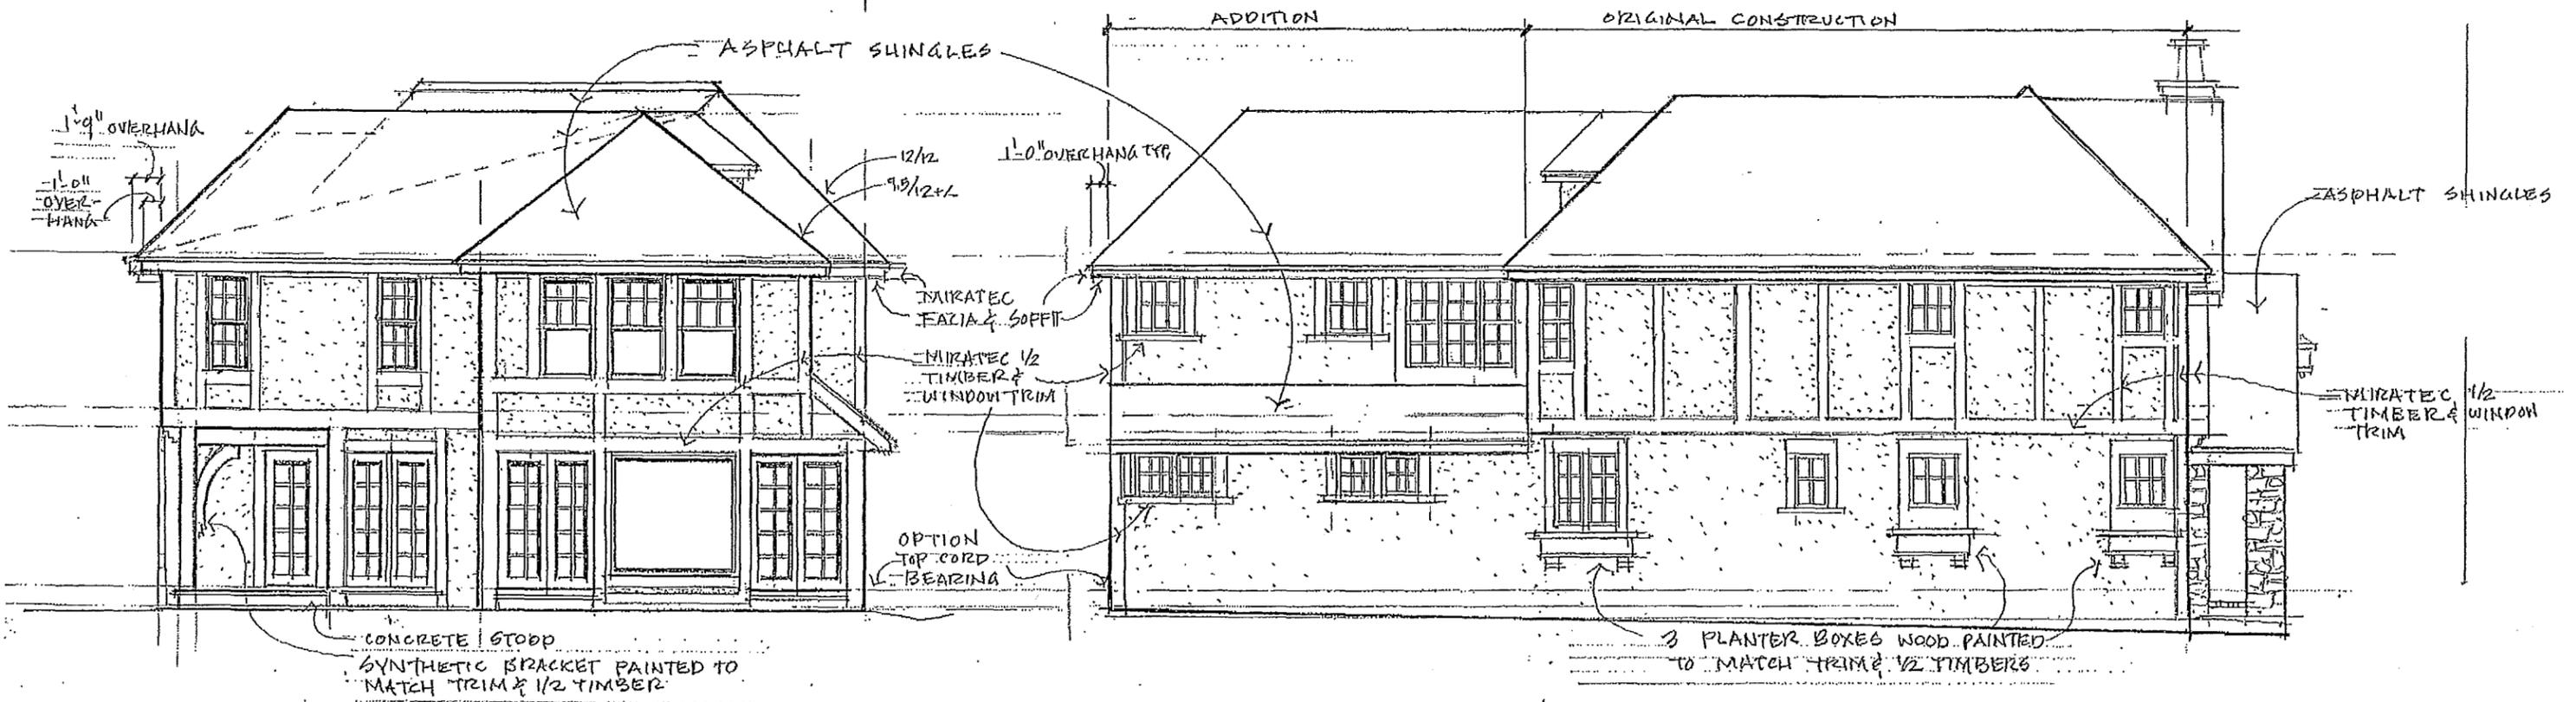
PROPOSED EAST ELEVATION
 $\frac{1}{8}'' = 1'-0''$

PROPOSED NORTH ELEVATION
 $\frac{1}{8}'' = 1'-0''$

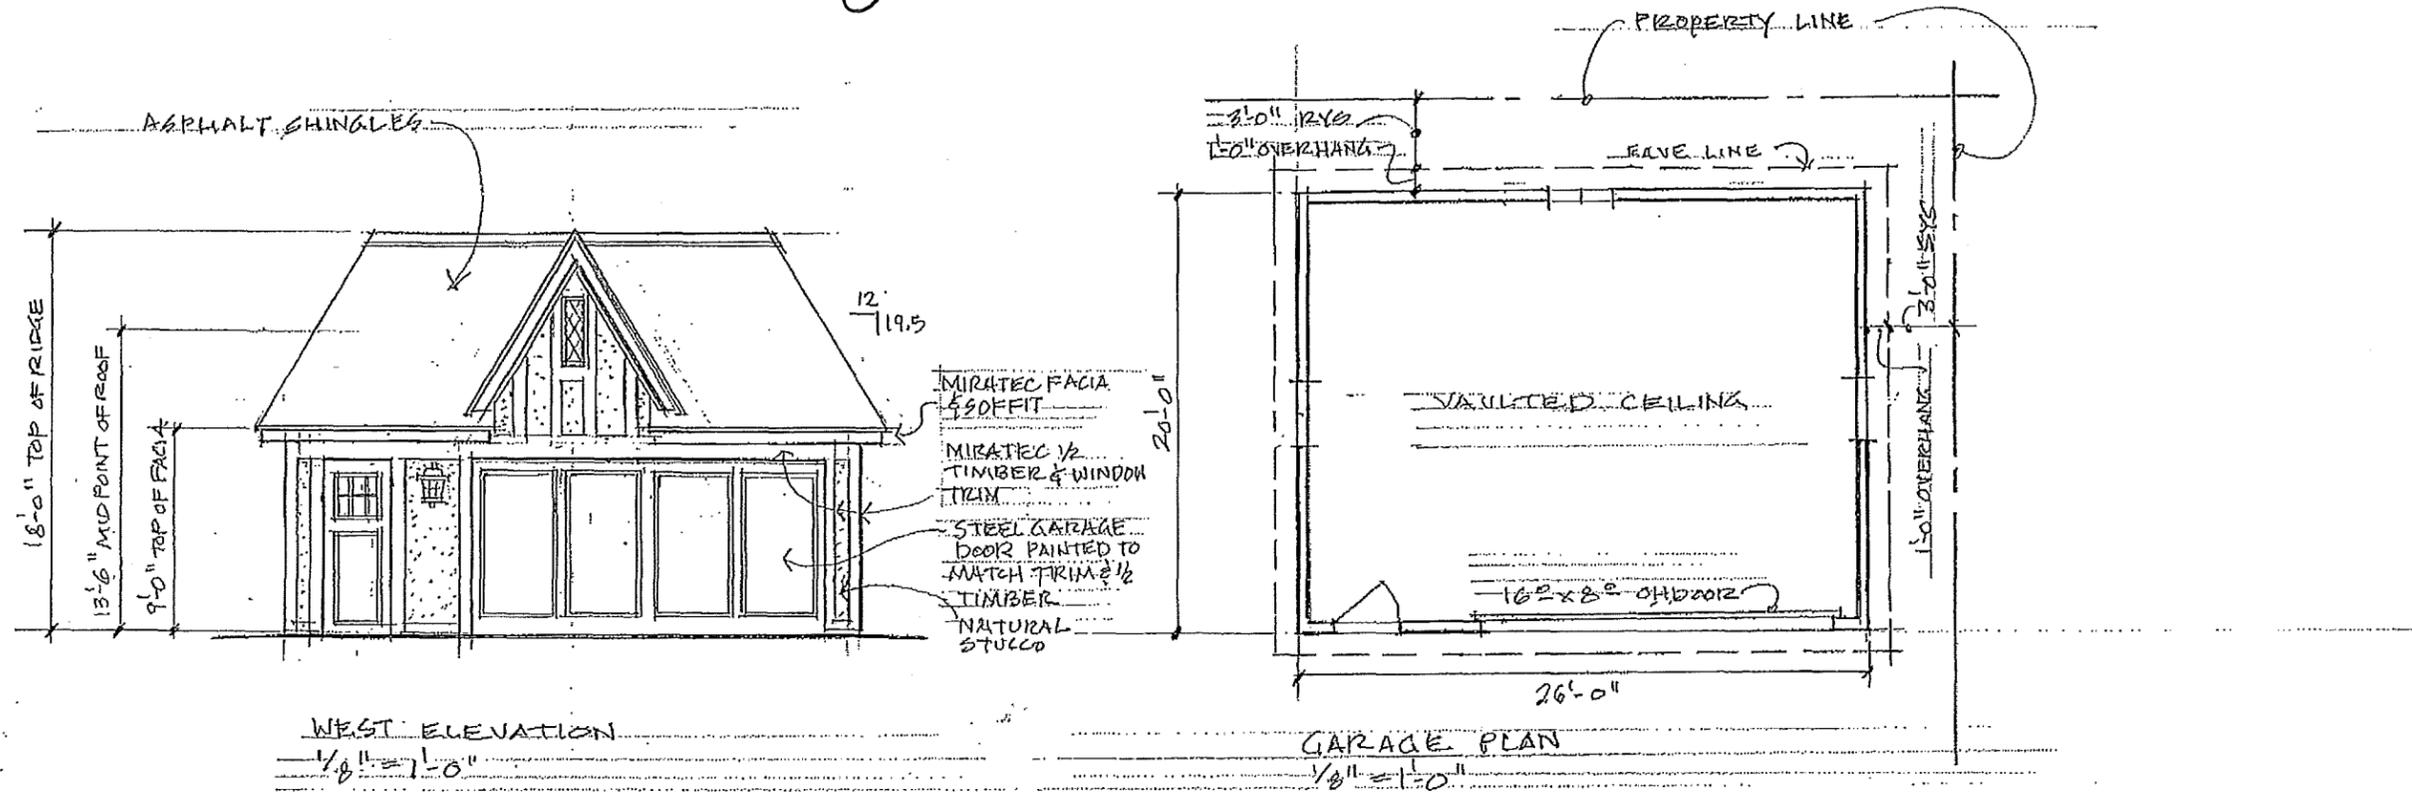
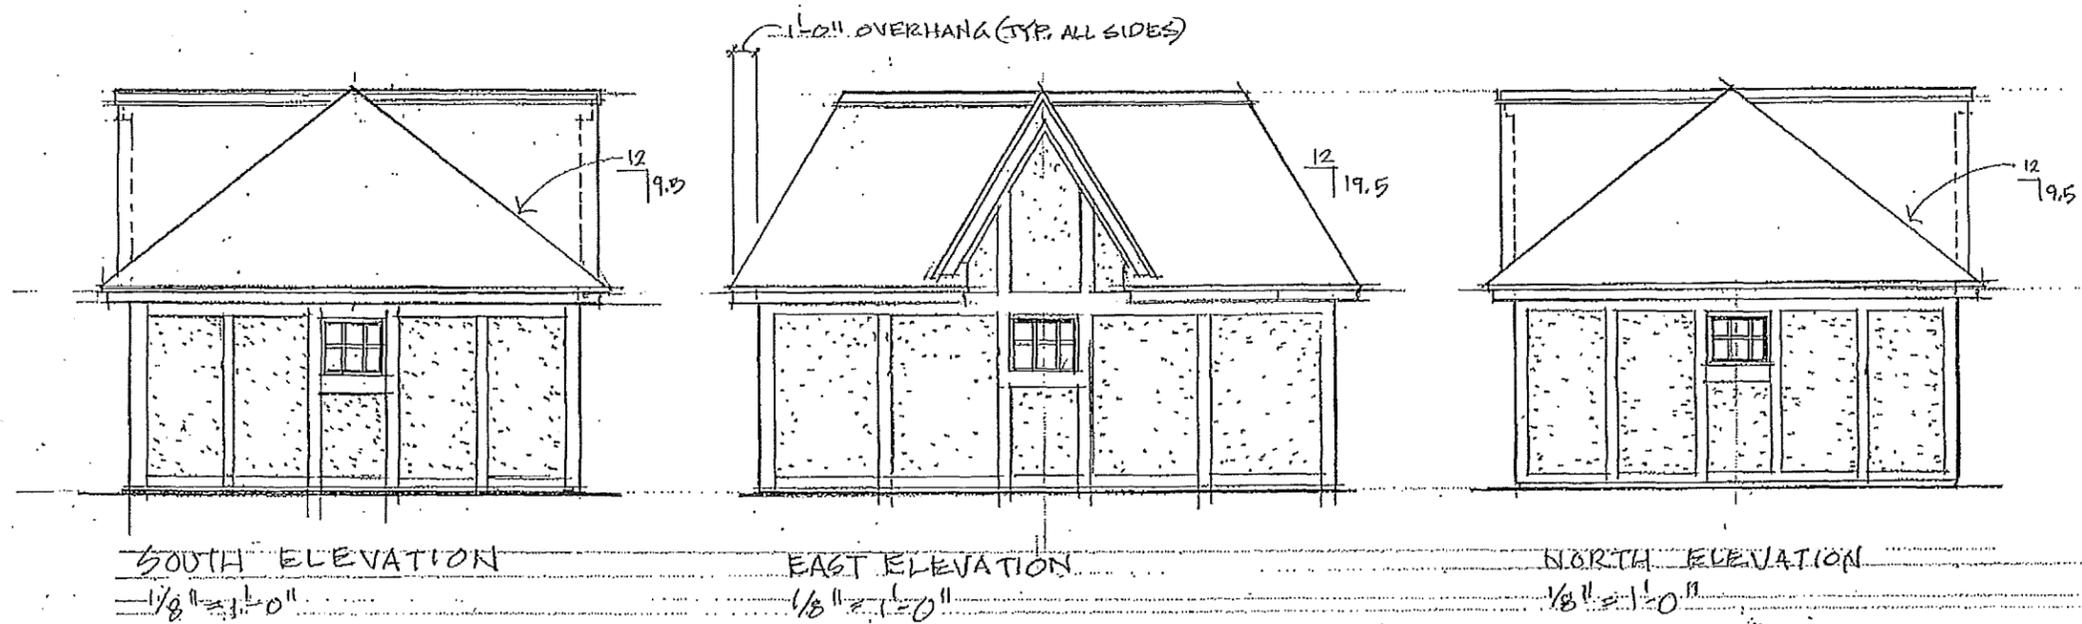
PROPOSED NEW DETACHED GARAGE:

4505 ARDEN AVE
COUNTRY CLUB DISTRICT, EDINA

Arden Avenue, but very handsome. Relative to the detached garage design, he observed that the gables on all elevations are symmetrical to the structure, whereas the gables found on the home are more offset. He also inquired about the materials proposed for the garage doors. Mr. Busyn responded that they plan on installing steel doors were also installed on the new detached garage at 4620 Moorland Avenue. He added that they prefer steel because it is a sturdier product that takes well to the dark paint proposed.

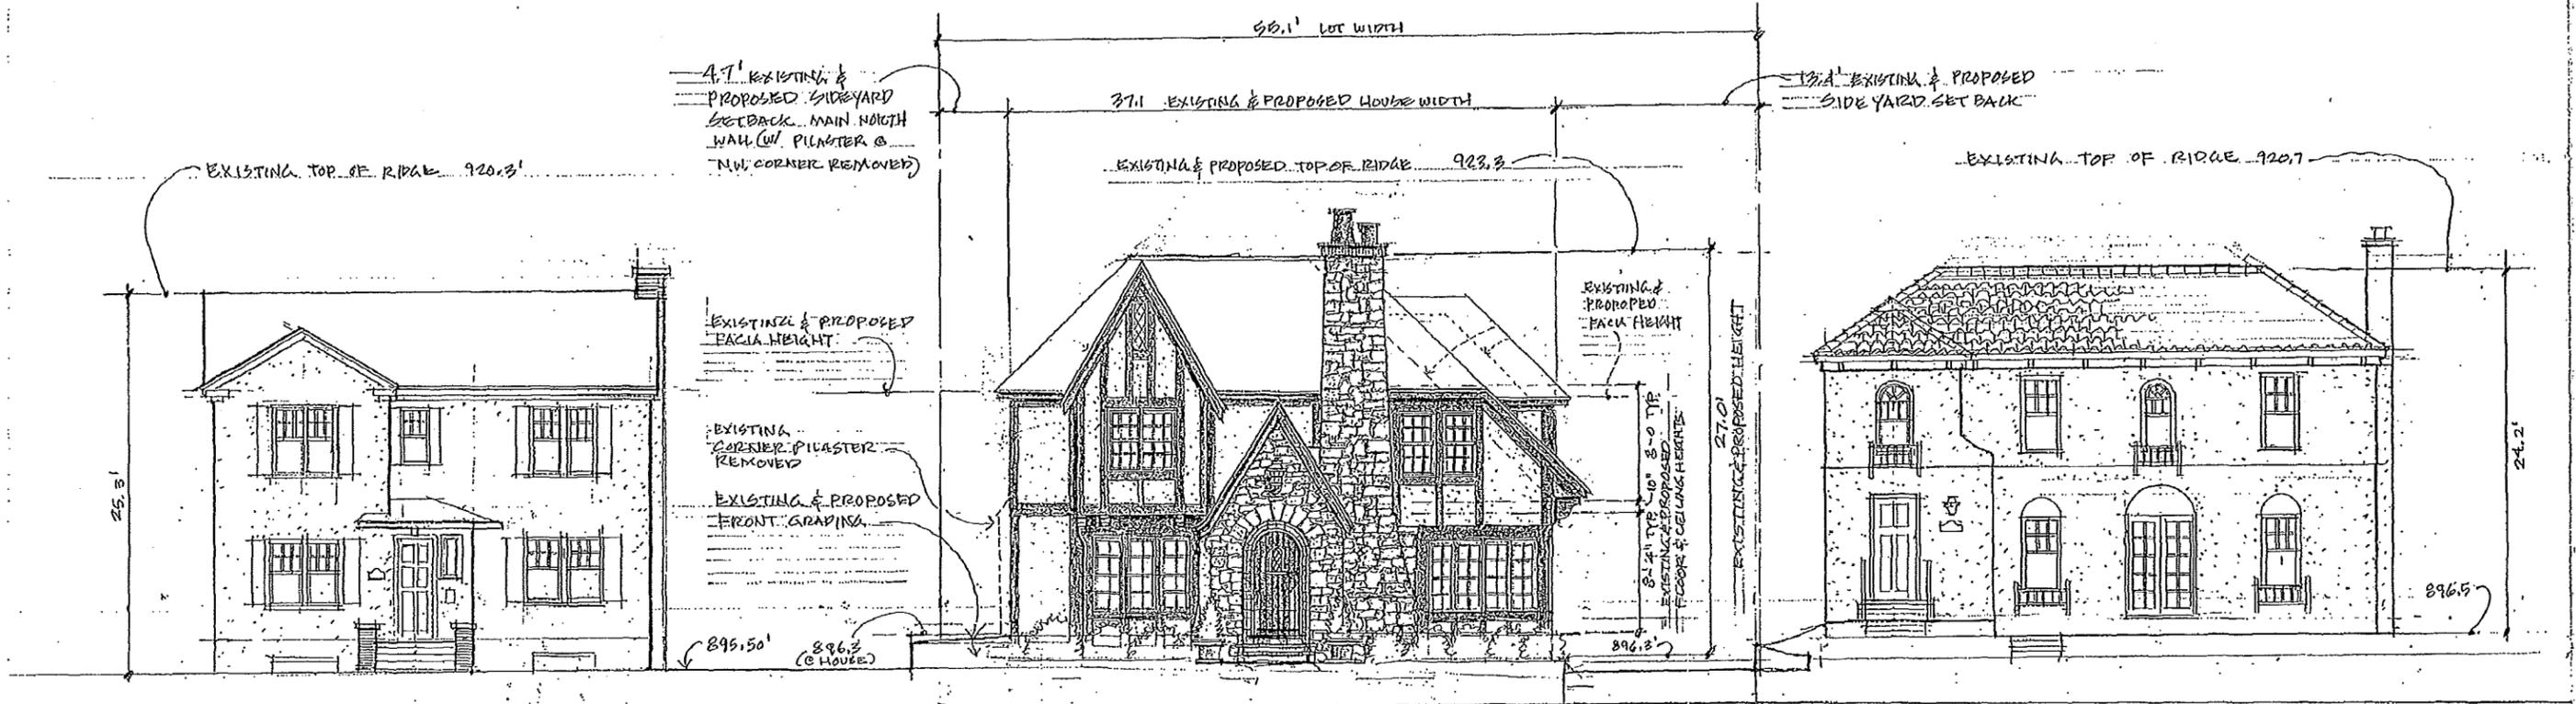
4503 ARDEN AVENUE (EXISTING HOME)

PROPOSED 4605 ARDEN AVE

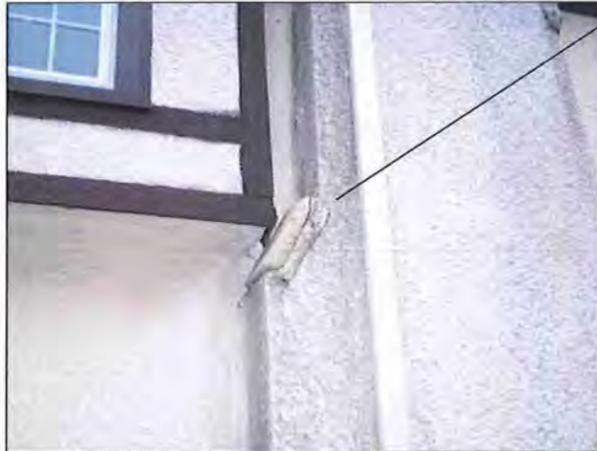
Front view – chimney – water damaged stucco and wood rot of window soffit.

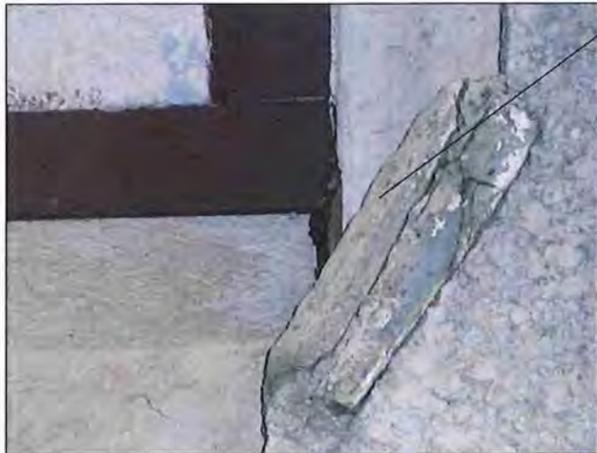
Front view – chimney – water damaged stucco and wood rot of window soffit.

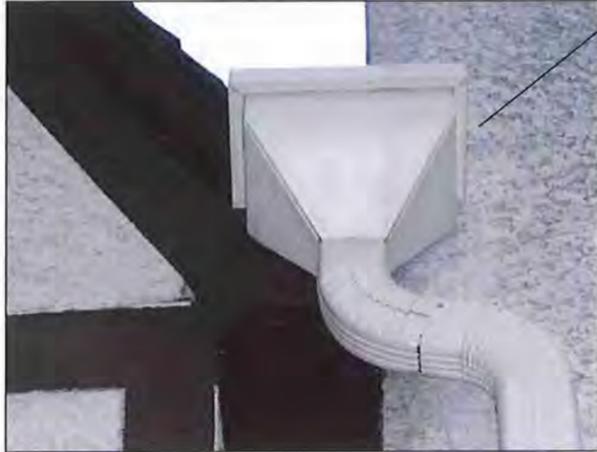
Front view – chimney / roof intersection – water damaged stucco and wood damage to the fascia.

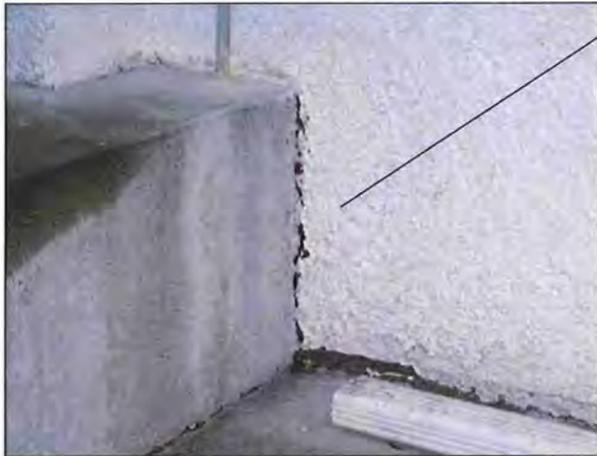
Front view – front stoop – water damaged stucco and poor seal / flashing at concrete intersection.

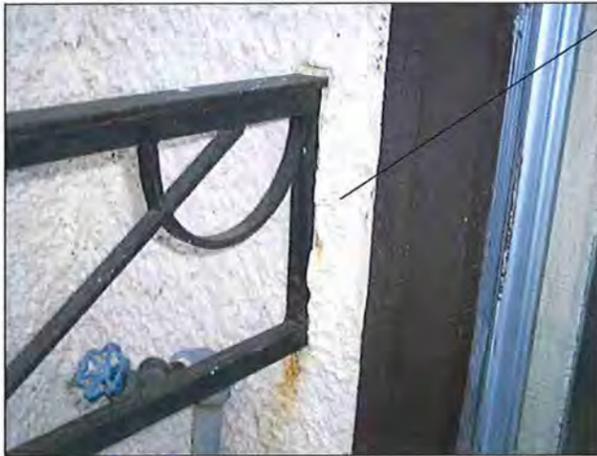
Front view – front stoop handrail – water damaged stucco and poor seal / flashing at rail intersection.

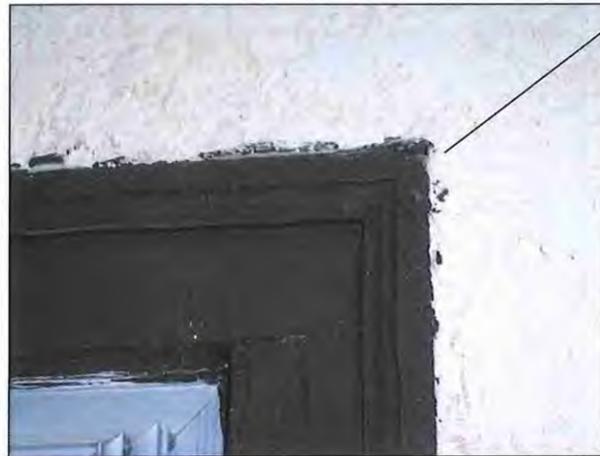
Front view – water damaged stucco and no flashing above window. Water damaged wood window framing.

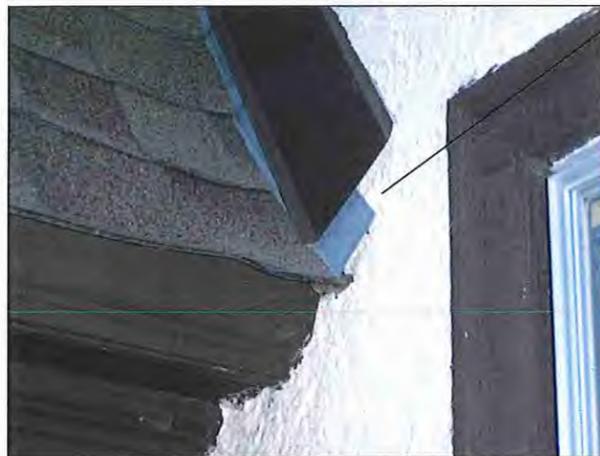
Front view – water damaged stucco and poor flashing at roof intersection.

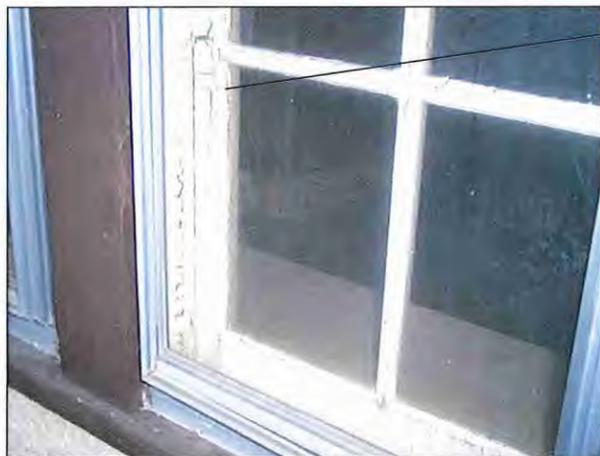
Front view – window framing water damage.

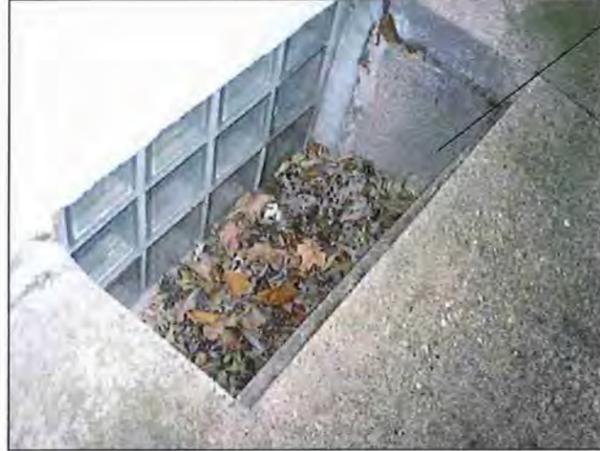
Front view – water infiltration in lower level window well.

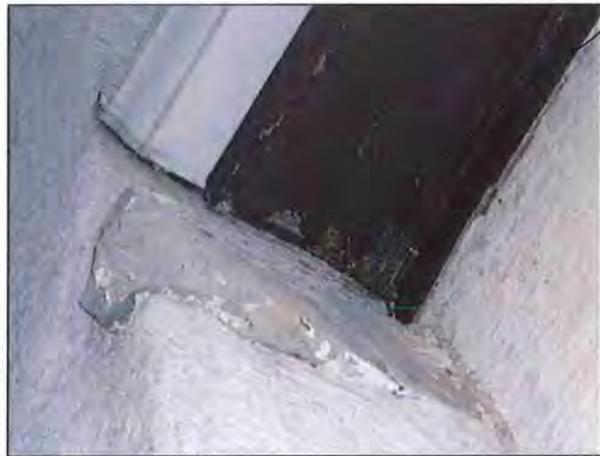
Front view – water damaged stucco and poor water capture of roof. Water damaged and rotted wood soffit and fascia.

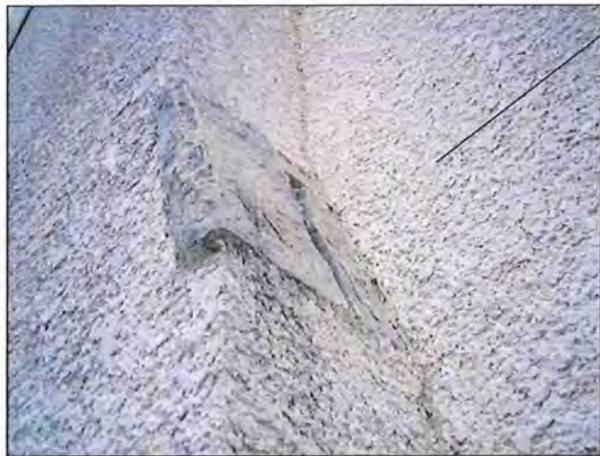
Front view – water damaged stucco along chimney.

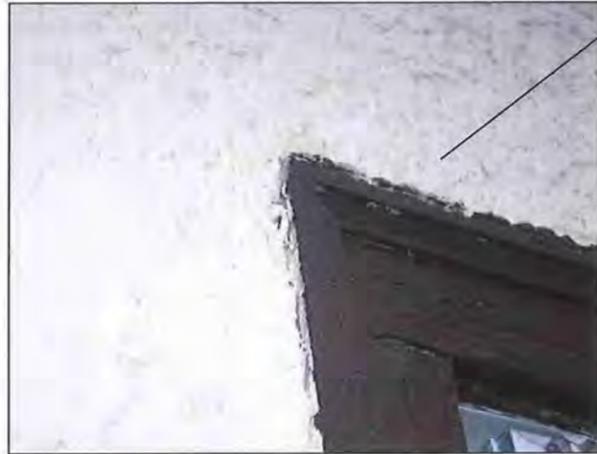
Front view – water damaged stucco and no flashing above window. Water damaged wood window framing.

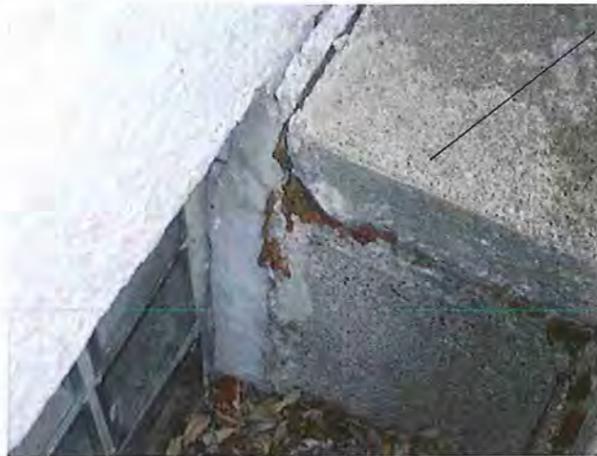
Front view – water infiltration in lower level window well. Foundation cracking and slab pulling away from foundation.

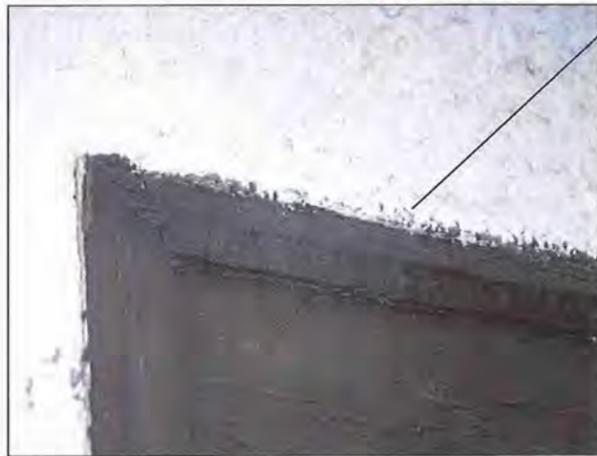
Front view – water damaged stucco and no flashing above window. Water damaged wood window framing.

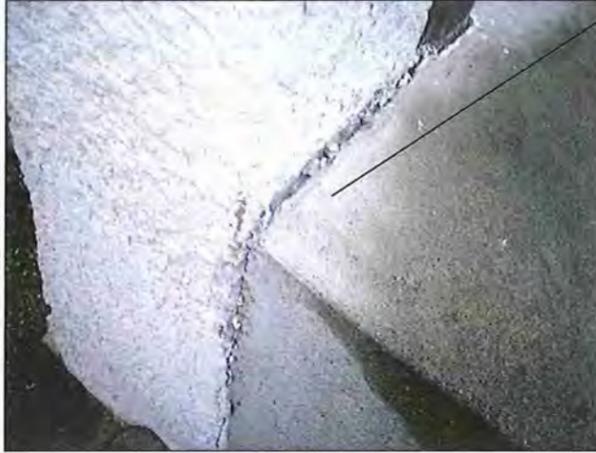
Front view – front stoop – water damaged stucco and poor seal / flashing at concrete intersection.

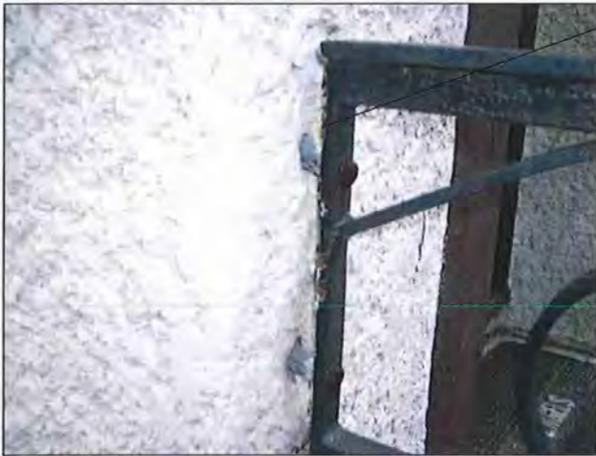
Front view – front stoop – water damaged stucco and poor seal / flashing at handrail intersection.

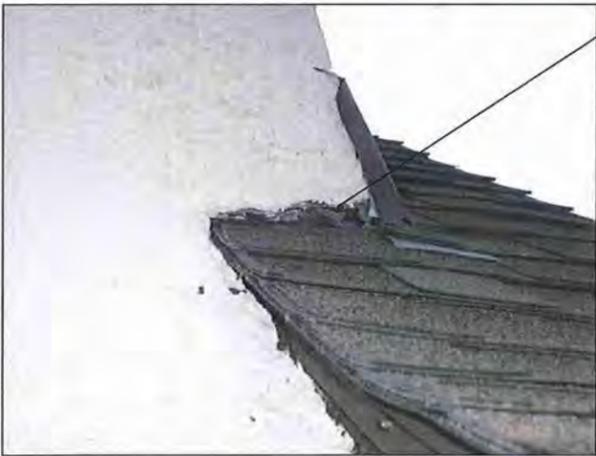
North facing view – water damaged stucco and poor seal / flashing at roof / wall intersection.

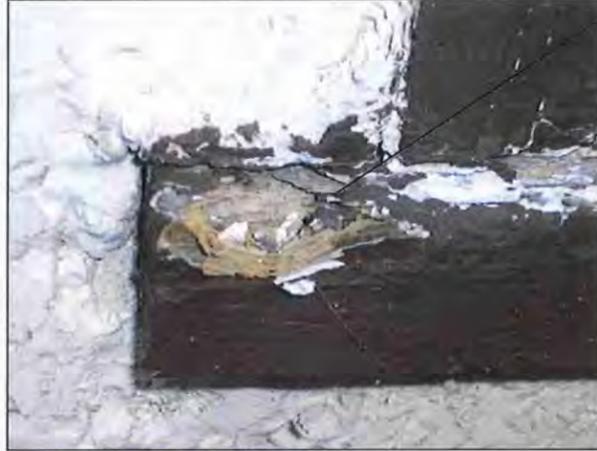
North facing view – water damaged and rotten wood window frame. This condition was typical for a majority of the windows in the home.

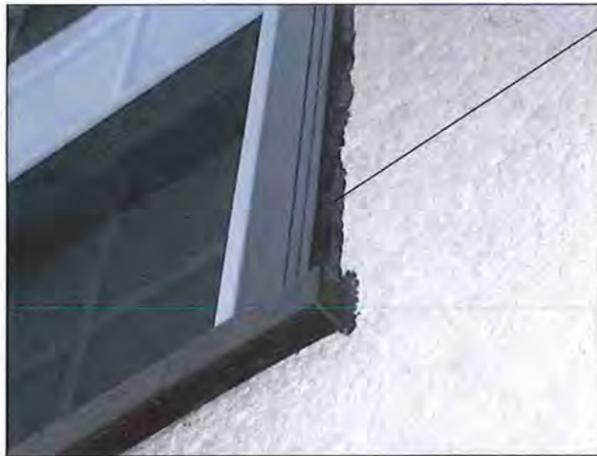
North facing view – poor application of caulk at frame / stucco intersection.

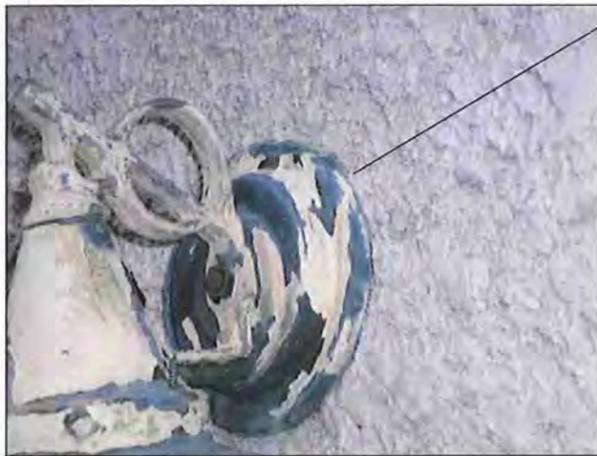
North facing view – water damaged stucco and poor seal / flashing at light fixture intersection.

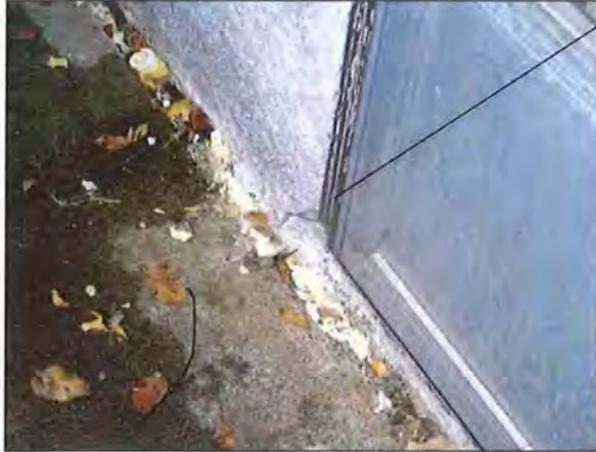
North facing view – water damaged stucco and grading along home was pulling away from foundation allowing water to infiltrate along foundation wall.

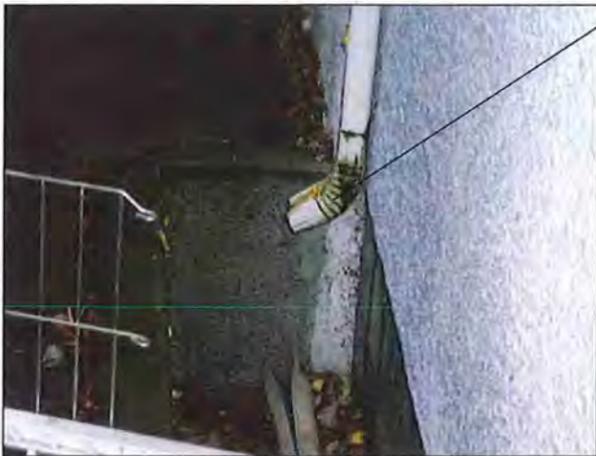
North facing view – water draining from roof to grade and into window well allowing water to infiltrate along foundation wall.

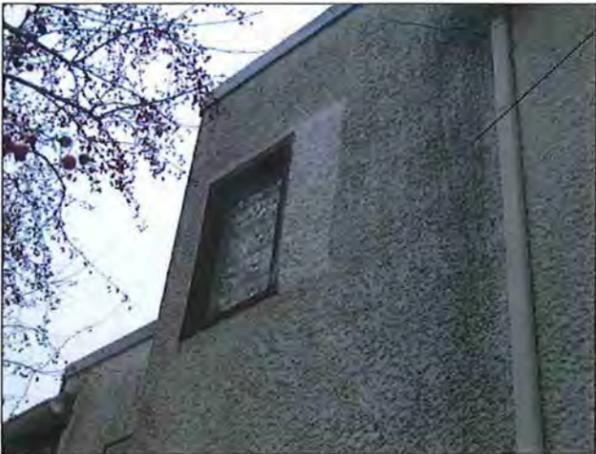
North facing view – water damaged stucco exterior, poor drainage and poor stucco exterior repair.

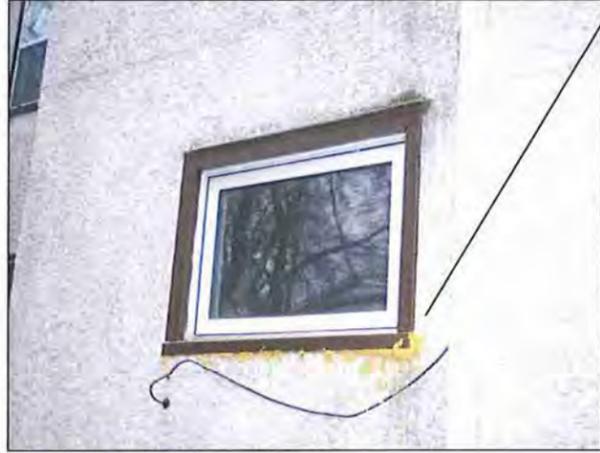
North facing view – water damaged stucco exterior, poor window flashing and wood frame rot noted.

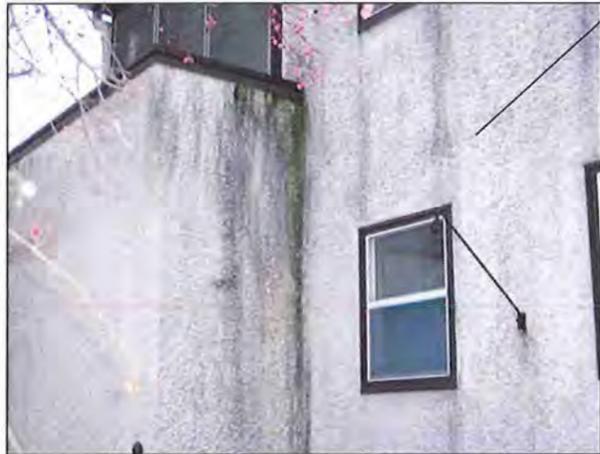
Northeast facing view – water damaged stucco exterior, poor drainage and poor stucco exterior repair.

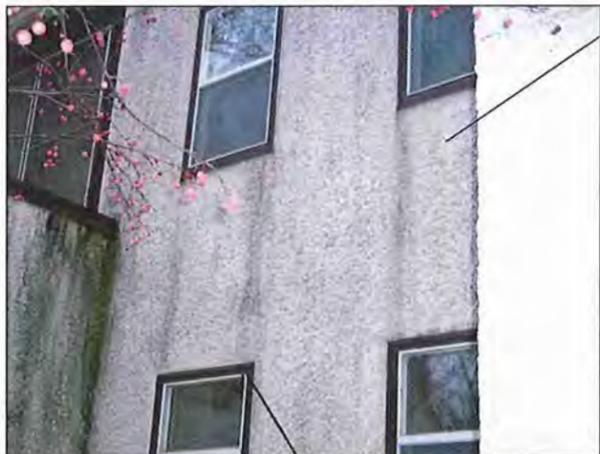
Northeast facing view – water damaged stucco exterior, poor drainage and poor stucco exterior repair.

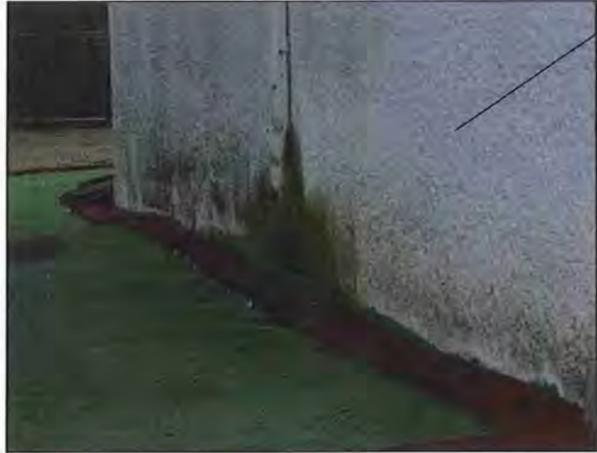
North facing view – water damaged stucco exterior, poor drainage and poor stucco exterior repair.

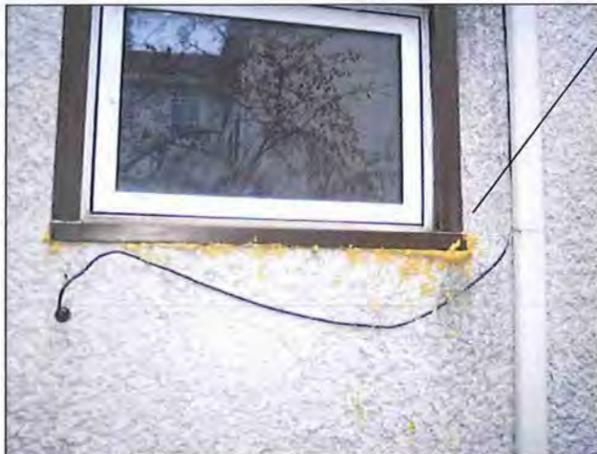
North facing view – water damaged stucco exterior, poor window flashing and wood frame rot noted.
