Subject: Appeal of the Certificate of Appropriateness issued for a new detached garage and changes to the street facing façade of the home at 4505 Arden Avenue. File # H-Resolution No. 2014-43

Adopt the attached Resolution upholding the March 11, 2014 decision of the Heritage Preservation Board approving a Certificate of Appropriateness for a new detached garage and changes to the street facing façade of the home at 4505 Arden Avenue.

March 11, 2014
Plans

PROPOSED RECONSTRUCTION/ADDITION
 WITH ALTERED STREET FACADE;
 4505 ARDEN AVE. COUNTRY CLUB DISTRICT, EDINA

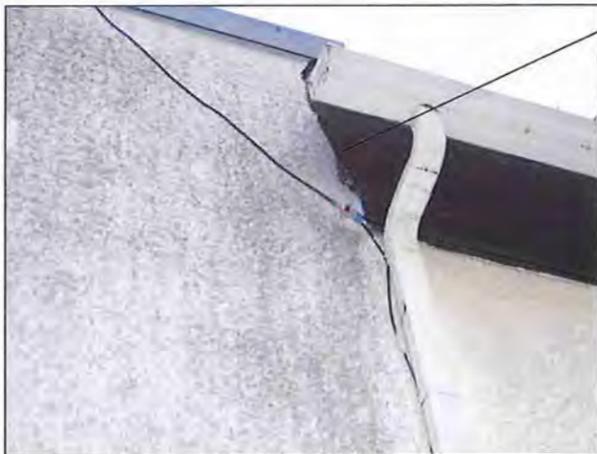
Northeast facing view – water damaged stucco exterior, poor drainage and poor stucco exterior repair.

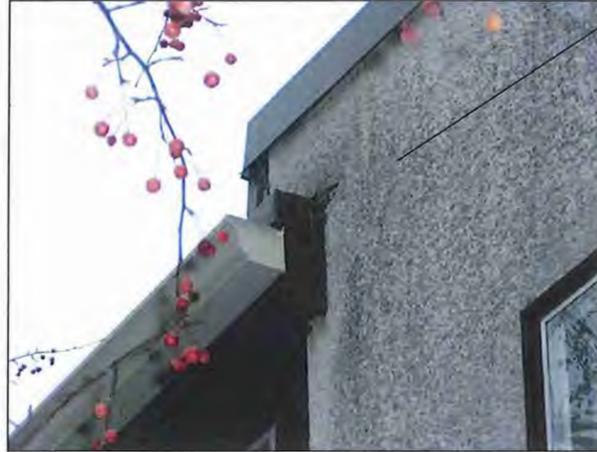
North facing view – water damaged stucco exterior, poor flashing and wood soffit / fascia water damage and rot.

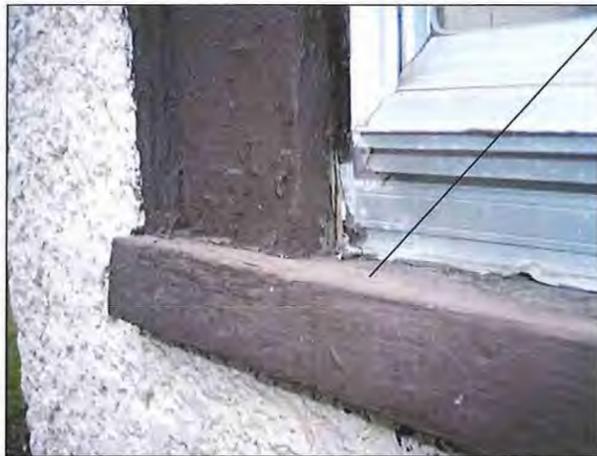
North facing view – water damaged stucco exterior, no flashing and wood window frame water damage and rot.

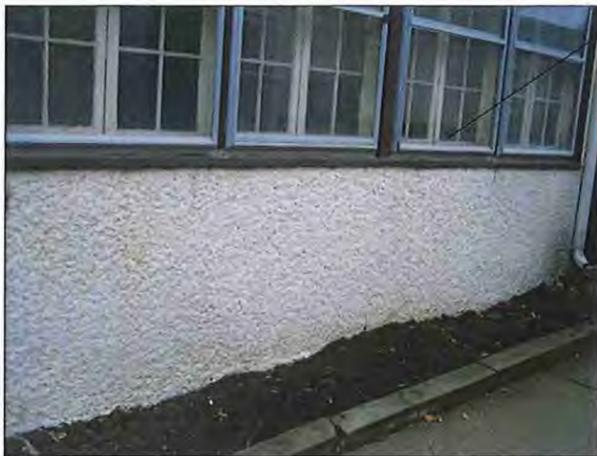
East facing view – water damaged stucco exterior, poor drainage and wood window frame water damage and rot.

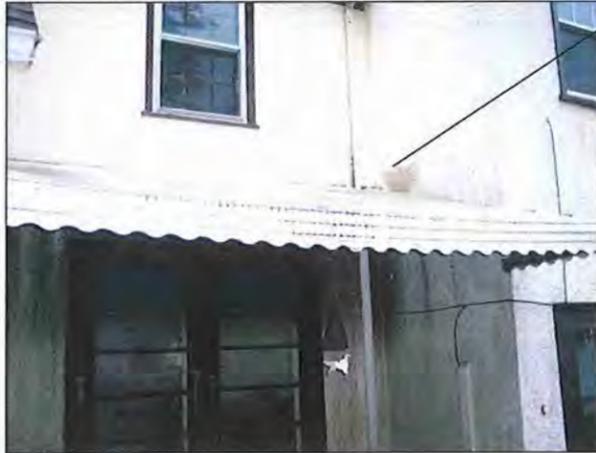
South facing view – water damaged stucco exterior, poor flashing and structurally compromised awning.

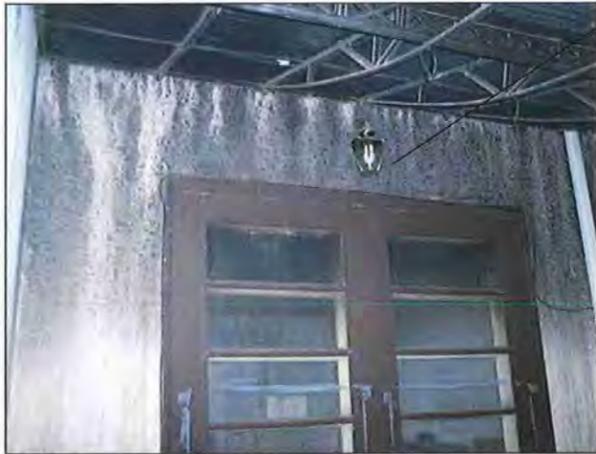
South facing view – water damaged stucco exterior, poor flashing and structurally compromised awning.

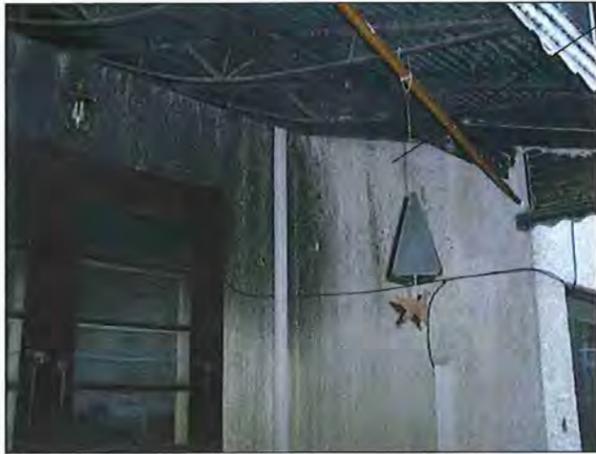
South facing view – water damaged stucco exterior, poor flashing and structurally compromised awning.

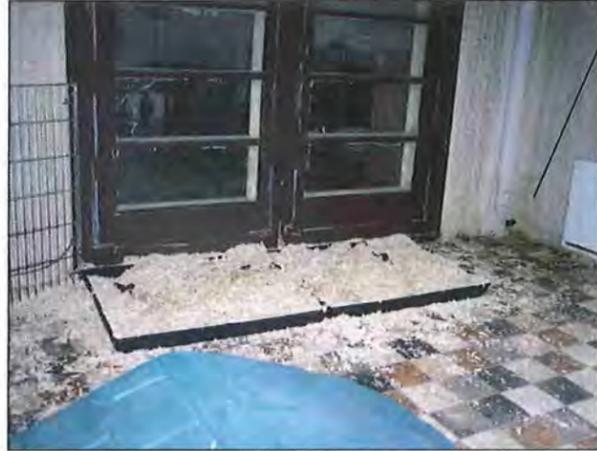
South facing view – water damaged stucco exterior, poor flashing and roof water drainage.

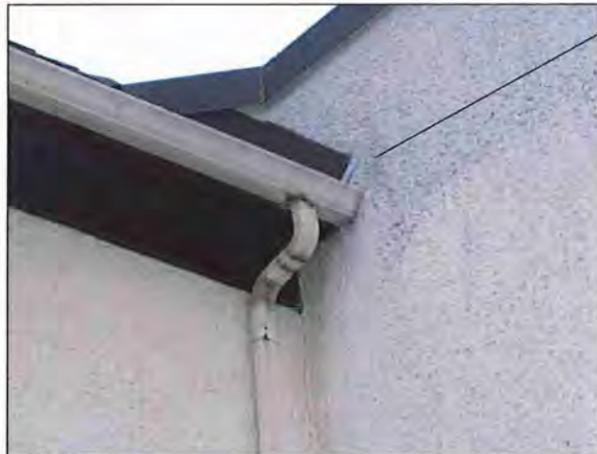
Southeast facing view – water damaged stucco exterior, poor flashing and water damaged and rotted soffit / fascia.

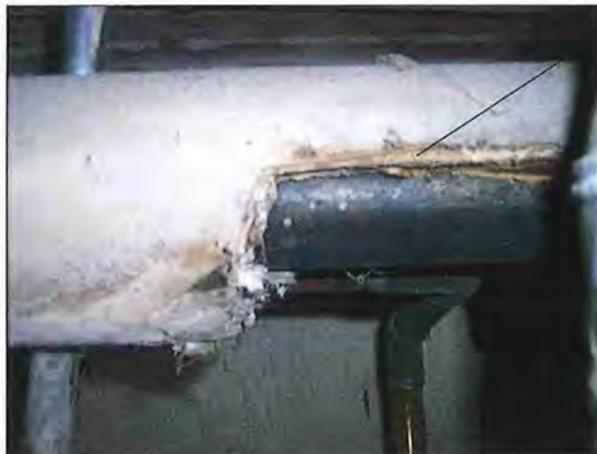
Lower level – damaged hot water pipe insulation. Unknown as to what type of materials this may be (asbestos, etc).

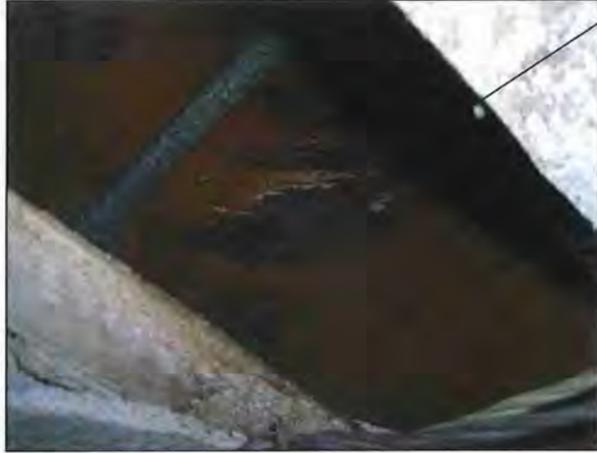
Lower level – water damaged subfloor for the main level due to bathroom leaks. Visual mold growth and wood rot identified on the surface of the wood subfloor.

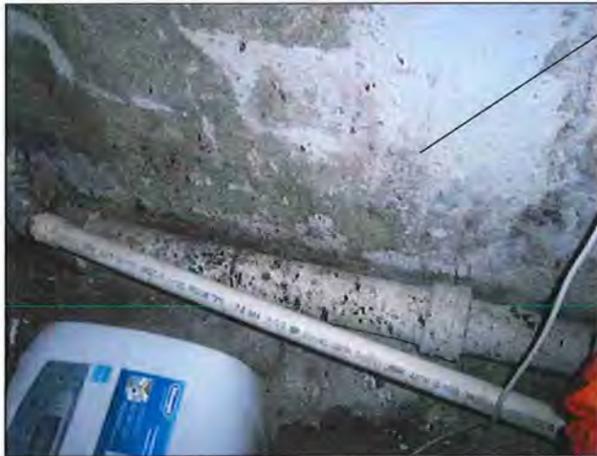
Lower level – water damaged foundation wall along north facing side of home. Visual mold growth identified on the base of the wall near floor.

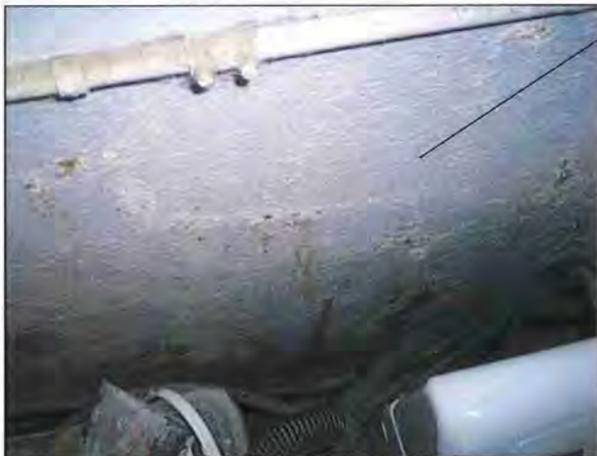
Lower level – water damaged foundation wall along north facing side of home. Visual mold growth identified on the base of the wall near floor.

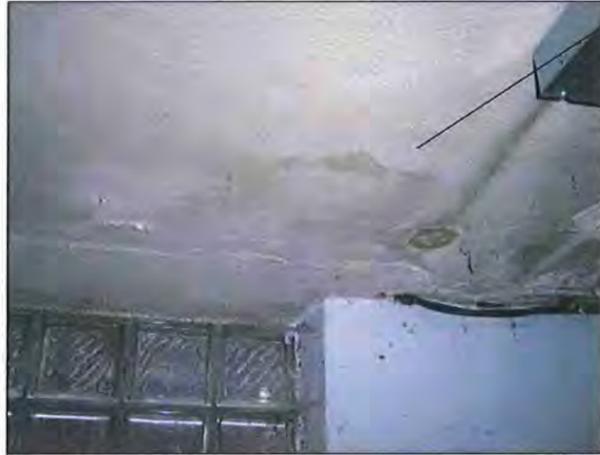
Lower level – water damaged foundation wall along north facing side of home. Visual mold growth identified on the base of the wall near floor.

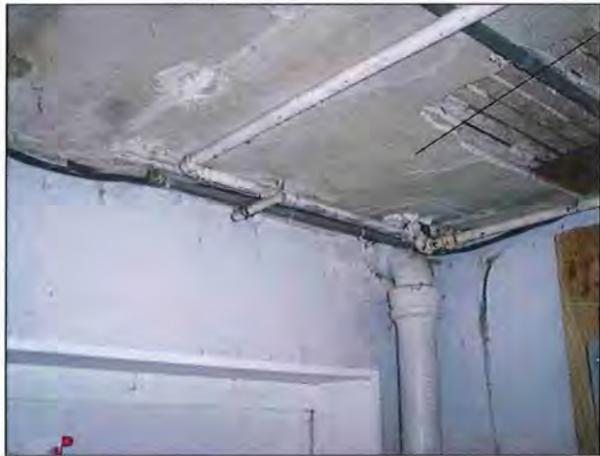
Lower level – water damaged ceiling due to water leaks on main level (bathroom and or kitchen). Visual mold growth identified on the exposed subfloor sections in lower level.

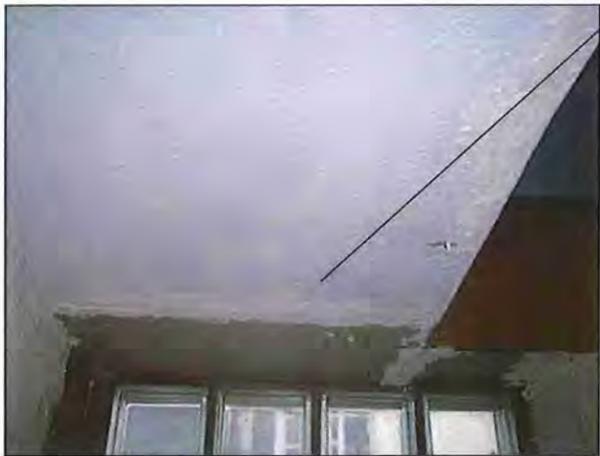
Lower level – water damaged foundation wall and ceiling along north facing side of home. Concrete delamination was noted at the base of the wall.

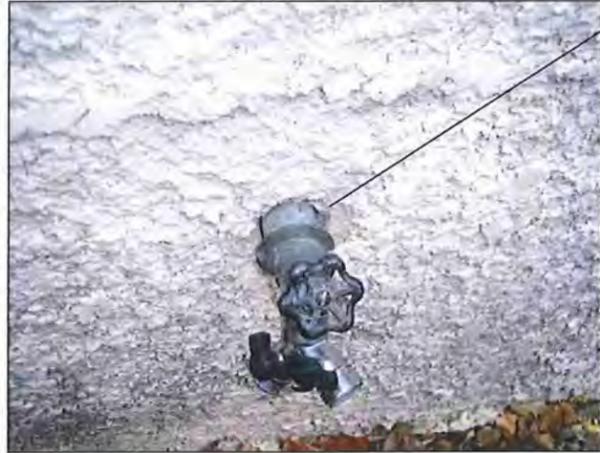
North facing view – water damaged stucco, poor seal around wall penetration, which is allowing water to infiltrate into building envelope.

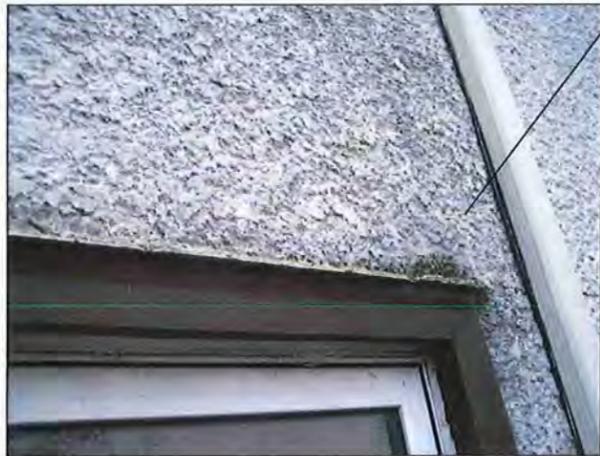
North facing view – water damaged stucco, poor flashing at window and wood damage and rot of window frame.

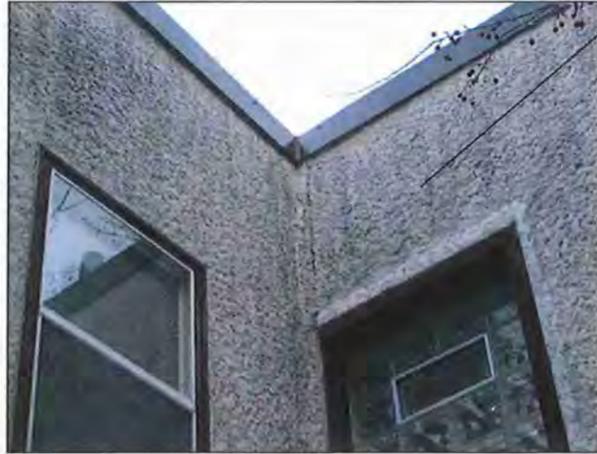
Northeast facing view – water damaged stucco, poor flashing at windows and wood damage and rot of window frames.

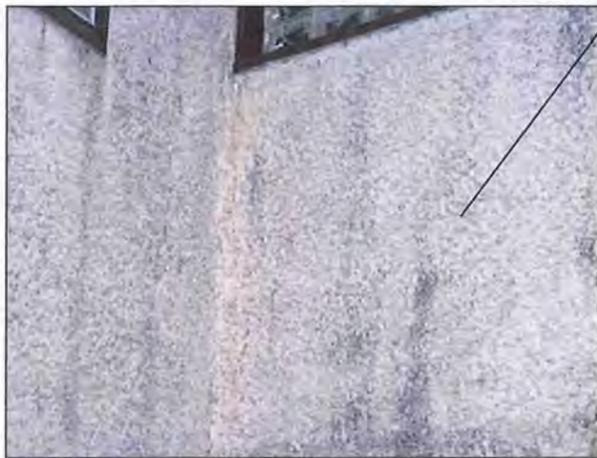
North facing view – water damaged stucco, poor flashing at window and wood damage and rot of window frame.

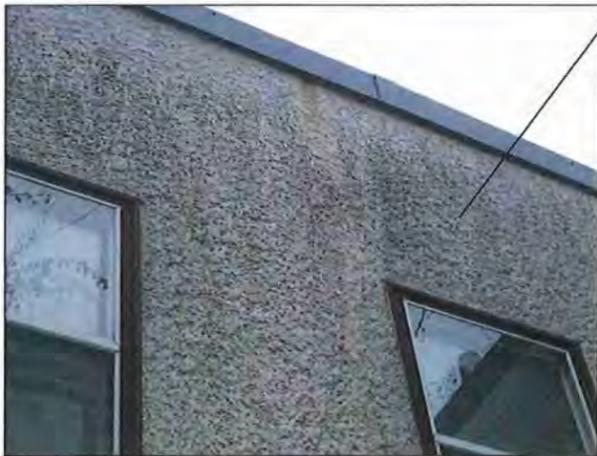
North facing view – water damaged stucco, poor flashing at window and wood damage and rot of window frame.

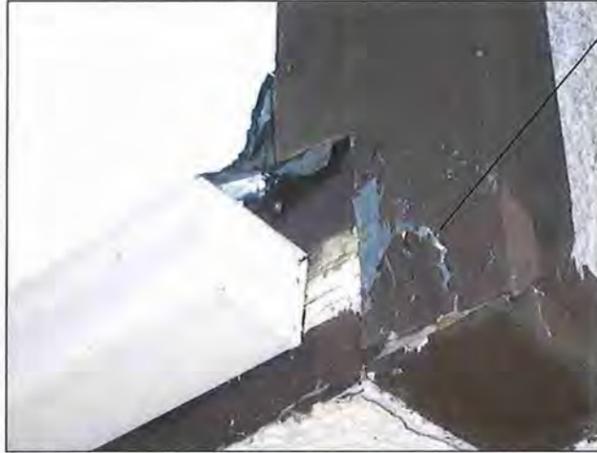
North facing view – water damaged stucco, poor flashing at roof details and rotten soffit / fascia along rear porch roof of home.

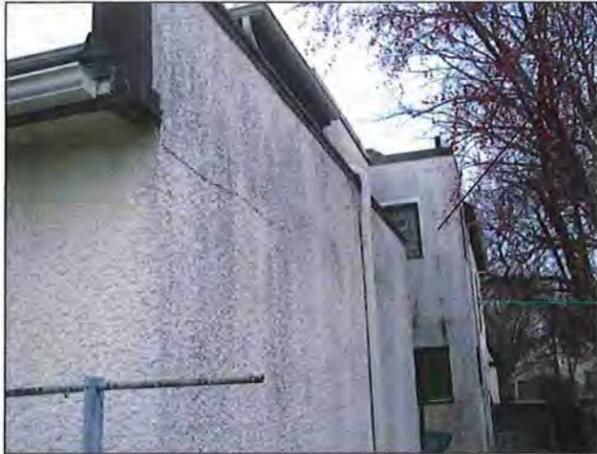
North facing view – water damaged stucco, poor flashing at window and roof details.

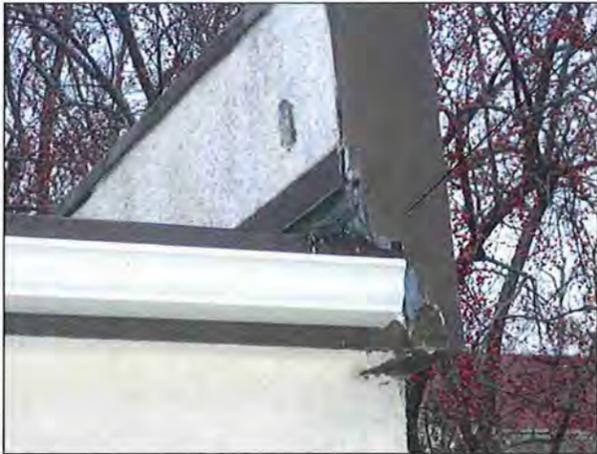
East facing view – water damaged stucco, poor flashing at roof details and rotten soffit / fascia along rear porch roof of home.

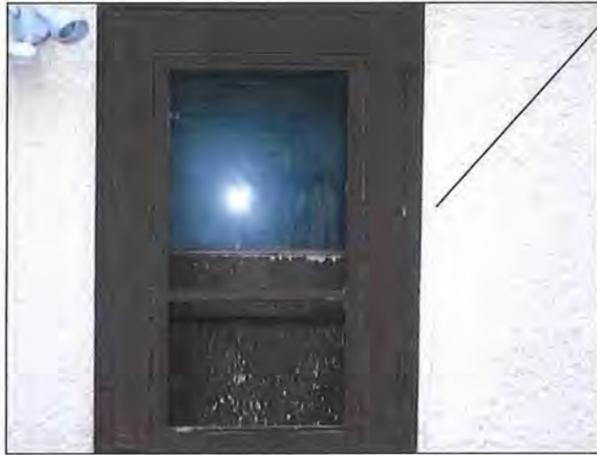
East facing view – water damaged stucco, poor flashing at door details and rotten wood framing.

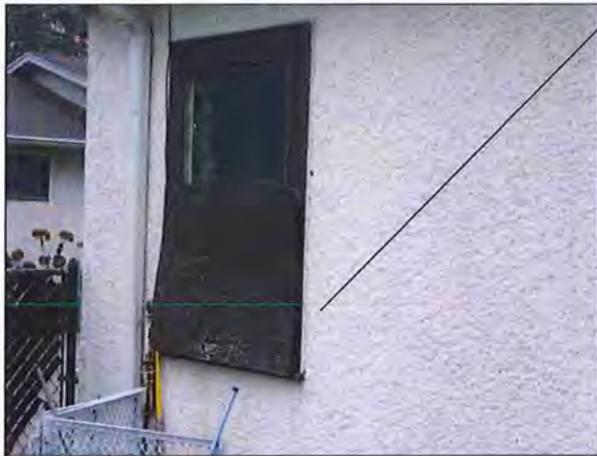
East facing view – water damaged stucco, poor flashing at window details and rotten wood framing.

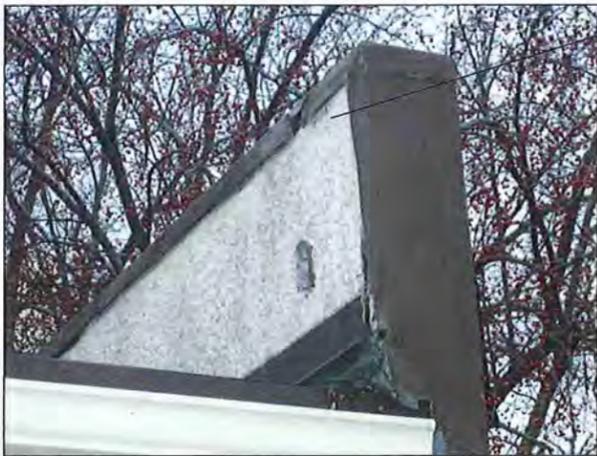
East facing view – water damaged stucco, poor flashing at roof and parapet details and rotten soffit / fascia along rear porch roof of home.

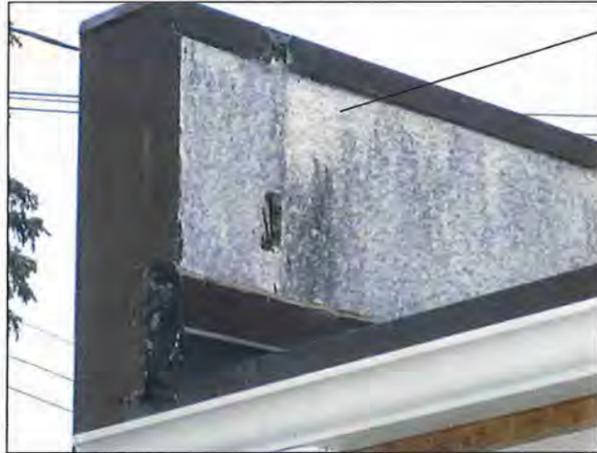
East facing view – water damaged stucco, poor flashing at roof and parapet details and rotten soffit / fascia along rear porch roof of home.

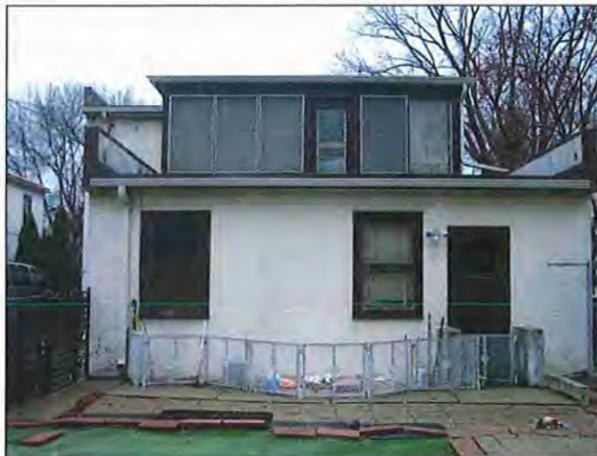
East facing view – water damaged stucco, poor flashing at roof and parapet details and rotten soffit / fascia along rear porch roof of home.

Also, no safety railing in place above porch.

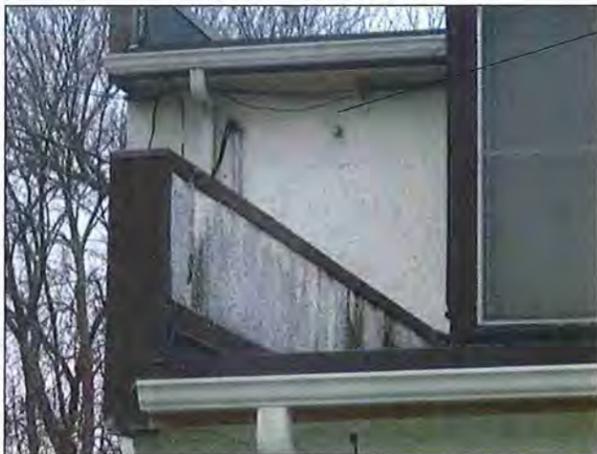
East facing view – water damaged stucco, poor flashing at roof and parapet details and rotten soffit / fascia along rear porch roof of home.

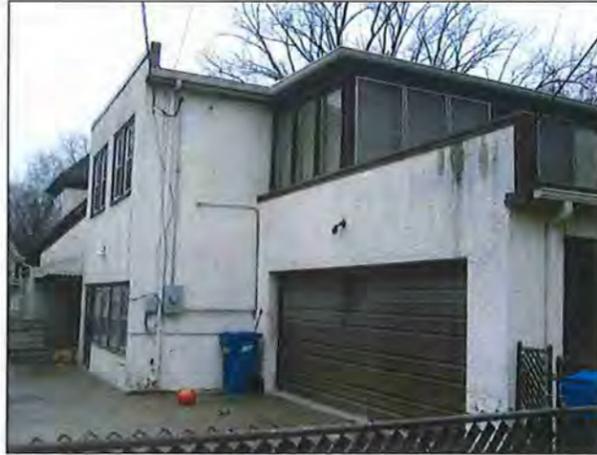
South facing view – water damaged stucco, poor flashing at window details and rotten wood window framing. Also, poor flashing at roof and parapet details and rotten soffit / fascia along rear porch roof of home.

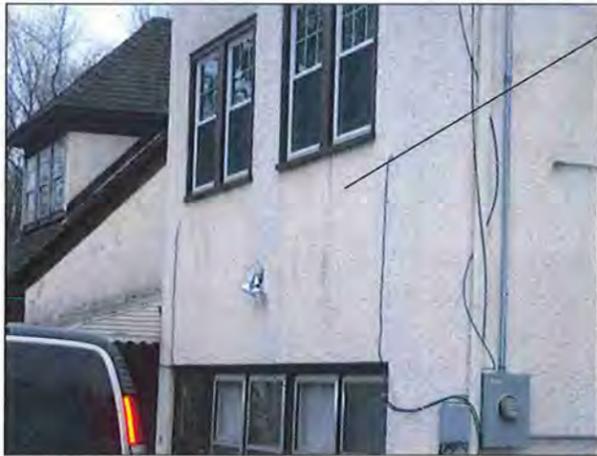
South facing view – water damaged stucco, poor flashing at window details and rotten wood window framing.

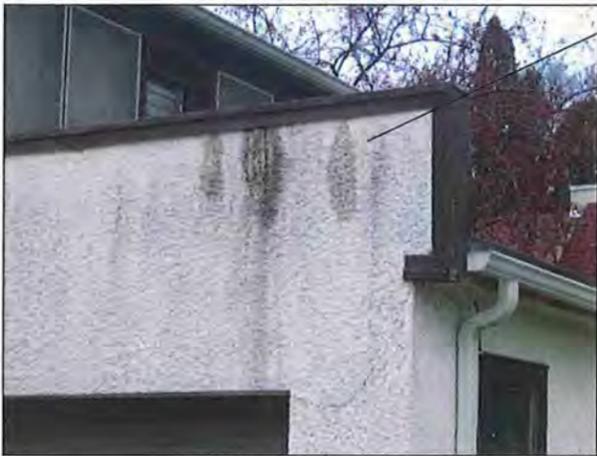
South facing view – water damaged stucco, poor flashing at roof and parapet details and rotten soffit / fascia along rear porch roof of home.

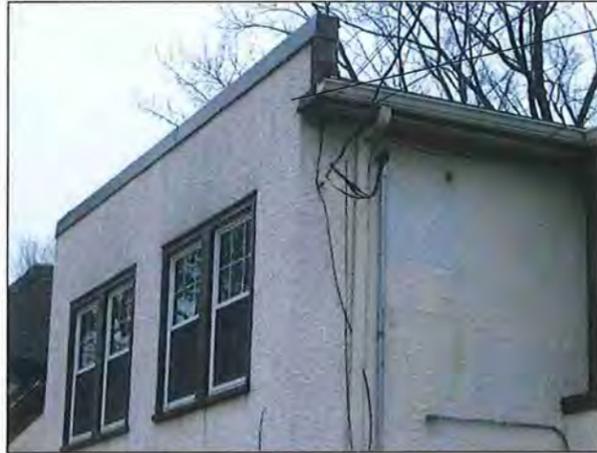
South facing view – water damaged stucco, poor flashing at window details and rotten wood window framing. Also, poor flashing at roof and parapet details and rotten soffit / fascia along south facing side of home.

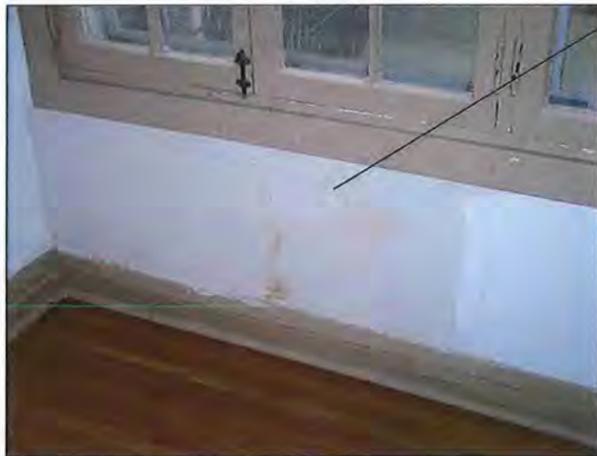
South facing interior wall – water damaged interior stucco under the windows.

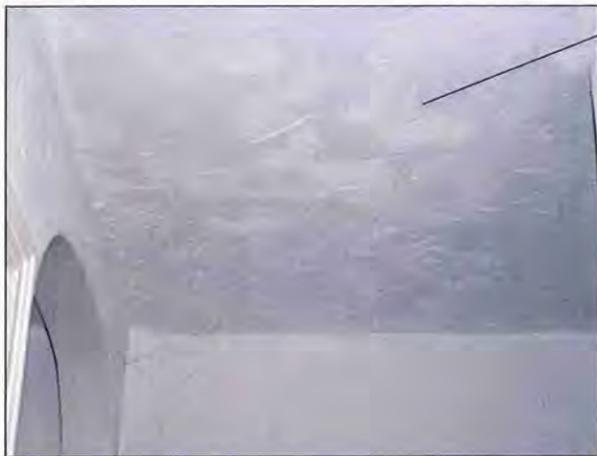
Second floor ceiling – above stairway – water damaged ceiling was patched. There are visual signs of water staining and related damage noted.

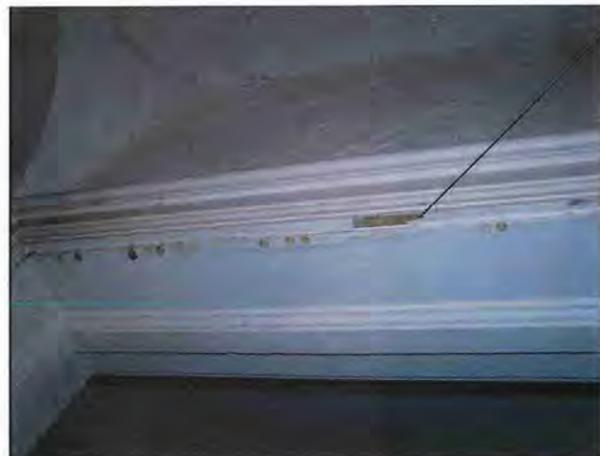
Second floor – water stains on top of door frame due to infiltration from the roof and attic. There are visual signs of water staining and related damage noted.

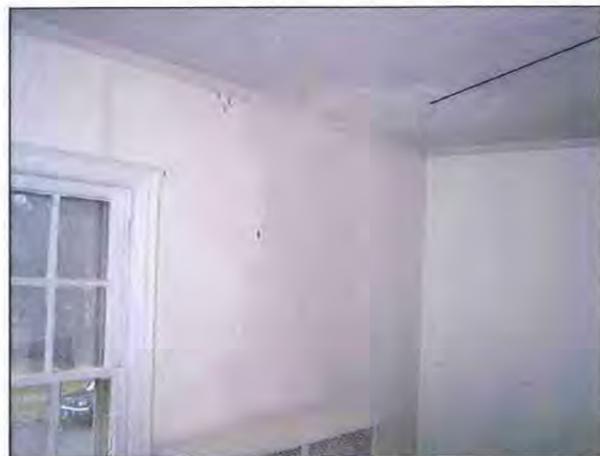
Second floor southwest bedroom – west facing wall and ceiling water damage. There are visual signs of water staining and related damage noted due to leakage around the exterior chimney construction.

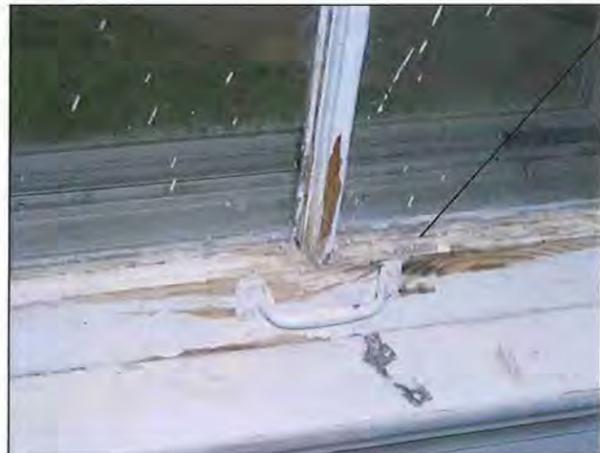
Second floor southwest bedroom – west facing wall water damage. There are visual signs of water staining and related damage noted due to leakage around the windows.

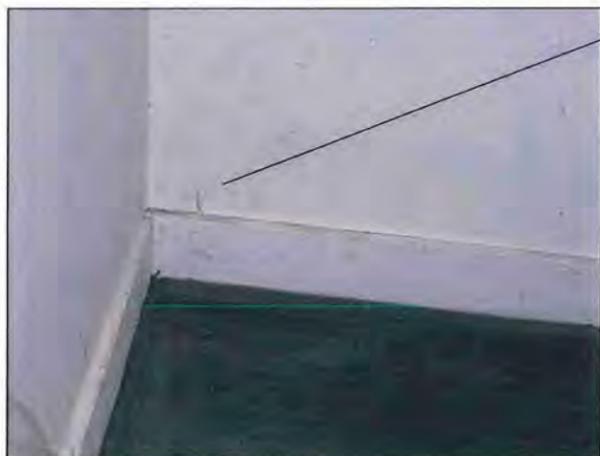
Second floor southwest bedroom – south facing wall water damage. There are visual signs of water staining and related damage noted due to leakage at the base of the wall.

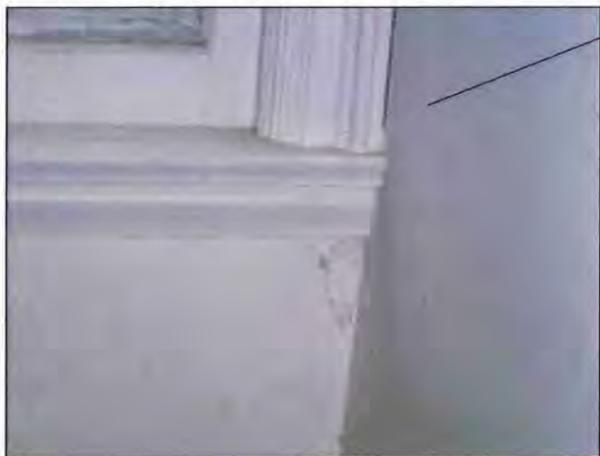
Second floor southwest bedroom – south facing wall water damage. There are visual signs of water staining and related damage noted due to leakage around the windows.

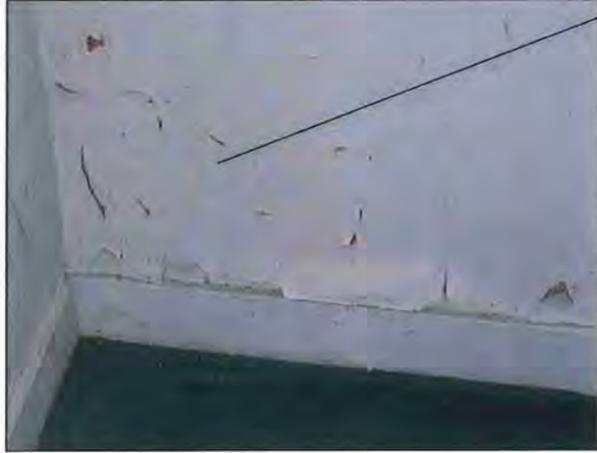
Second floor southwest bedroom – south facing closet wall water damage. There are visual signs of water staining and related damage noted due to leakage at the base of the wall.

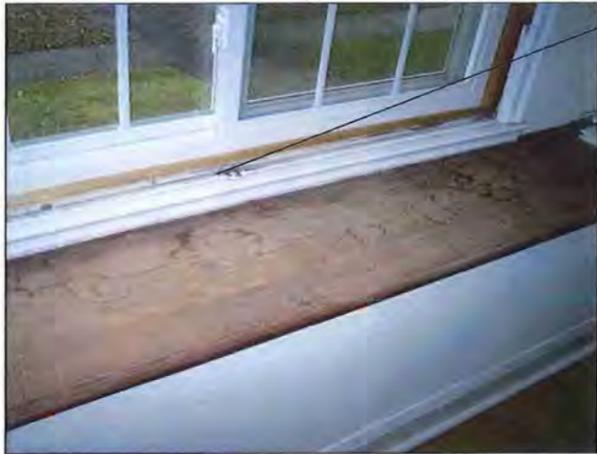
Second floor northwest bedroom – west facing wall water damage. There are visual signs of water staining and related damage noted due to leakage around the windows.

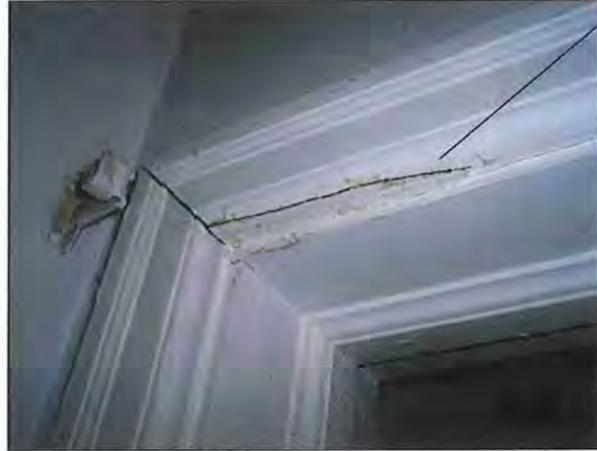
Second floor – hallway wall / door frame water damage. There are visual signs of water staining and related damage noted due to water infiltration through the roof and attic systems.

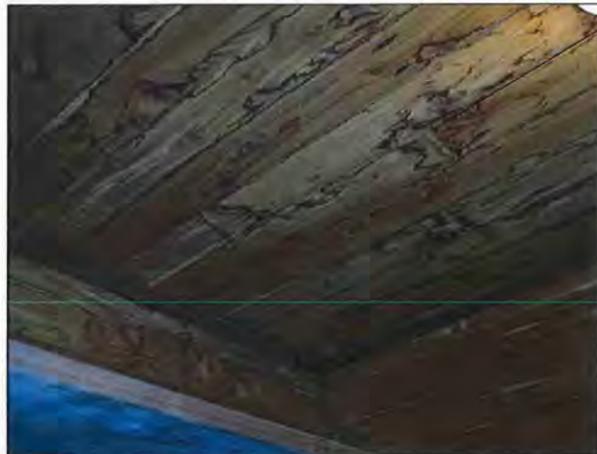
Second floor – southeast bedroom closet water damage. There are visual signs of water staining and related damage noted due to water infiltration through the roof and attic systems.

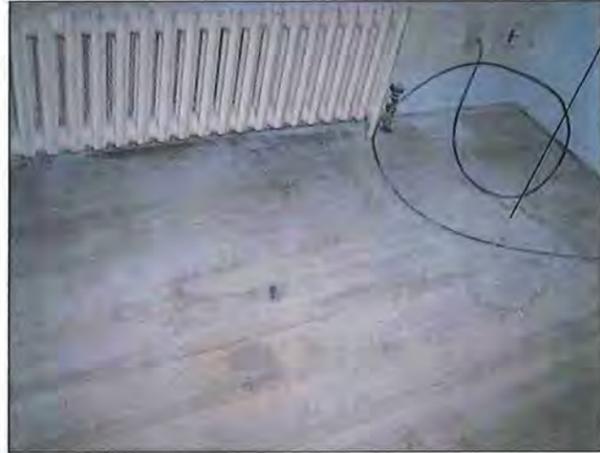
Second floor – southeast bedroom flooring water damage. There are visual signs of water staining and related damage noted due to water infiltration through the windows and perhaps hot water radiation system failures.

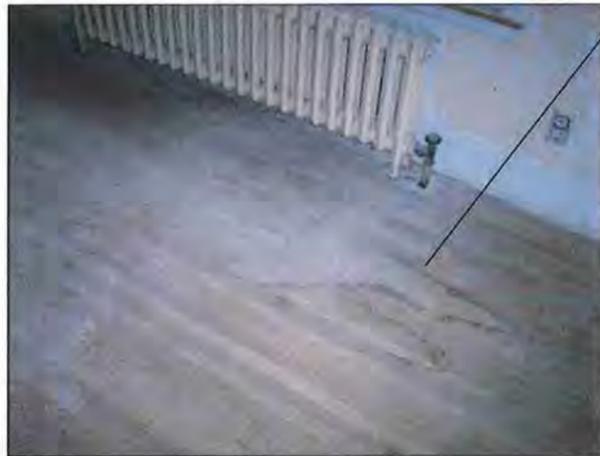
Second floor – southeast bedroom flooring water damage. There are visual signs of water staining and related damage noted due to water infiltration through the windows and perhaps hot water radiation system failures.

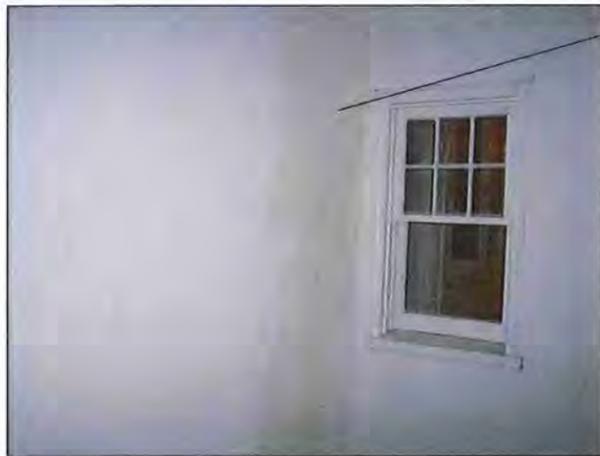
Second floor – southeast bedroom wall water damage. There are visual signs of water staining and related damage noted due to water infiltration through the roof system.

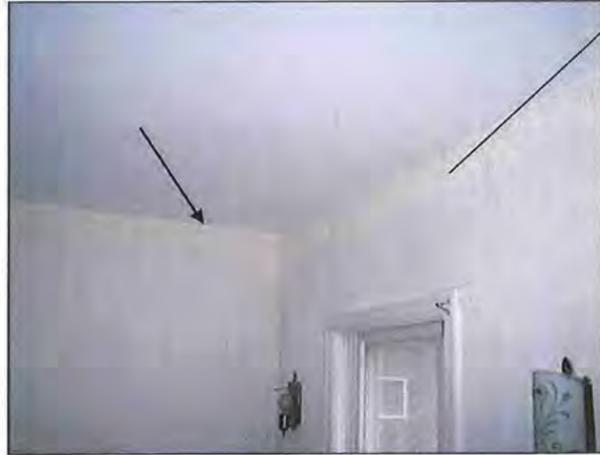
Second floor – southeast bedroom wall water damage. There are visual signs of water staining and related damage noted due to water infiltration through the roof system.

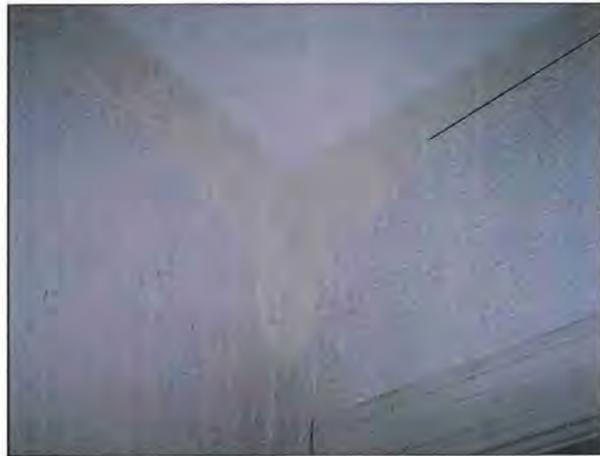
Second floor – southeast bedroom wall water damage. There are visual signs of water staining and related damage noted due to water infiltration through the roof system.

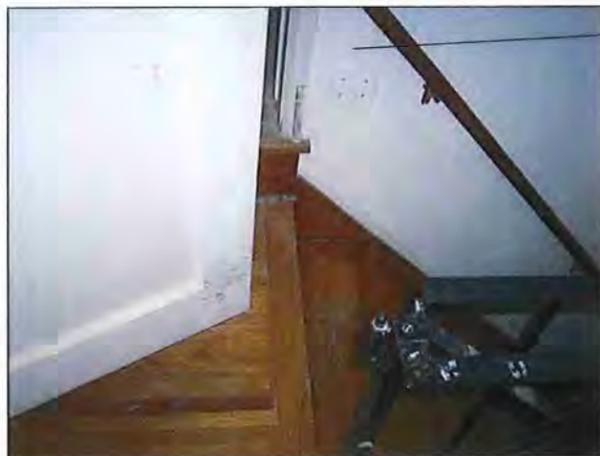
Second floor – east stairway. The door to the second floor east patio / porch opens above the stairway, which is a serious safety hazard for the occupants.

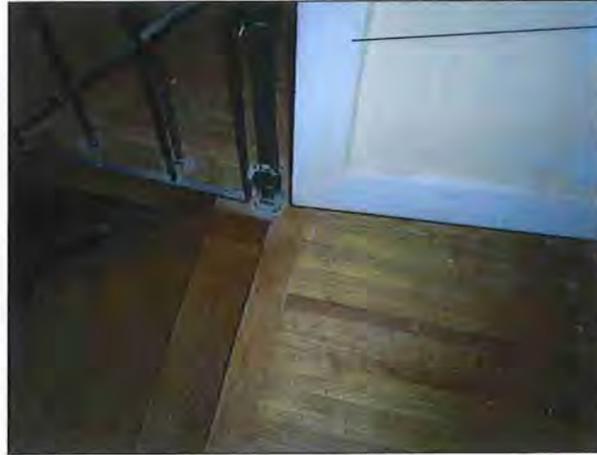
Second floor – east stairway.
The door to the second floor east patio / porch opens above the stairway, which is a serious safety hazard for the occupants.

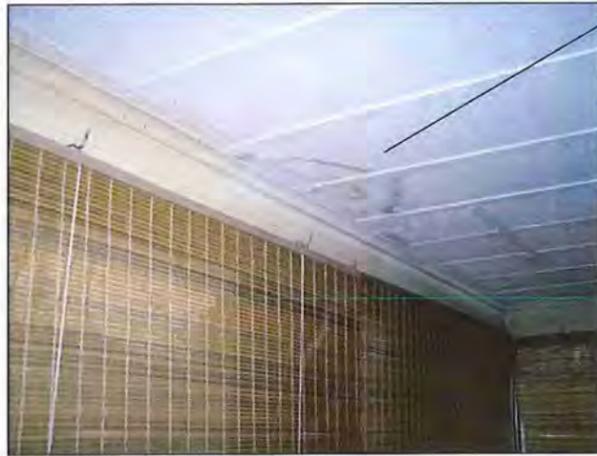
Second floor – east facing wall and ceiling in porch / patio water damage. There are visual signs of water staining and related damage noted due to water infiltration through the window and roof systems.

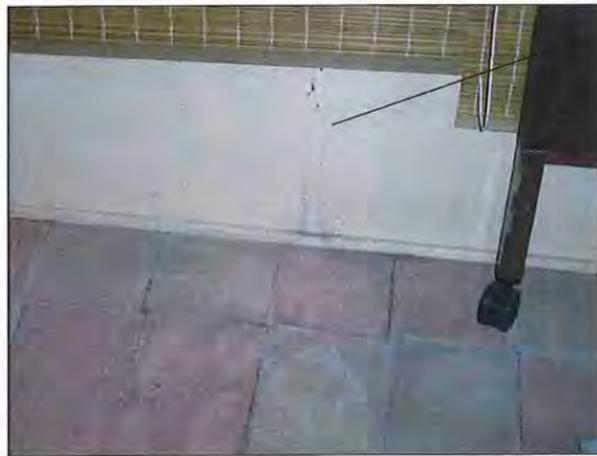
Second floor – east facing wall in porch / patio water damage. There are visual signs of water staining and related damage noted due to water infiltration through the window and roof systems.

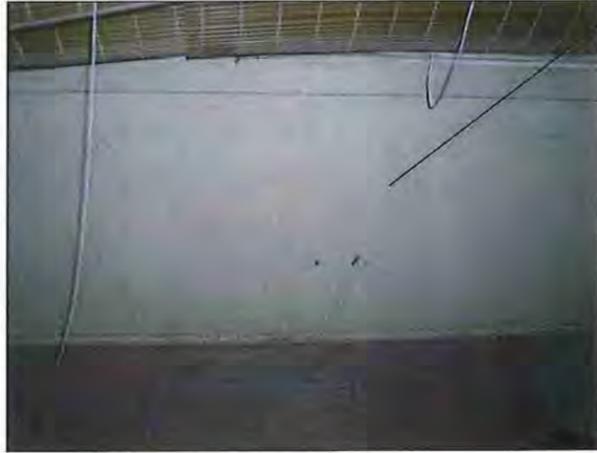
Second floor – south facing wall in porch / patio water damage. There are visual signs of water staining and related damage noted due to water infiltration through the window and roof systems.

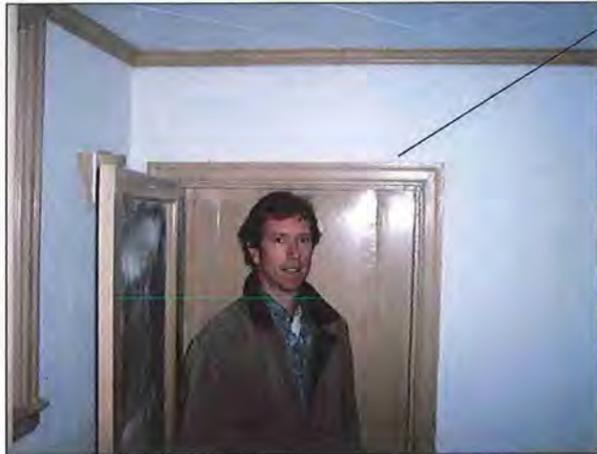
East entry to garage – Note the inadequate clearance into the garage. To improve this condition would require significant structural renovation to repair.

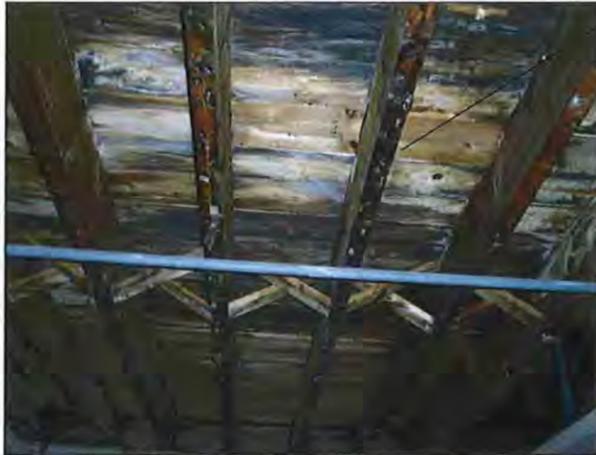
Garage under east side of home – Note the severe and significant visual signs of water staining, wood rot damage and mold growth contamination present on the framing and second floor subfloor systems.

- The ceiling framing and upper level porch subflooring materials as noted from the garage should be replaced to remove the wood rot and structural damage noted.

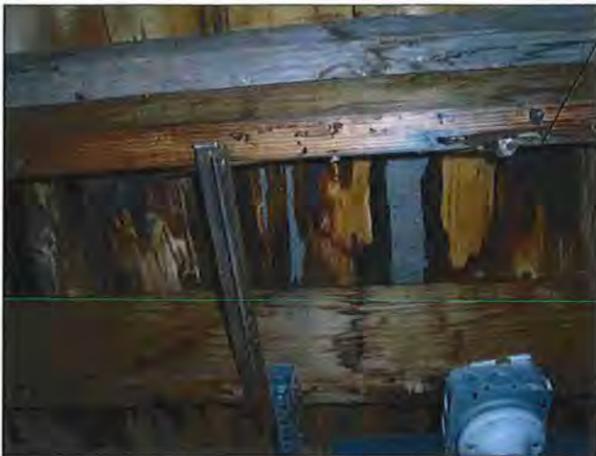
Garage under east side of home – Note the severe and significant visual signs of water staining, wood rot damage and mold growth contamination present on the framing and second floor subfloor systems.

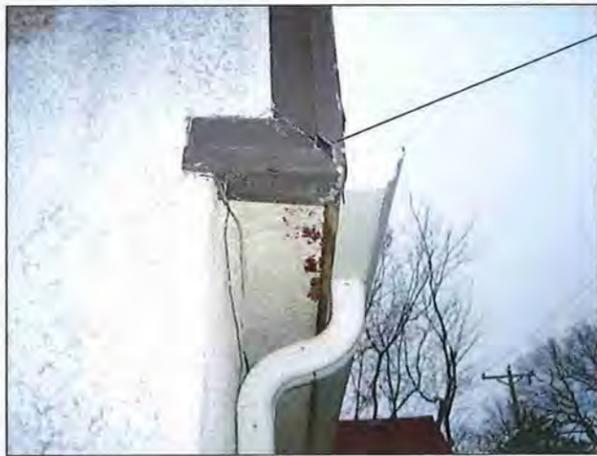
South facing view – water damaged stucco exterior, poor flashing and structurally compromised awning.

- The south facing awning should be removed and replaced if desired. This item is clearly an unsafe structure and could collapse under snow load, wind damage, etc. This system is also not properly flashed so this would also have to be corrected.

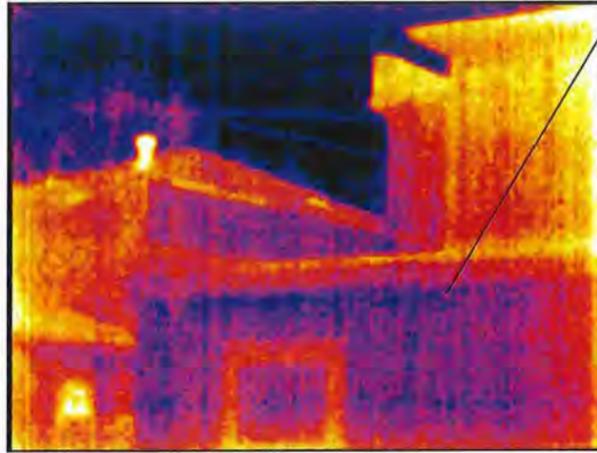
West facing exterior view – Note the severe and significant visual signs of water staining and wood rot damage present. The stucco wall system is also heavy stained and water damaged in this location.

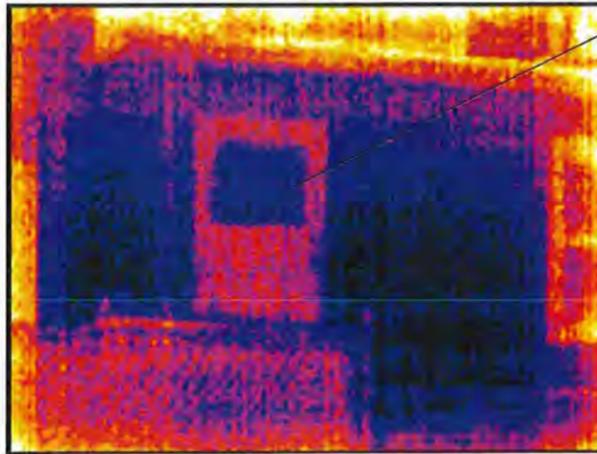
East facing exterior view – Note the dark discolorations (black and blue) are indicative of anomalies that are consistent with water intrusion in the thermal scanned building materials. Continued water incursion in the building envelope can cause mold growth to the structure and wood rot damage.

- The thermal imaging evaluation performed as part of this condition assessment indicates there are numerous and uniform anomalies to the building envelope of the home. BEM concludes these anomalies are likely indicative of significant evidence of water intrusion throughout the home. The entire extent of the water damage and potential structural wood damage or rot is unknown at the time of this evaluation; however, the thermal imaging evidence is significant and has likely caused extensive damage to the entire building envelope located above grade. The thermal imaging photographic documentation supports these findings.

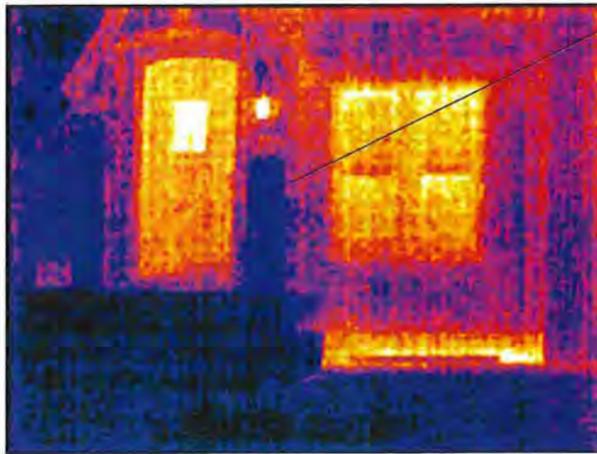
East facing exterior view – Note the dark discolorations (black and blue) are indicative of anomalies that are consistent with water intrusion in the thermal scanned building materials. Continued water incursion in the building envelope can cause mold growth to the structure and wood rot damage.

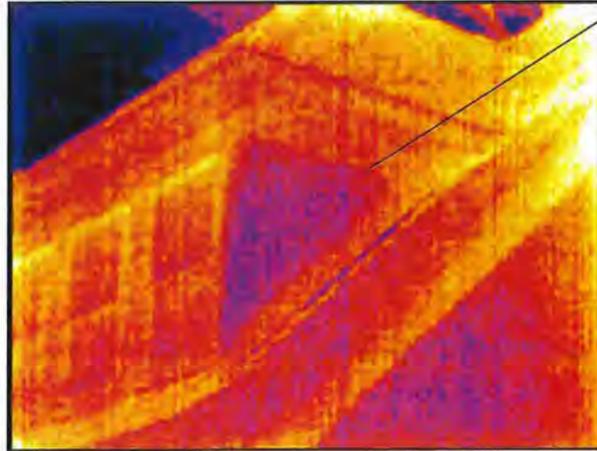
West facing exterior view – Note the dark discolorations (black and blue) are indicative of anomalies that are consistent with water intrusion in the thermal scanned building materials. Continued water incursion in the building envelope can cause mold growth to the structure and wood rot damage.

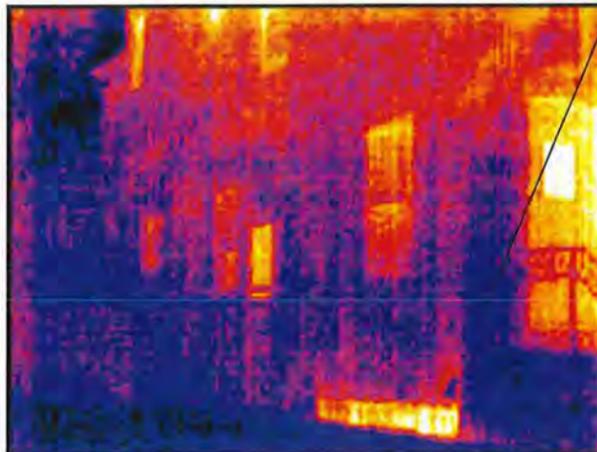
North facing exterior view – Note the dark discolorations (black and blue) are indicative of anomalies that are consistent with water intrusion in the thermal scanned building materials. Continued water incursion in the building envelope can cause mold growth to the structure and wood rot damage.

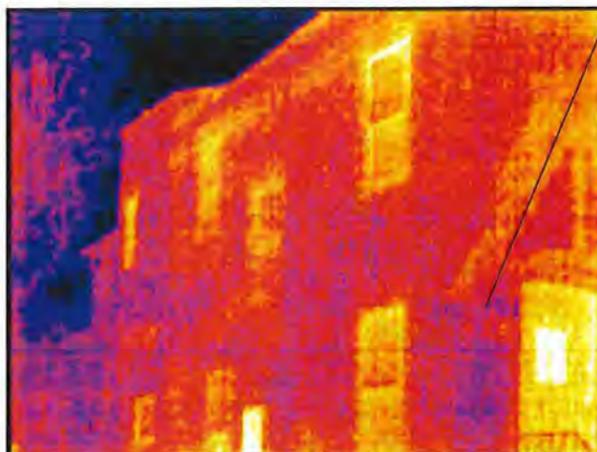
North facing exterior view – Note the dark discolorations (black and blue) are indicative of anomalies that are consistent with water intrusion in the thermal scanned building materials. Continued water incursion in the building envelope can cause mold growth to the structure and wood rot damage.

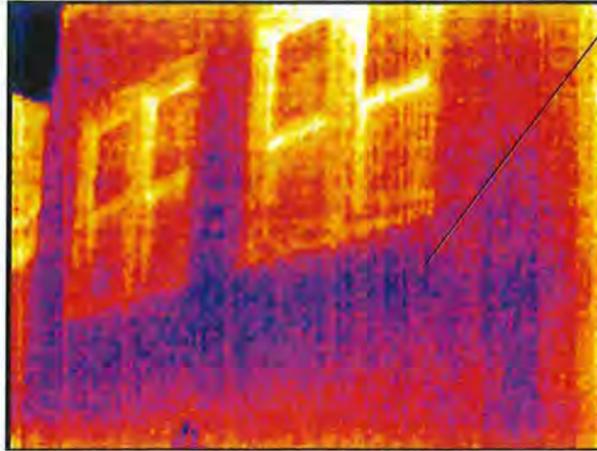
North facing exterior view – Note the dark discolorations (black and blue) are indicative of anomalies that are consistent with water intrusion in the thermal scanned building materials. Continued water incursion in the building envelope can cause mold growth to the structure and wood rot damage.

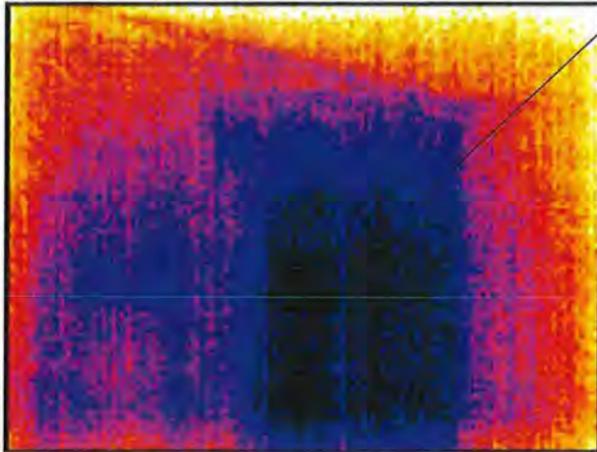
North facing exterior view –
Note the dark discolorations (black and blue) are indicative of anomalies that are consistent with water intrusion in the thermal scanned building materials. Continued water incursion in the building envelope can cause mold growth to the structure and wood rot damage.

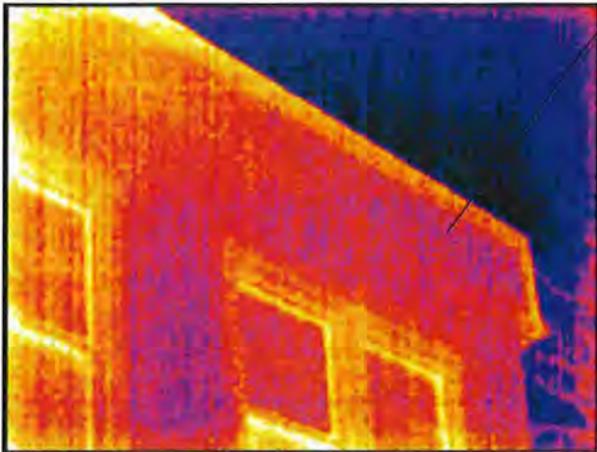
South facing exterior view –
Note the dark discolorations (black and blue) are indicative of anomalies that are consistent with water intrusion in the thermal scanned building materials. Continued water incursion in the building envelope can cause mold growth to the structure and wood rot damage.

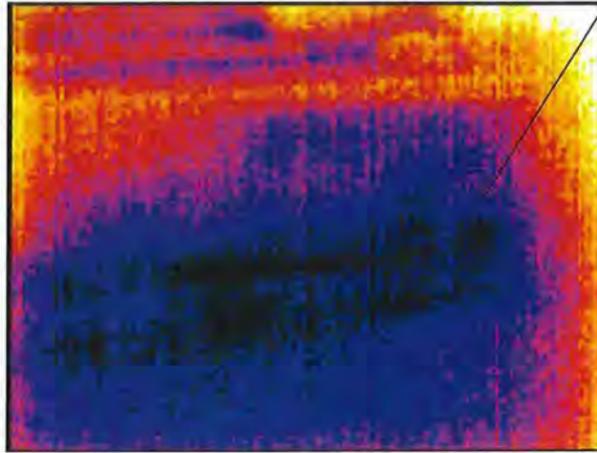
North facing exterior view –
Note the dark discolorations (black and blue) are indicative of anomalies that are consistent with water intrusion in the thermal scanned building materials. Continued water incursion in the building envelope can cause mold growth to the structure and wood rot damage.

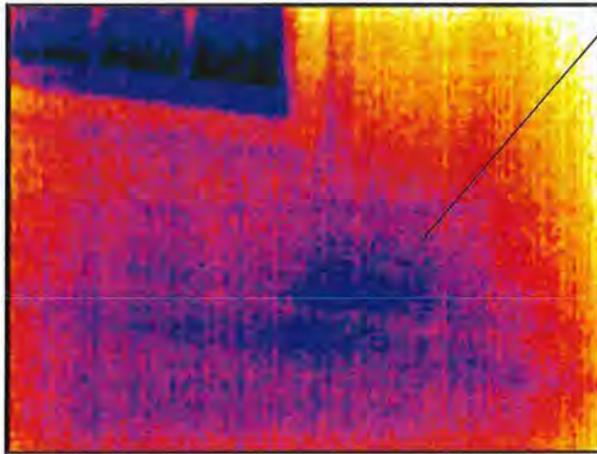
West facing interior view (living room near chimney) – Note the dark discolorations (black and blue) are indicative of anomalies that are consistent with water intrusion in the thermal scanned building materials. Continued water incursion in the building envelope can cause mold growth to the structure and wood rot damage.
