Subject: Appeal of the Certificate of Appropriateness issued for a new detached garage and changes to the street facing façade of the home at 4505 Arden Avenue. File # H-Resolution No. 2014-43

Adopt the attached Resolution upholding the March 11, 2014 decision of the Heritage Preservation Board approving a Certificate of Appropriateness for a new detached garage and changes to the street facing façade of the home at 4505 Arden Avenue.

March 11, 2014
Plans

PROPOSED RECONSTRUCTION/ADDITION
 WITH ALTERED STREET FACADE;
 4505 ARDEN AVE. COUNTRY CLUB DISTRICT, EDINA

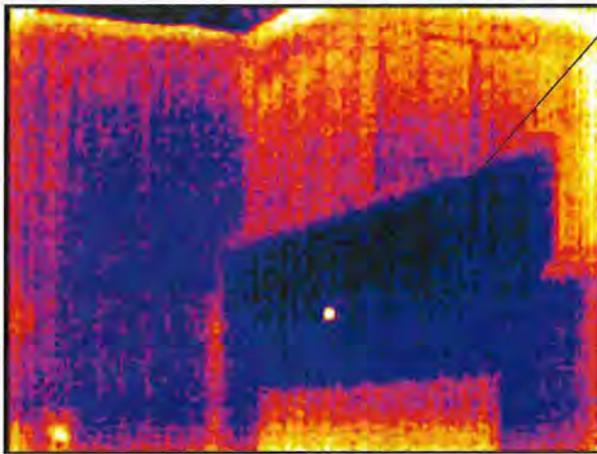
West facing interior view (living room) – Note the dark discolorations (black and blue) are indicative of anomalies that are consistent with water intrusion in the thermal scanned building materials. Continued water incursion in the building envelope can cause mold growth to the structure and wood rot damage.

- The thermal imaging evaluation performed as part of this condition assessment indicates there are numerous and uniform anomalies to the building envelope of the home. BEM concludes these anomalies are likely indicative of significant evidence of water intrusion throughout the home. The entire extent of the water damage and potential structural wood damage or rot is unknown at the time of this evaluation; however, the thermal imaging evidence is significant and has likely caused extensive damage to the entire building envelope located above grade. The thermal imaging photographic documentation supports these findings.

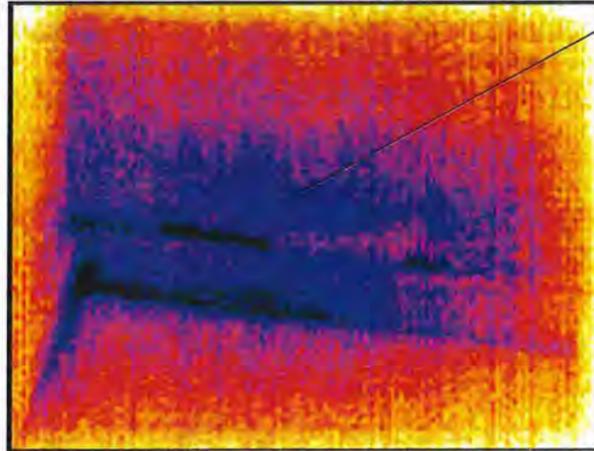
Southeast facing exterior view – Note the dark discolorations (black and blue) are indicative of anomalies that are consistent with water intrusion in the thermal scanned building materials. Continued water incursion in the building envelope can cause mold growth to the structure and wood rot damage.

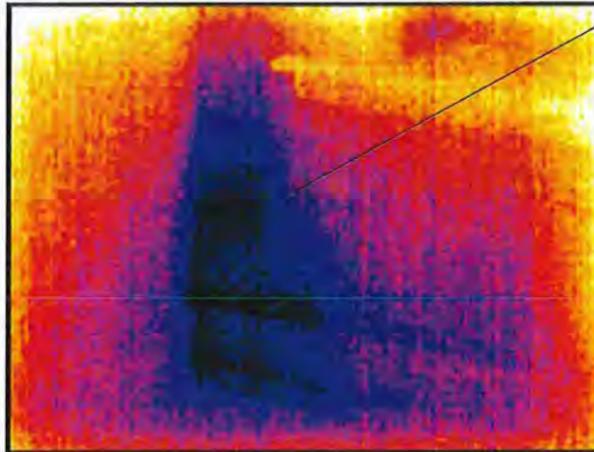
South facing interior view (upper level southwest bedroom) – Note the dark discolorations (black and blue) are indicative of anomalies that are consistent with water intrusion in the thermal scanned building materials. Continued water incursion in the building envelope can cause mold growth to the structure and wood rot damage.

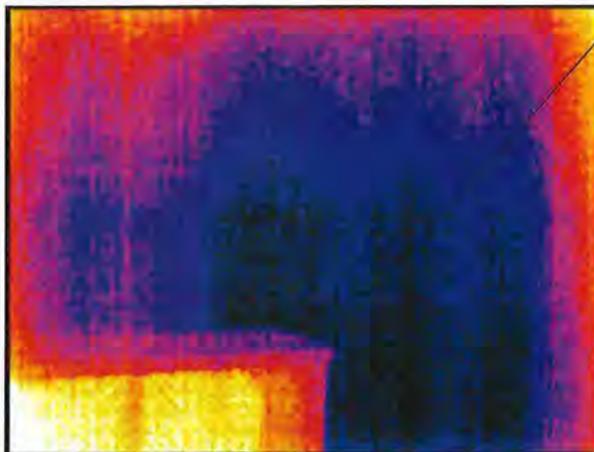
South facing interior view (upper level southwest bedroom) – Note the dark discolorations (black and blue) are indicative of anomalies that are consistent with water intrusion in the thermal scanned building materials. Continued water incursion in the building envelope can cause mold growth to the structure and wood rot damage.

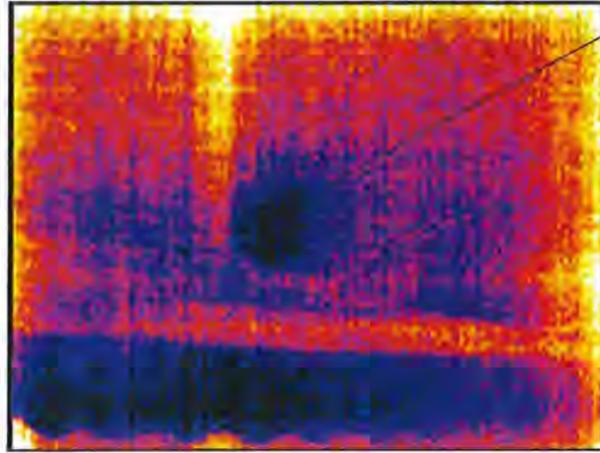
Northwest facing interior view (upper level northwest bedroom) – Note the dark discolorations (black and blue) are indicative of anomalies that are consistent with water intrusion in the thermal scanned building materials. Continued water incursion in the building envelope can cause mold growth to the structure and wood rot damage.
