# REPORT / RECOMMENDATION

**Subject:** Traffic Safety Committee Report of December 4, 2013

## TRAFFIC SAFETY COMMITTEE REPORT

Wednesday, December 4, 2013

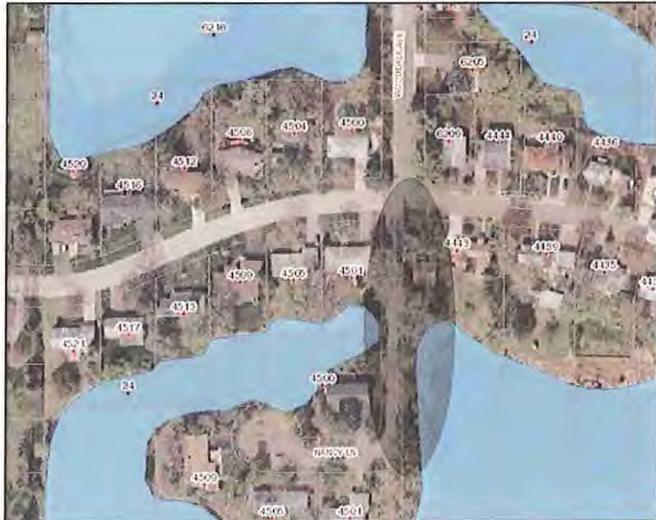
*Map: Wooddale Ave at Garrison and Nancy Ln*

Measurements were taken of the road widths; Garrison Lane 31.5 ft. back of curb to back of curb, Nancy Lane 30.5 ft., Wooddale Ave. south of Garrison 21.5 ft. Neither Nancy Lane nor Wooddale Ave. have curb. Wooddale Avenue is a bike route.

**Staff recommends approval of No Parking on the east side of Wooddale Avenue south of Garrison Lane. Staff recommends denying the request for No Parking on Garrison Lane and Nancy Lane.**

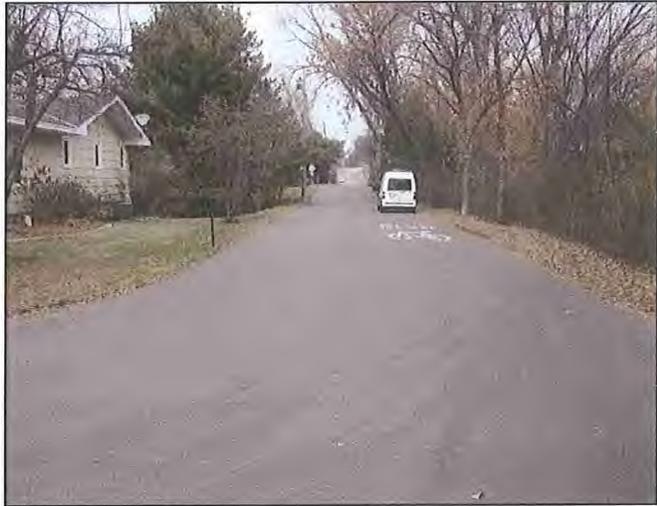
Picture: Nancy Lane and Wooddale Ave. facing north

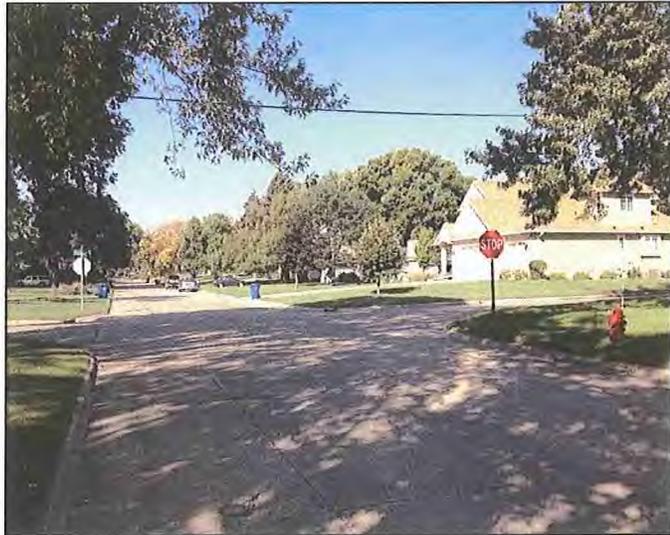
Photo: Tracy Avenue and Brook Drive looking west

Traffic counts and pedestrian counts were conducted at this intersection. This intersection has an Average Daily Traffic (ADT) of 1565 vehicles entering. A total of 34 pedestrians, including bikes, entered the intersection during that time. 1599 total intersection volume being below the required 2000. There are no visibility issues at the intersection. There are no recorded crashes at this intersection. A speed count was also done with the 85<sup>th</sup> percentile speed of 30.65 mph, the posted speed limit is 30 mph.

After discussion, staff recommends denying the request, since the intersection did not meet warrants for an four-way stop.

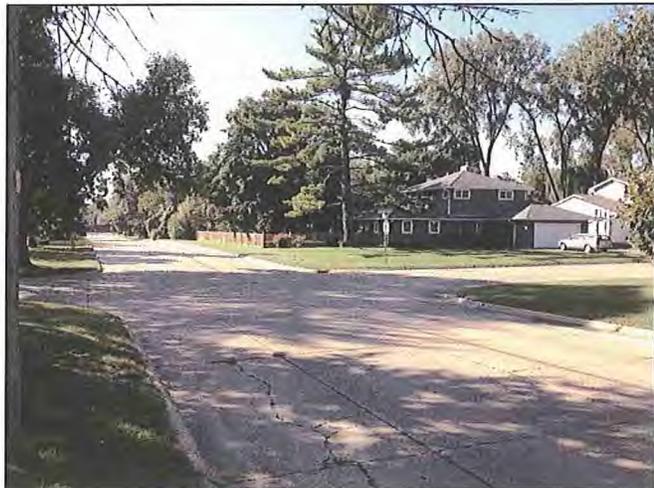
Photo: Tracy Avenue and Brook Drive looking

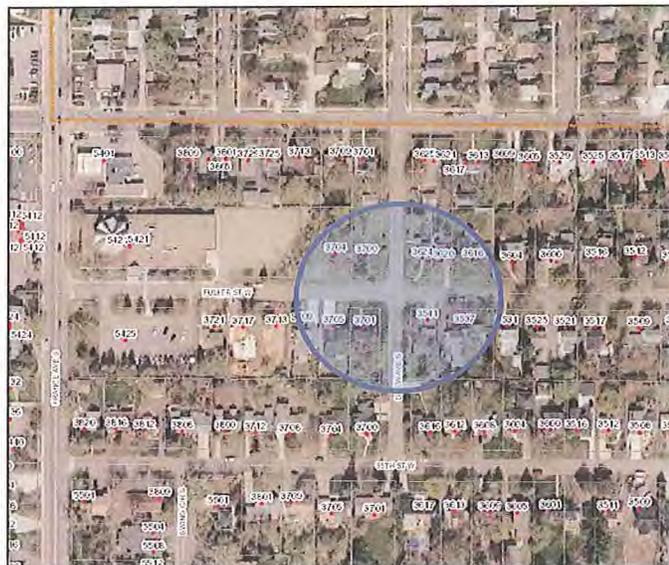
Map: Drew Avenue and Fuller Street

this intersection (a property damage accident in November, 2007 and a personal injury accident in December 2010). In June 2011 the committee recommended the denial of stop signs at the intersection of Drew Ave. and Fuller St.

**Staff recommends denying the request, since the intersection did not meet warrants for a stop sign.**

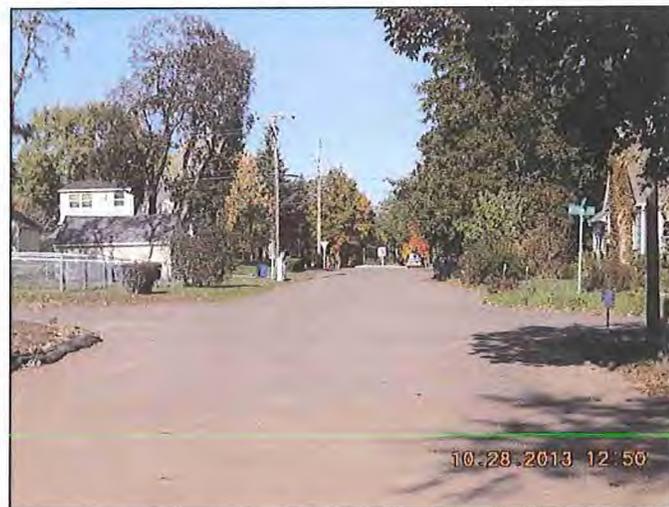
Photo: Drew Ave and Fuller St looking north

Traffic, pedestrian and bicycle counts were conducted at this intersection. This intersection has an Average Daily Traffic (ADT) of 406 vehicles and a total of 53 pedestrians and bicycles entering the intersection during that time, for a combined total of 459. There are two recorded crashes at

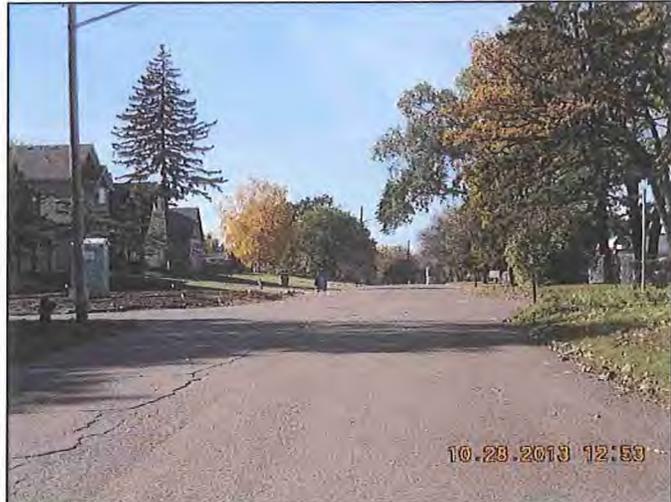
*Photo: Drew Ave and Fuller St looking west*

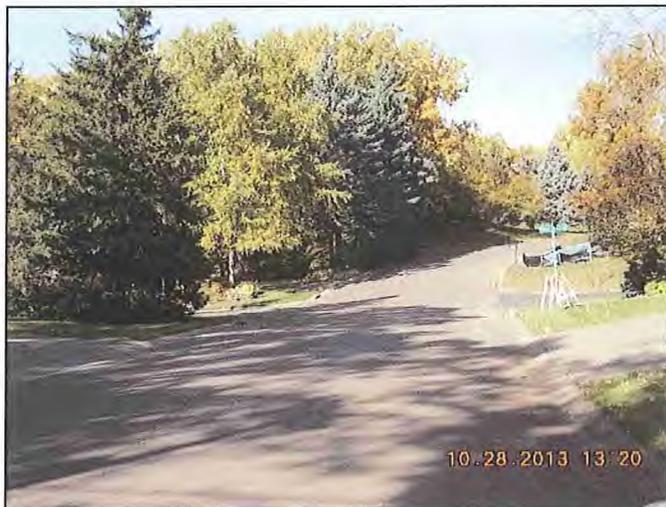
Photo: Willow Wood Road and Larada Lane looking north

Traffic, pedestrian and bicycle counts were conducted at this intersection. This intersection has an ADT of 426 vehicles and a total of 36 pedestrians and bicycles entering the intersection during that time, for a combined total of 426. There are no recorded crashes at this intersection.

**Staff recommends denying the request, since the intersection did not meet warrants for an all-way stop.**

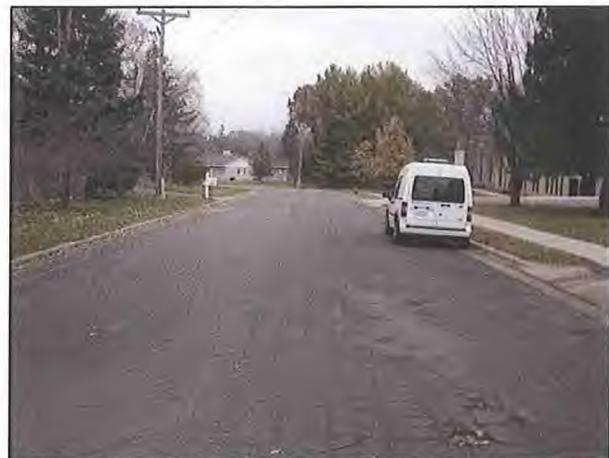
This request comes from a resident who lives in the area. The requestor states that when vehicles are parked on both sides of Wycliffe Road there is not enough room for two cars to pass each other. Also, the curving nature of the street hinders drivers' ability to see approaching cars between the parked vehicles. There is a church located at the intersection of Wycliffe Road and Grove Street.

*Photo: Wycliffe Road looking north*

Requestor would like No Parking on one side of Wycliffe. Currently there is no parking Monday thru Friday from 7 a.m. to 4 p.m. on the east side of the street in front of the church property. The road width from back of curb to back of curb is 30.5 ft. Typical residential streets are 31 ft.

**After discussion the staff recommends denying the request, finding the street wide enough to accommodate parking and traffic.**

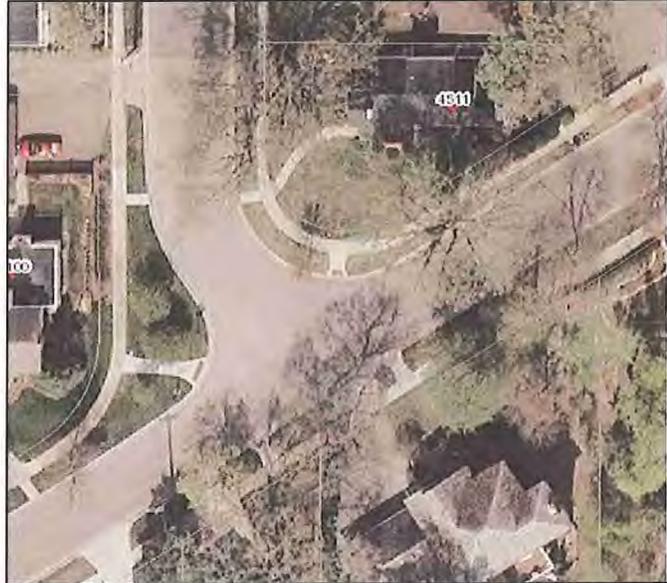
This request comes from a resident who lives in the area. The requestor states that vehicles are not stopping for pedestrians at the intersection of Grimes Avenue and Sunnyside Road. There is a Stop sign on southbound Grimes at Sunnyside. There is a Stop sign on Sunnyside at Arden. There are no other Stop signs on Sunnyside between Arden and France Avenue. There is a marked crosswalk on Sunnyside at Arden. Curb ramps exist for crosswalks as shown in the picture. There are no other marked crosswalks between Arden and France Avenue. There are recorded crashes at the intersection.

*Photo: Sunnyside Road and Grimes Avenue*

Counts of pedestrians were taken at the intersection. A maximum total of 7 pedestrians were recorded crossing Sunnyside Road and a maximum total of 7 pedestrians crossing Grimes Avenue at the intersection within a two-hour period. This is below the warrants for placing a crosswalk. The TSC deferred a request for an All-Way stop sign at this intersection on August 1, 2012.

After discussion the staff recommends denying this request since the intersection did not meet the minimum warrants for pedestrians crossing in a two-hour window.

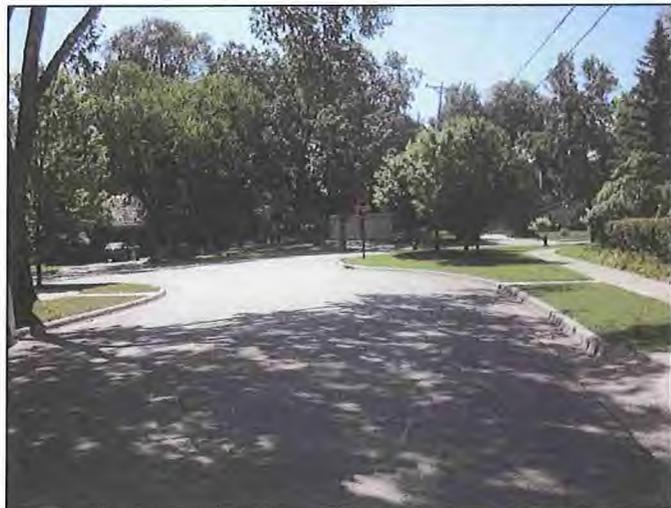
*Photo: Grimes Ave. and Sunnyside Rd looking south*

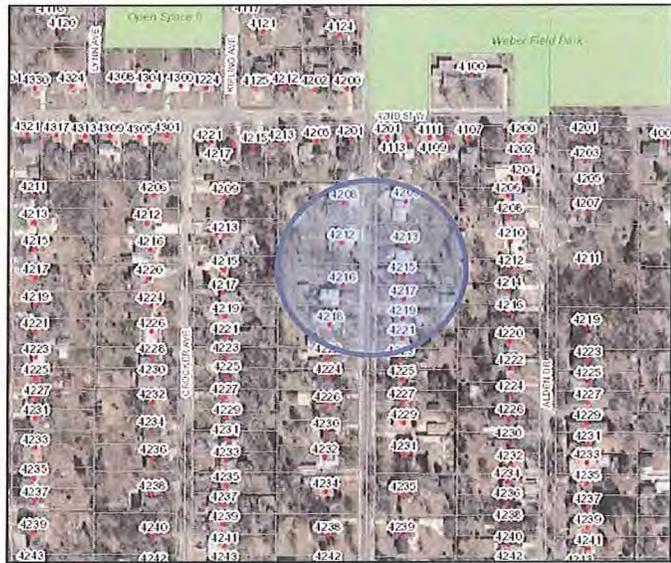
Map: 4200 block of Grimes Ave

Requestor would like parking restrictions on the east side of Grimes near these addresses. Currently there is no parking allowed on the west side of the street. Pavement at this location is 25.5' (face to face). In 2005 a traffic count was taken. The ADT was 806 vehicles with an 85<sup>th</sup> percentile speed of 31.3 mph. The calculated Stopping Sight Distance (SSD) based on the MNDOT road design manual; for this section of Grimes with a 30 mph speed limit and a grade of 14 percent is 171.7 ft. The measured SSD was 172 ft.

After discussion staff recommends doing more research on nearby similar streets for comparison, and to research how this compares with the Living Streets policy.

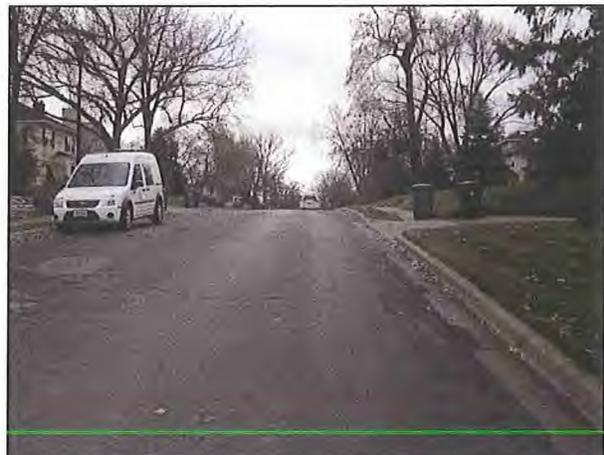
This request comes from a resident who lives in the area and often travels through this section of Grimes Avenue. Requestor states that vehicles travelling northbound on Grimes have to swerve around vehicles parked on the east side of the street, potentially ending up in the southbound lane. Requestor states that this section of Grimes (4215-4219) is on a hill which could potentially block sightlines of vehicles.

Photo: 4213 Grimes Ave, looking south

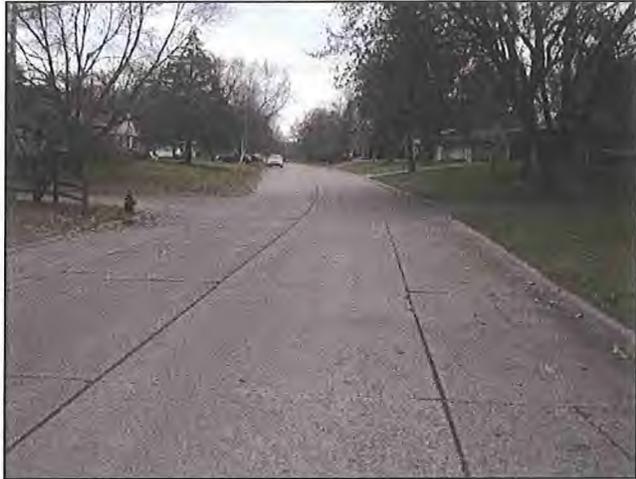
This request comes from a resident living near the intersection. Requestor states vehicles crossing St. Johns Avenue are being hit by people going too fast down St. Johns. Also, the Yield signs on Garrison and Ashcroft Lanes are hard to see and are not being observed. Currently there are Yield signs for traffic crossing St. Johns Avenue.

In 2000 a traffic count was completed for St. Johns Avenue north of Garrison resulting in an ADT of 101, and an 85<sup>th</sup> percentile speed of 26.9 mph. In 2004 a traffic count was completed for Garrison Lane east of St. Johns resulting in an ADT of 212 and an 85<sup>th</sup> percentile speed of 28 mph. There are two recorded auto crashes; a crash resulting in property damage in 2002, and a crash resulting in personal injury in 2013.

*Photo: St. Johns Ave. looking south*

**After discussion, the staff recommends looking further into the crash from 2013 to see if it was an unavoidable crash.**

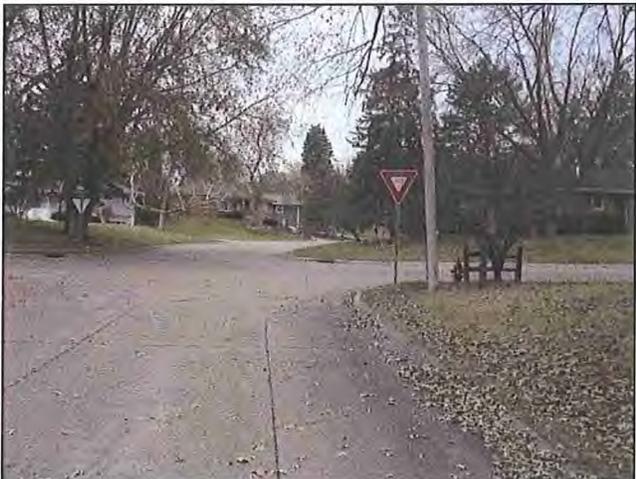
*Photo: St. Johns Ave. and Garrison Ln. looking west*
