# Architect's Observation Report

Report: 08  
Date: July 15, 2014  
Time: 2:29 pm  
Temp: 77 Degrees  
Weather: Partially Cloudy

Project: 13-0639 – Edina Sports Dome and Ice Rink  
Owner: City Of Edina  
Architect: Cunningham Group Architecture Inc.  
Copy To: File

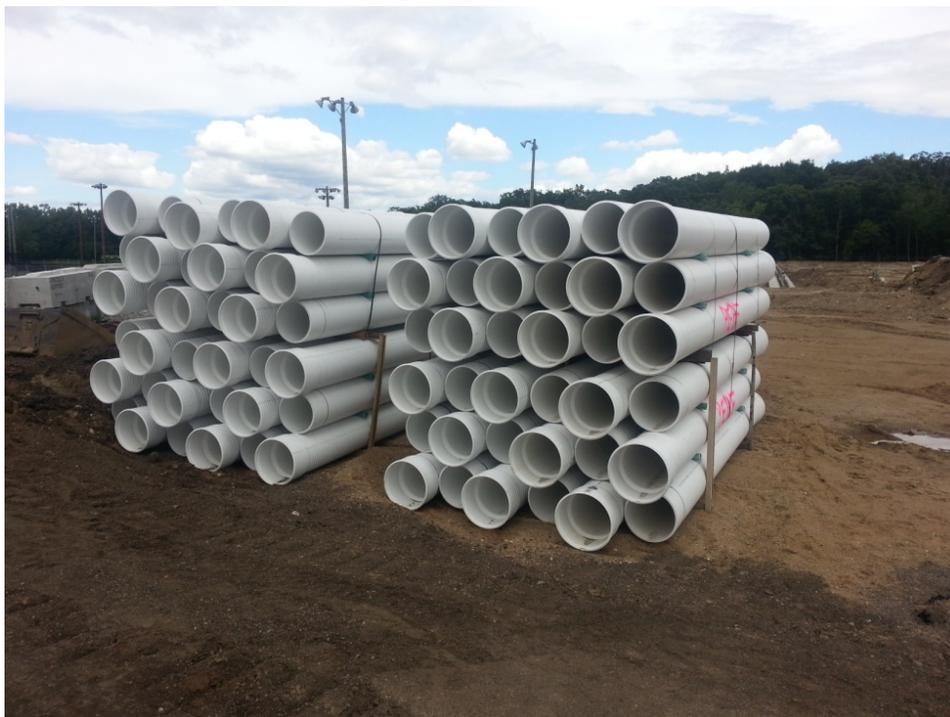
1. Perforated PVC collector pipes onsite for installation of some water collection and storage sub-grade system.

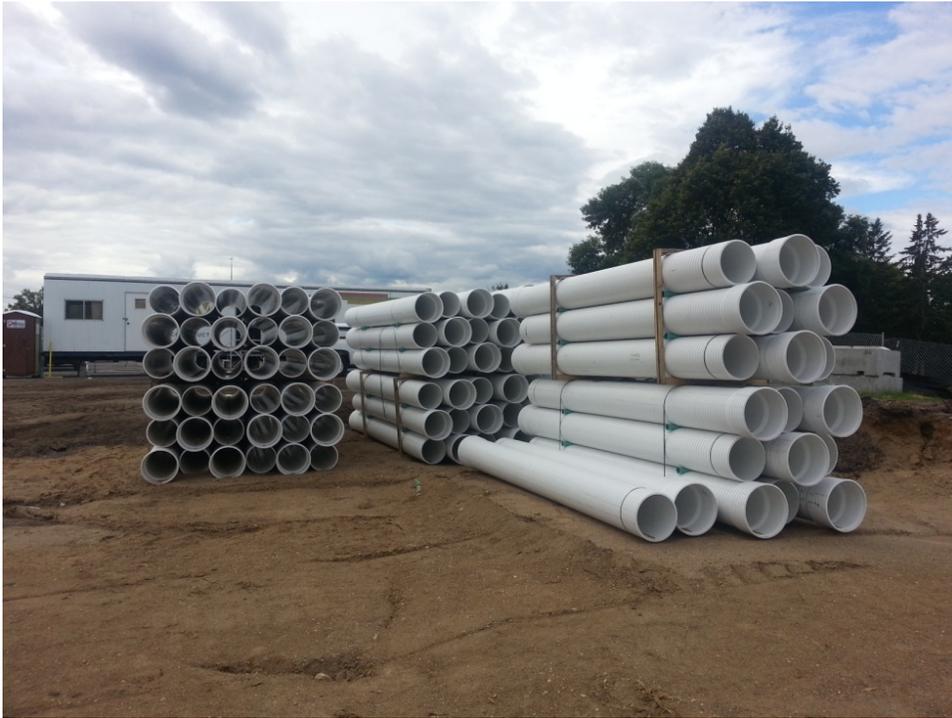
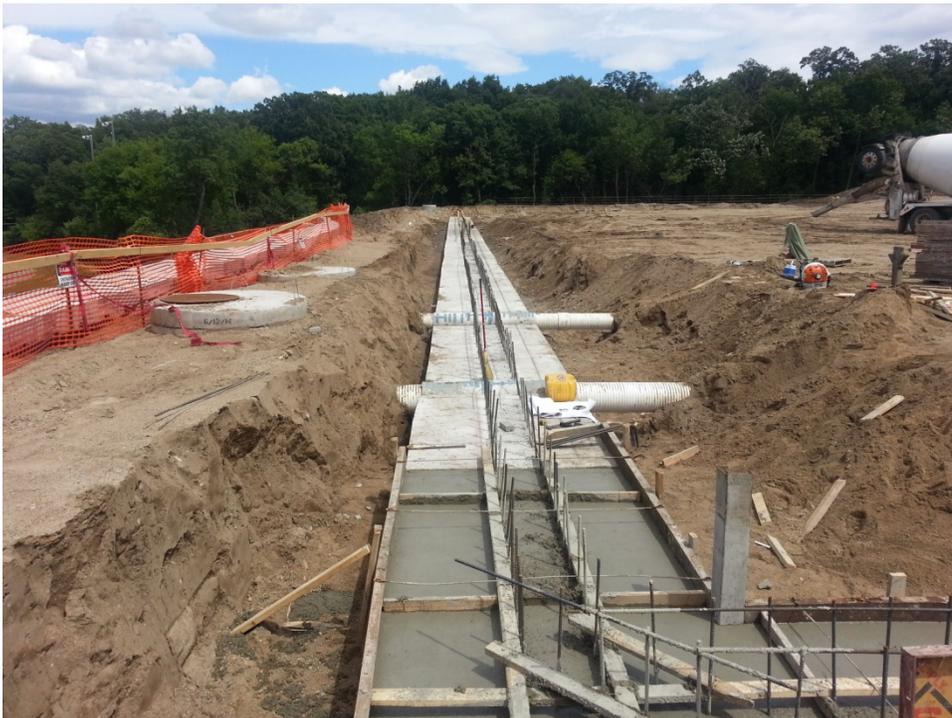
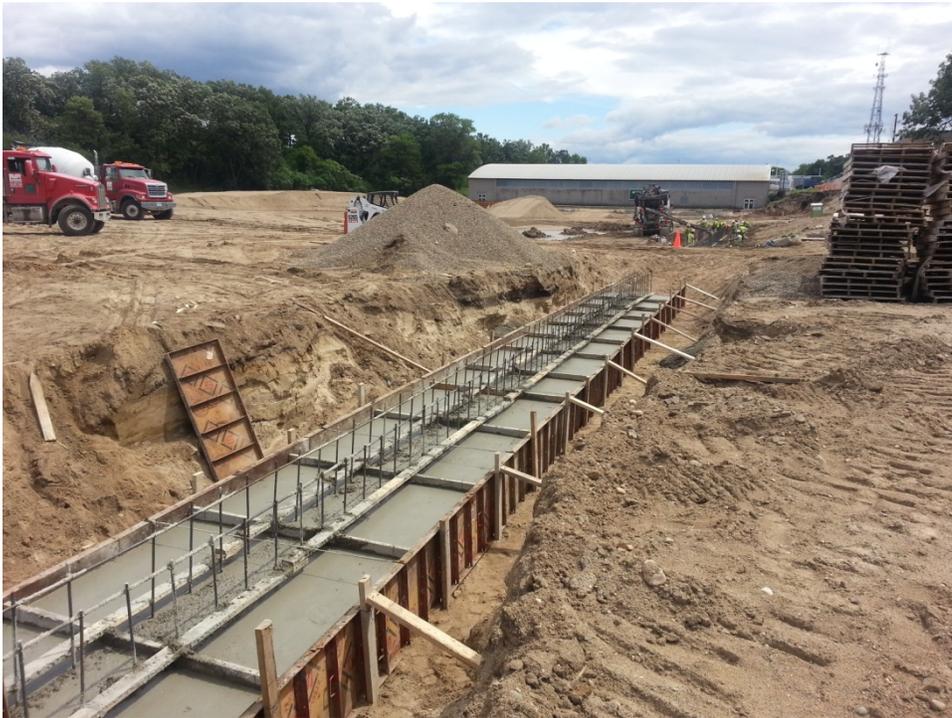
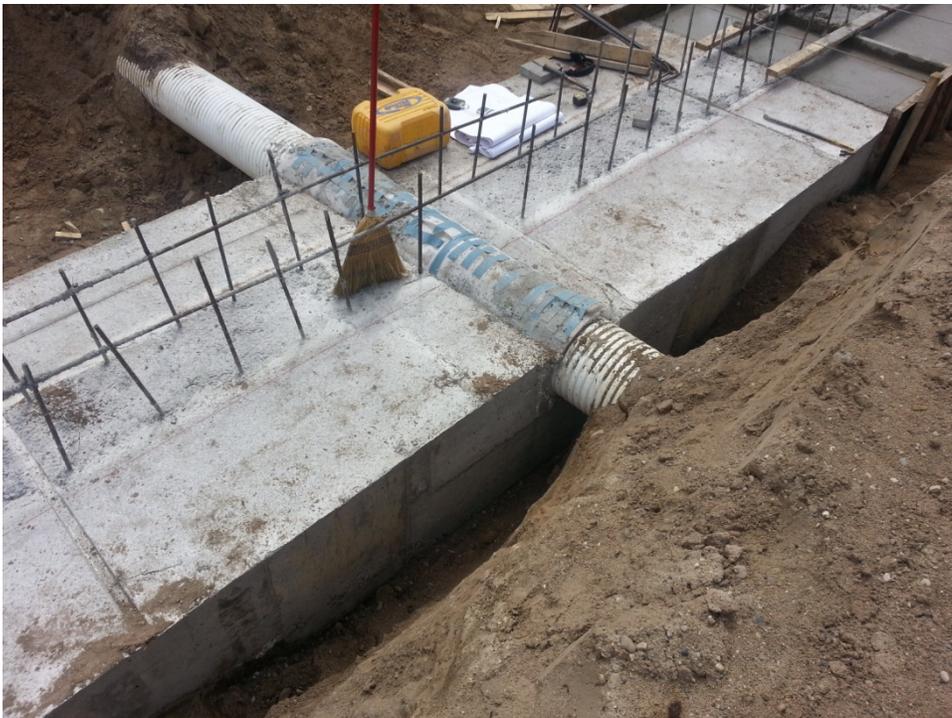
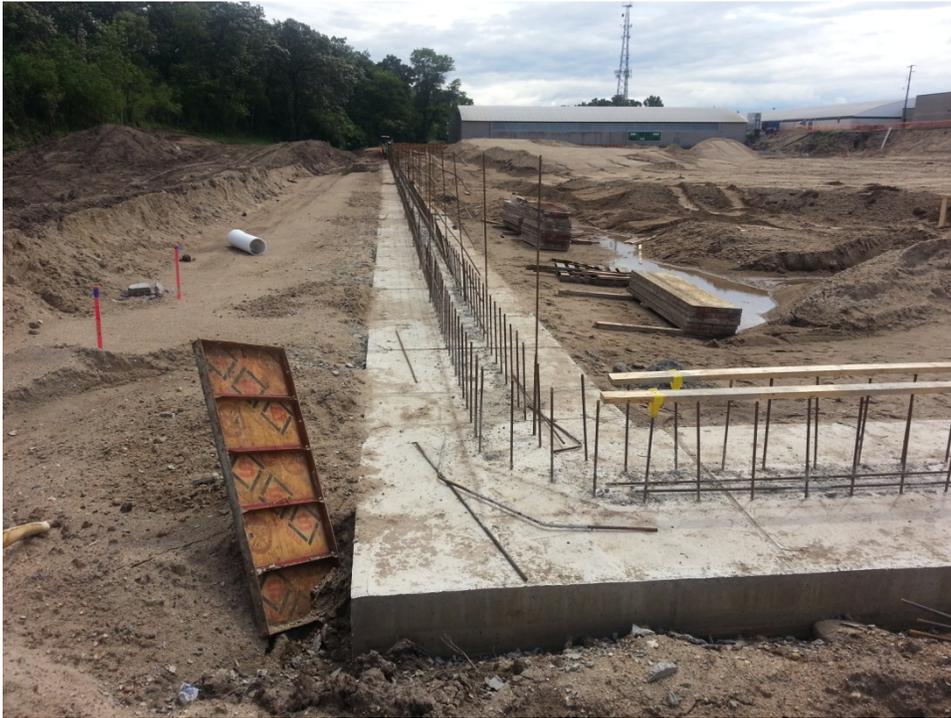
2. Progress with the grade beam footing on the east and north side has been poured and a portion of the south end, west side of dome footing is currently being poured. PVC pipe penetration; footing on north side has been stepped.

1. Dome grade beam installation expected to begin ~~Monday July 7~~ ~~Thursday July 10, 2014~~, after coordination with the dome shop drawings. ~~Design team is currently reviewing dome shop drawings.~~ Shop drawings have been reviewed and approved
2. Ice rink structural steel and joists installation will be pushed back to July 21<sup>st</sup>.
3. West retaining wall (just outside north access to East Arena) installation scheduled to begin in the week of ~~July 7, 2014~~ July 21, 2014 - east exits in North Arena will have to be blocked up during the installation. Susie Miller to close off east side seating in North Arena.

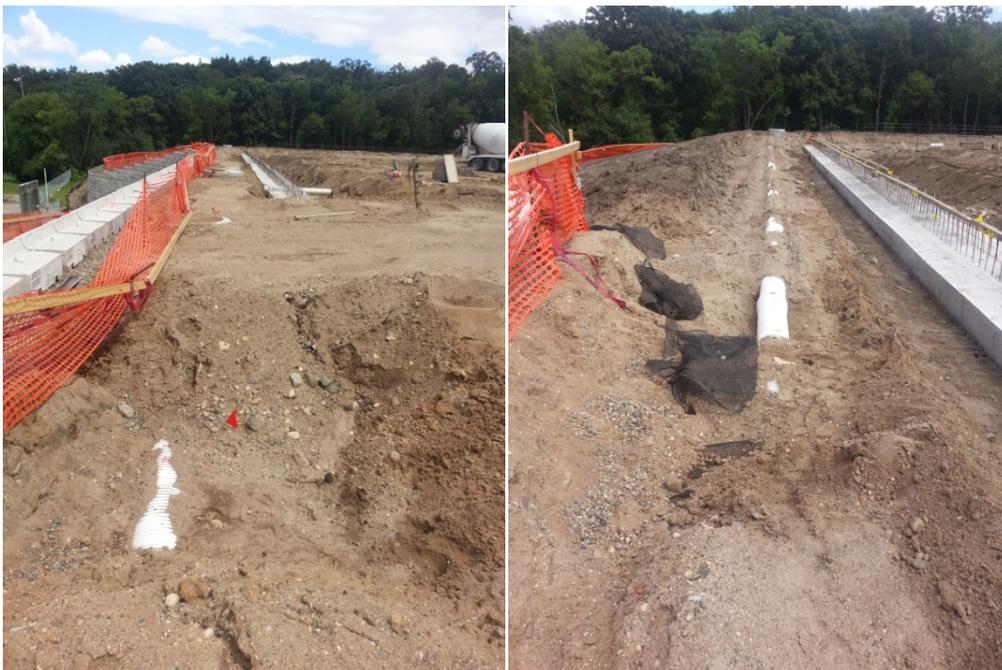
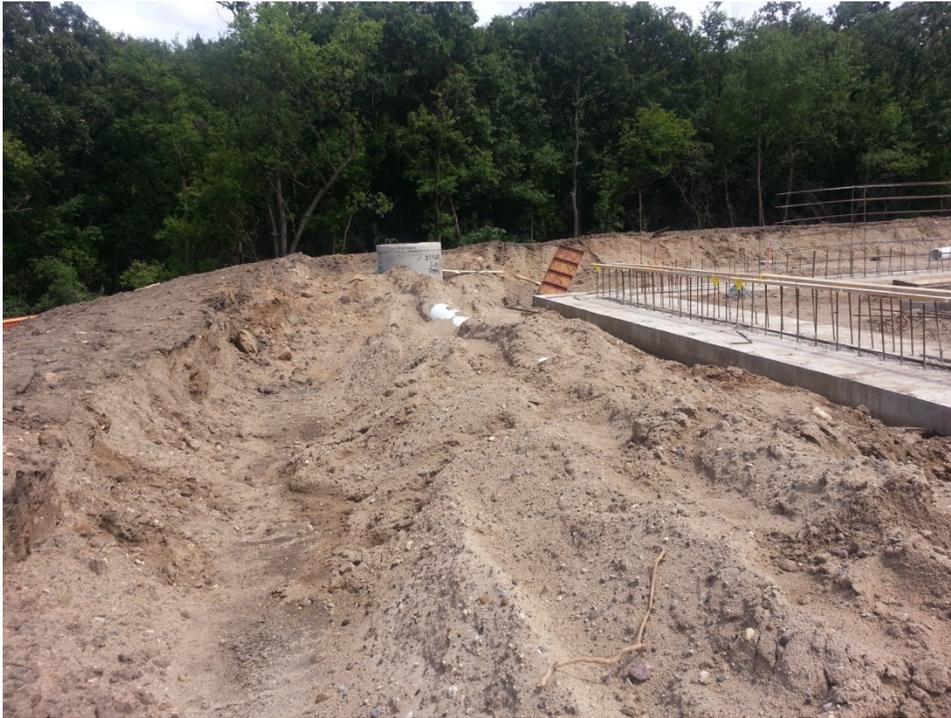
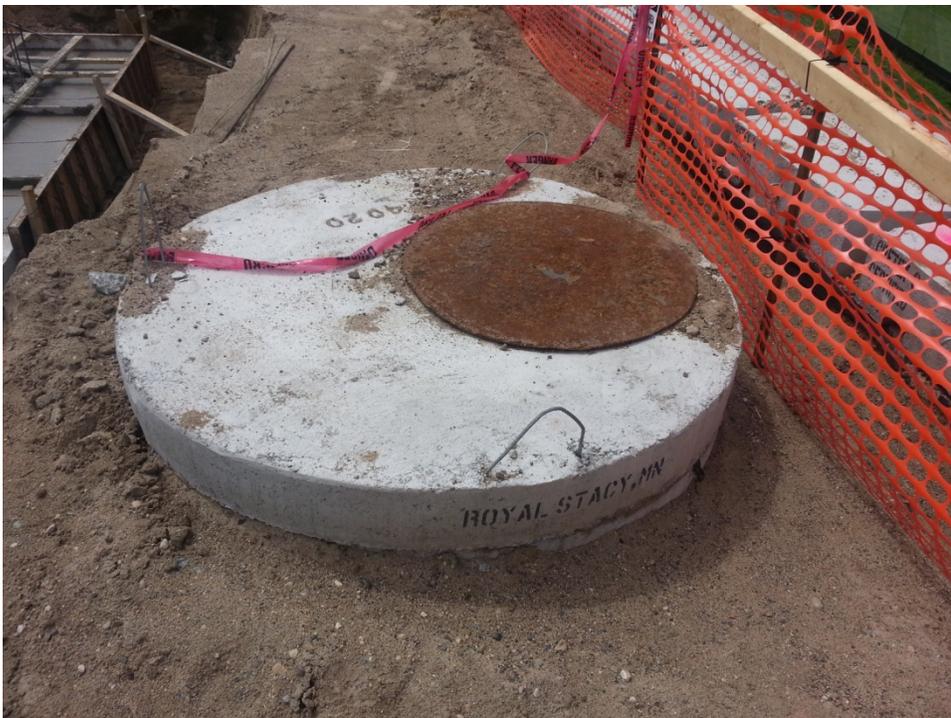
3. Catch basin 1, 2, 3,4 and 5 have been installed on along the north side of the dome with sloped PVC piping connecting them.

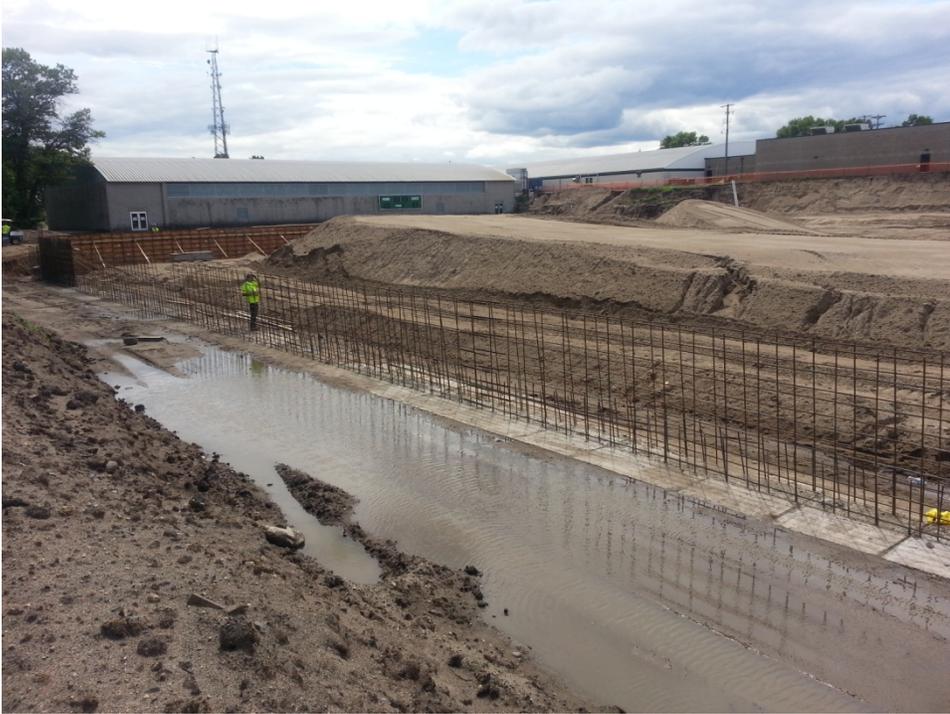
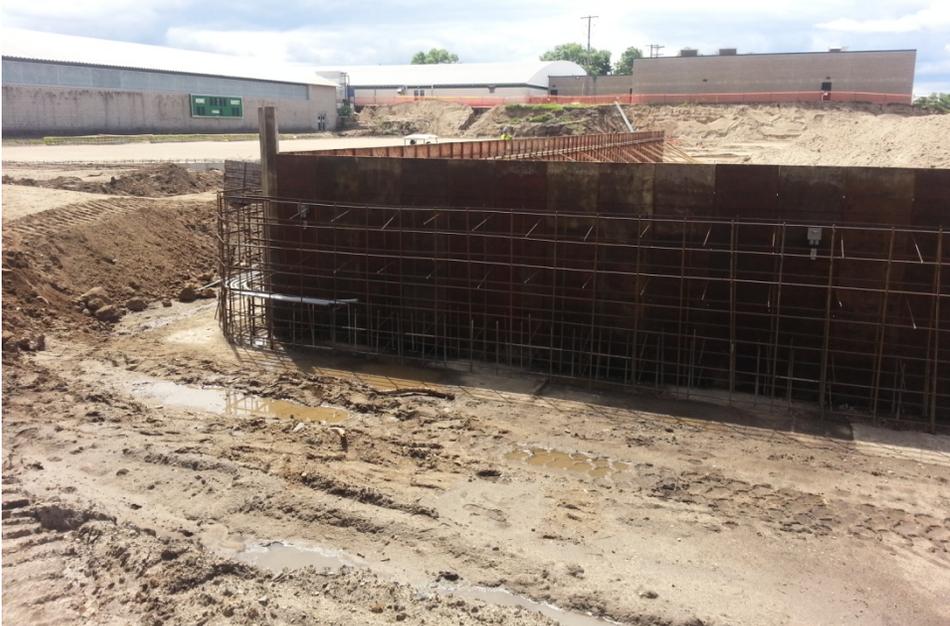
4. Formwork installation for grade beam wall on south side of grade beam is in progress, rebar, conduit and conduit boxes are also being set within the formwork.

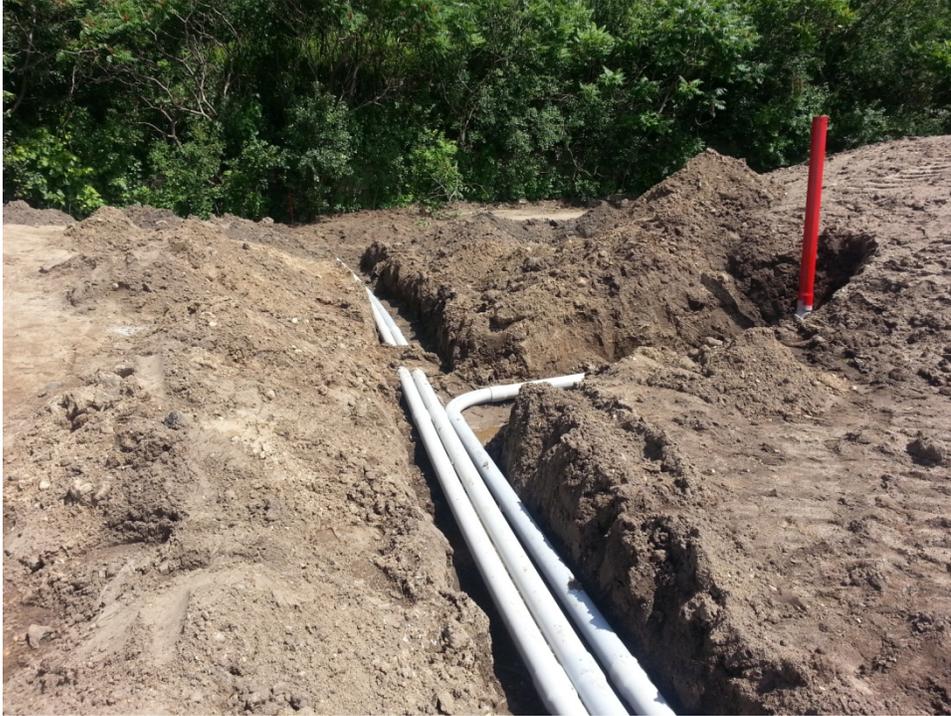
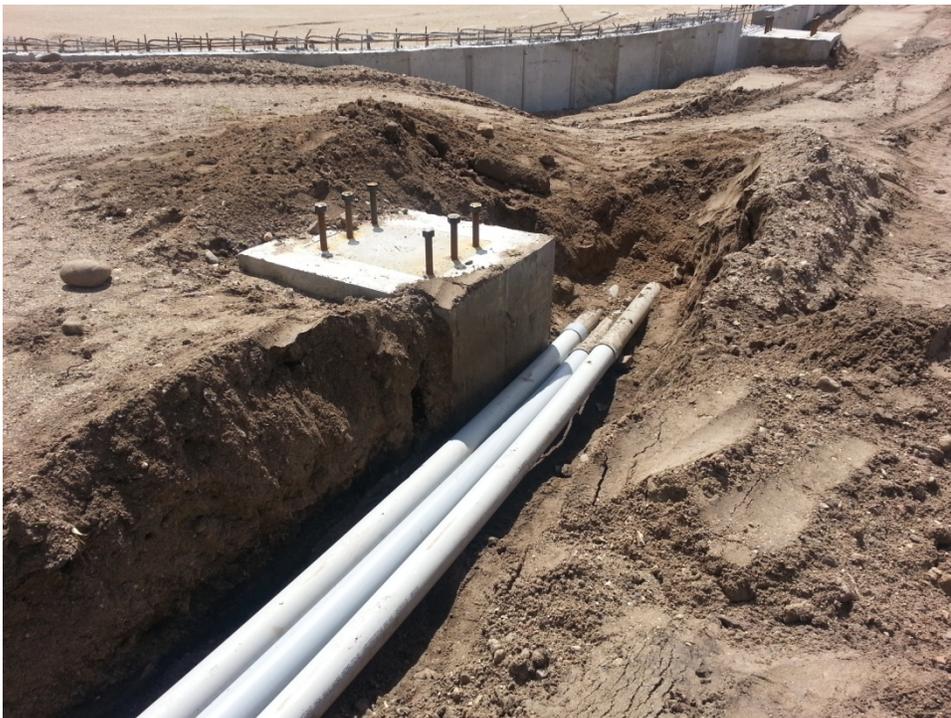
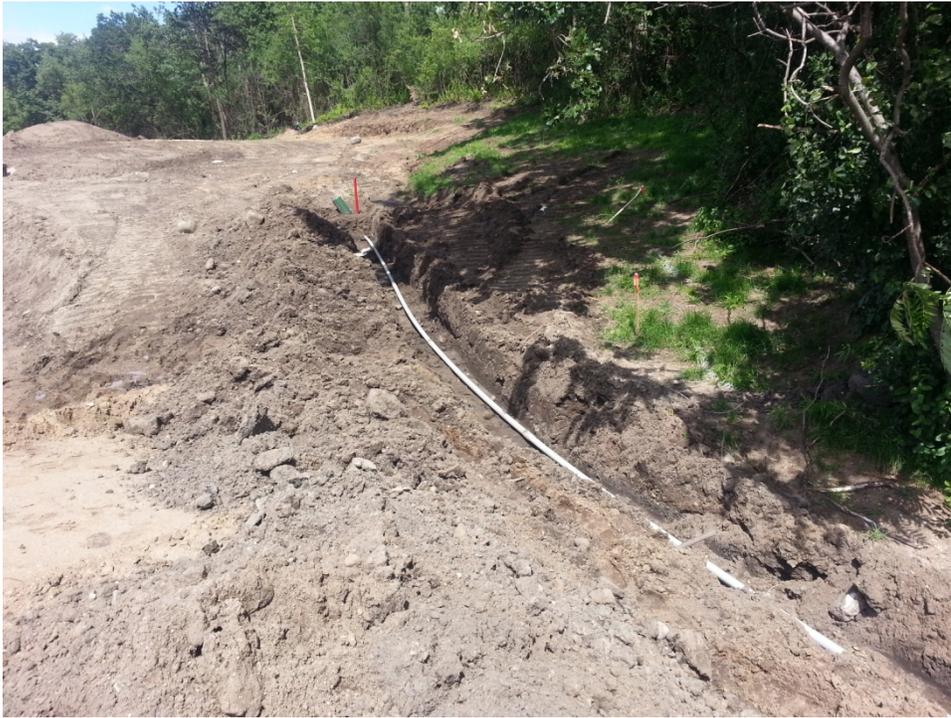
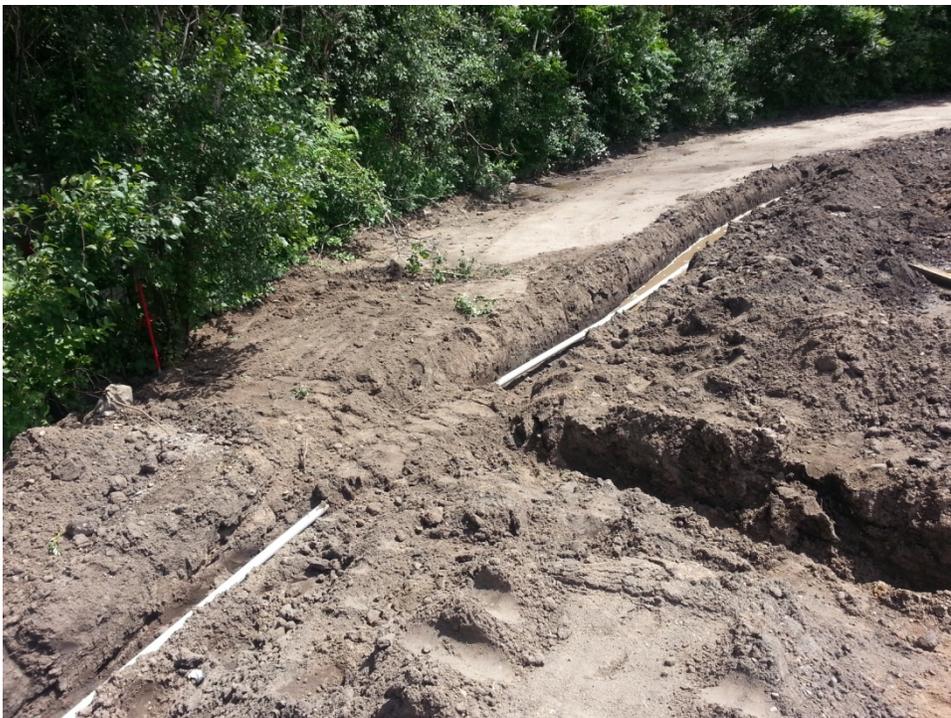
5. Electrical site utility installation between dome and ice rink is currently installed and backfilled.

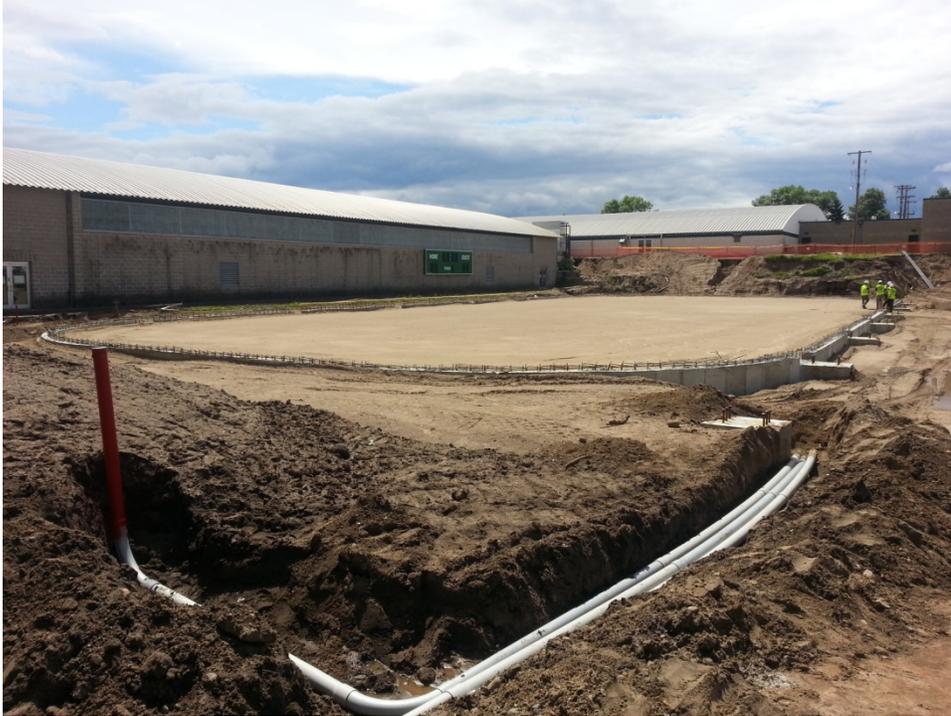
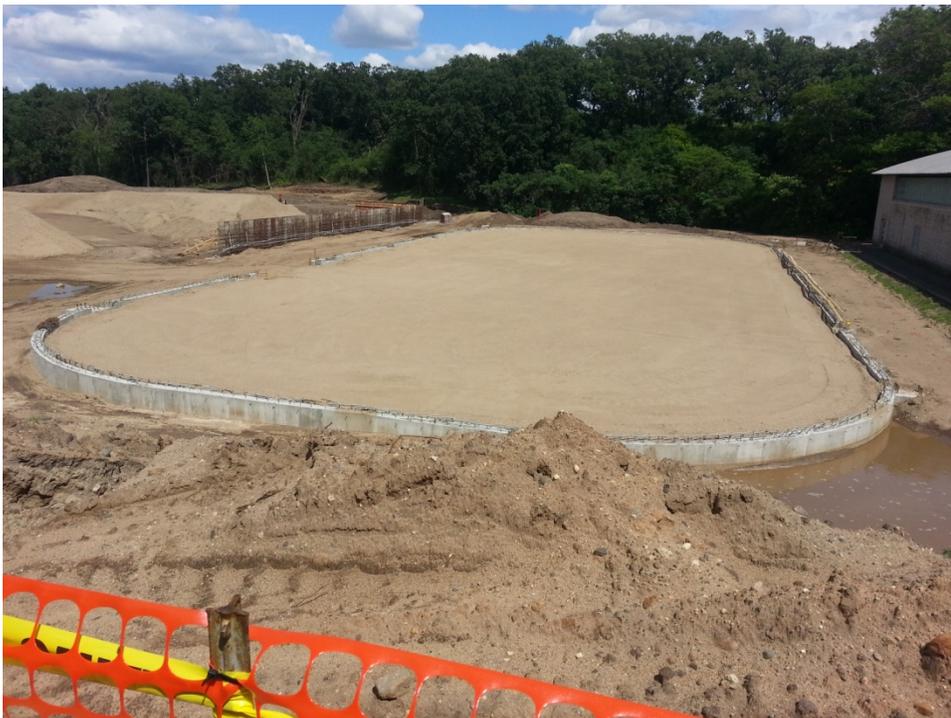
6. Backfill and drain tile installation within ice rink foundation wall is complete with the exception of the opening in the ice rink foundation wall.

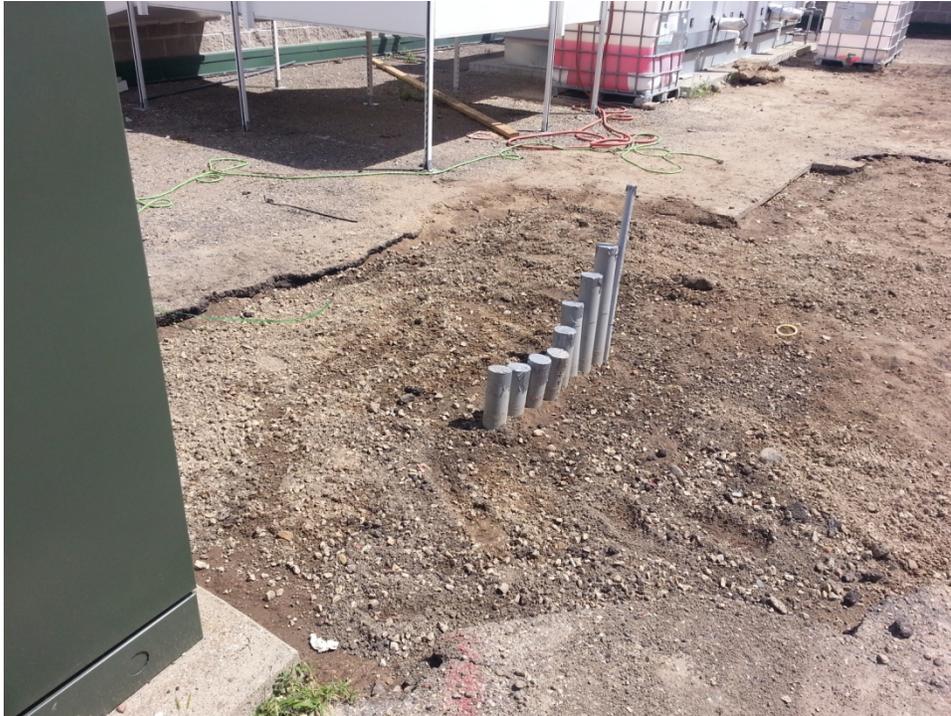
7. Underground utility installation at East Arena transformer complete.
